**April 19, 2023**

**North Bay Village Building & Zoning**  
1666 79<sup>th</sup> Street Causeway #101  
North Bay Village, FL 33141  
**ATTN: Pedro Martinez, Chief Building Official**

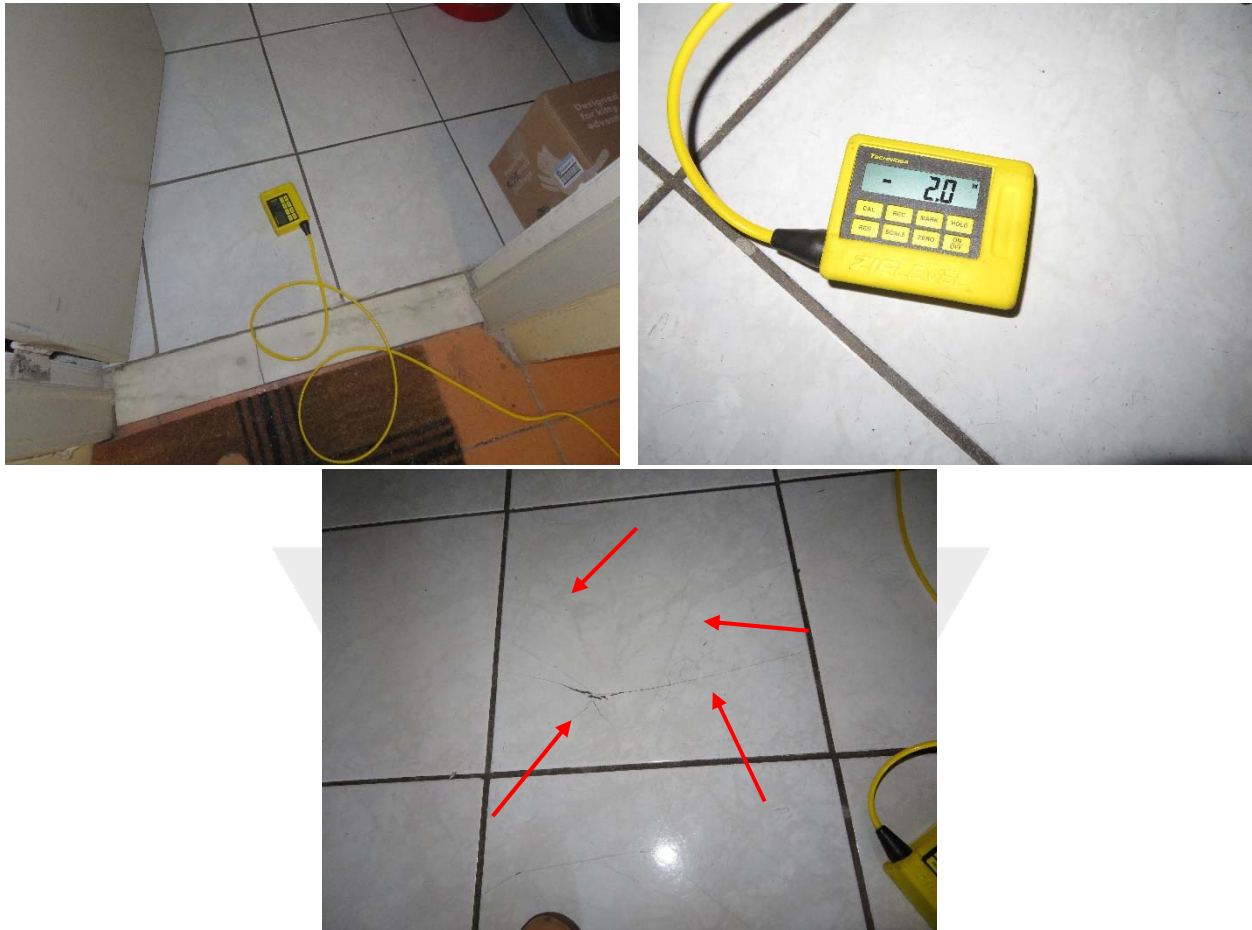
**Figure 2.** Summary of observations made in Unit 310: Relative elevation measurements taken with ZipLevel (**top row**); cracks in ceramic tile flooring installation in middle of living room (**bottom row**).

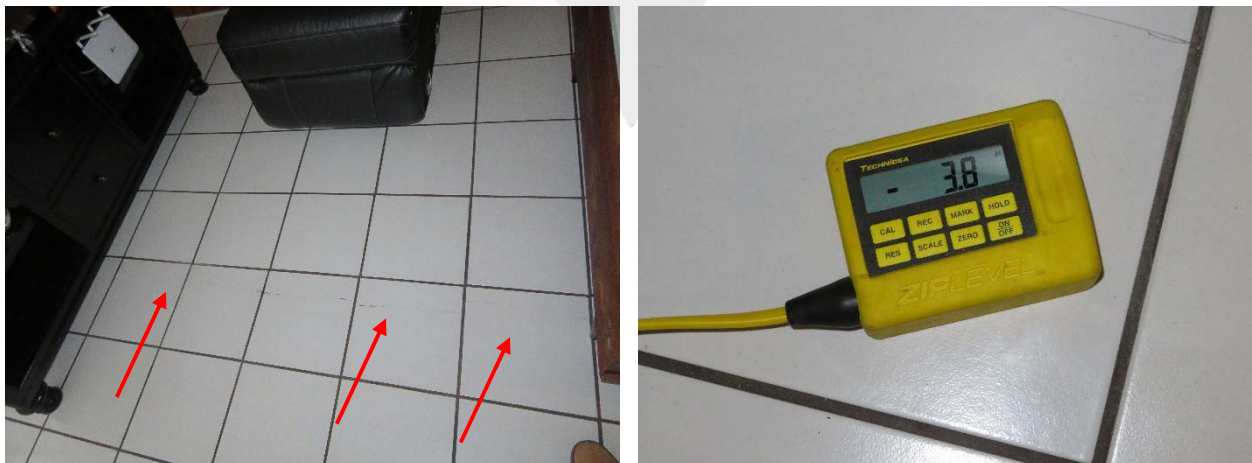
**Figure 3.** Summary of observations made in Unit 308: Linear crack in ceramic tile flooring installation extending across living room (**left**); relative elevation measurement taken with ZipLevel (**right**);.

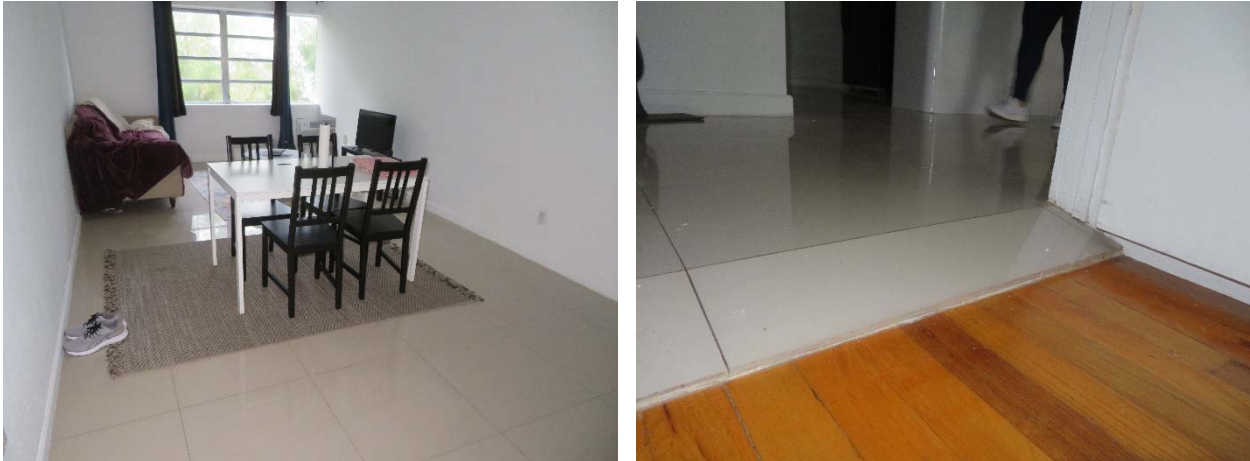
**Figure 4.** Summary of observations made in Unit 307: Installation of ceramic tile flooring within living room (left); termination of ceramic tiles at bedroom entrance, noted by ramp constructed (right).

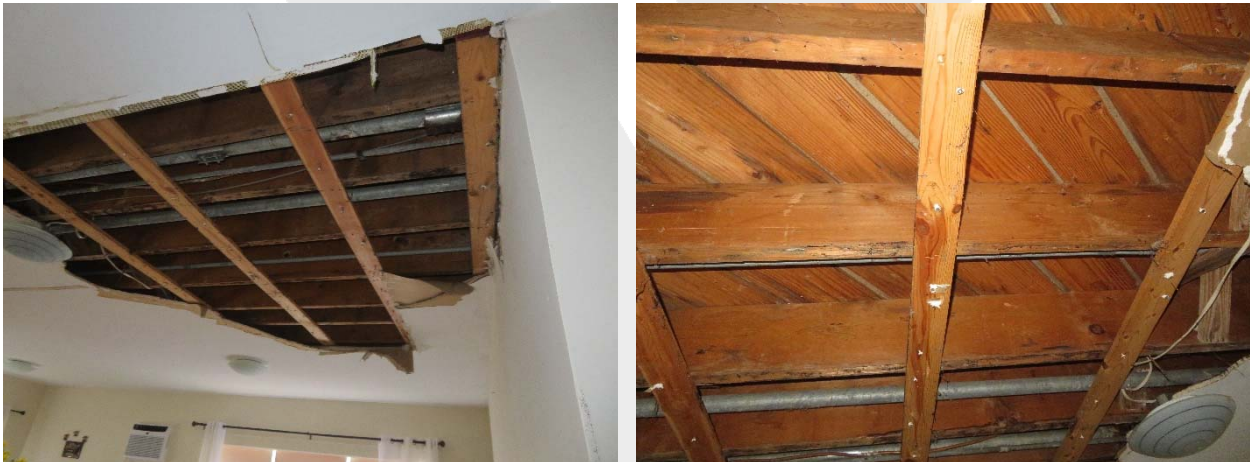
**Figure 5.** Summary of observations made in Unit 209: Exposed ceiling framing below recent water leak from roof drain (left); closeup indicating termite damage to floor joists (right).

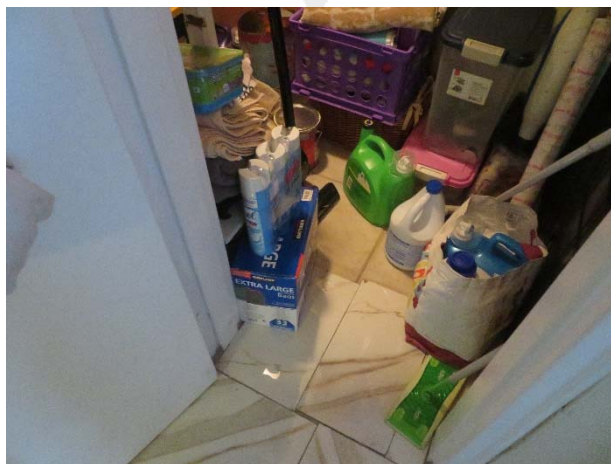
**Figure 6.** Two layers of tile installed over wood decking (Unit 206).
