ORDINANCE NO. 2021-006

AN ORDINANCE OF THE MAYOR AND COMMISSION OF NORTH BAY VILLAGE, FLORIDA, AMENDING THE VILLAGE UNIFIED LAND DEVELOPMENT CODE OF ORDINANCES BY CREATING SECTION 8.16, ENTITLED, “SEA WALL STANDARDS,” IN DIVISION 4, “SUPPLEMENTAL DEVELOPMENT STANDARDS,” CHAPTER 8, “ZONING”; ESTABLISHING SEA WALL DESIGN STANDARDS THROUGHOUT THE VILLAGE; PROVIDING FOR CONFLICTS; PROVIDING FOR SEVERABILITY; PROVIDING FOR INCORPORATION; PROVIDING FOR IMPLEMENTATION; AND PROVIDING FOR AN EFFECTIVE DATE

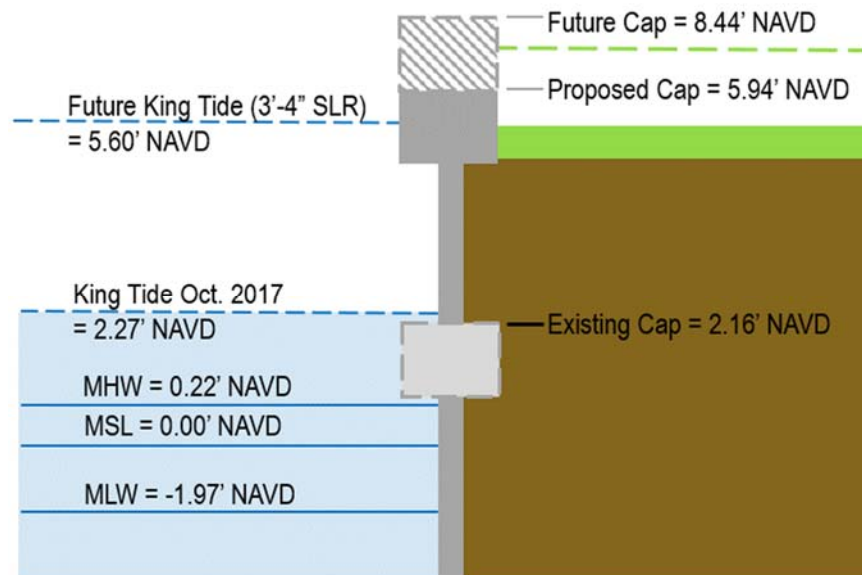
Figure 3-1: Proposed Cap Elevation in relation to Existing and Future Water Levels

The proposed ordinance for Miami21 proposes to raise the minimum seawall elevation to 6.0 ft NAVD (7.55 ft NGVD). The City of Miami Beach utilizes a minimum cap elevation of 5.70 ft NAVD (7.26 ft NGVD) for public properties. The new seawall installed along North Bay Village's Benihana's waterfront has a cap elevation of 5.94 ft NAVD (7.50 ft NGVD). After reviewing the predicted sea level rise and the minimum cap elevations proposed by various governing bodies, the suggested minimum seawall elevation is 5.94 ft NAVD (7.5 ft NGVD). To be in agreement with the NBV100 Study, the structural design of the seawall must also account for the ability to raise the cap in the future by an additional 2.5 feet to an elevation of 8.44 ft NAVD (10.0 ft NGVD) in the future without redesign of the seawall. This adaptability is also appropriate for planning purposes due to uncertainties with sea level rise predictions in the long-term. Figure 3-1 shows both the existing and predicted future (Year 2070) water levels in relation to the proposed seawall cap elevation of 5.94 ft NAVD.

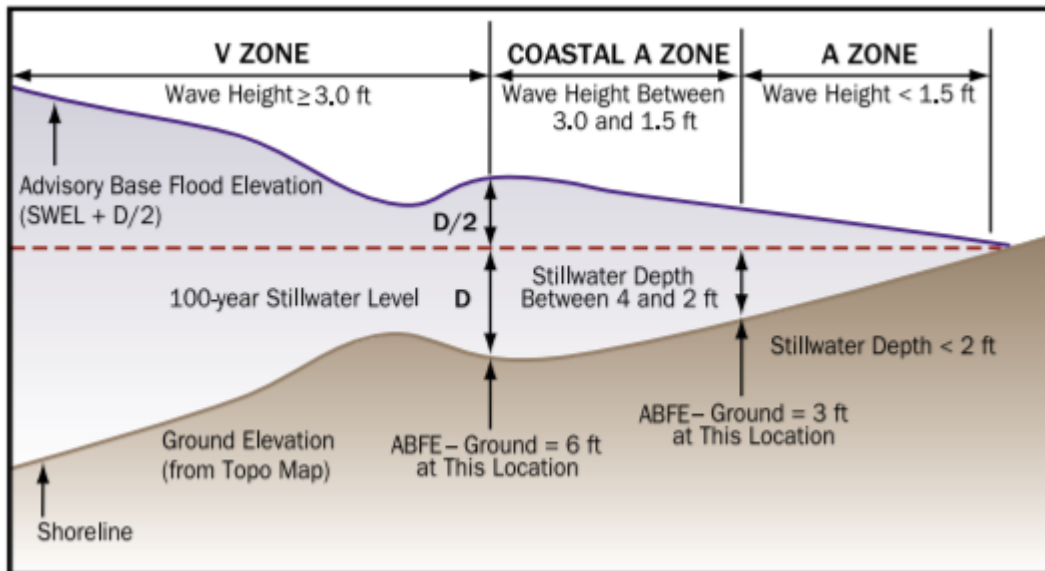
Figure 3-3: Graphic of the Coastal A Zone (Source: FEMA)

The Coastal A Zone is within an AE Zone, and delineates an area that may be affected by 1.5-foot or higher breaking waves and may therefore, be at significant risk during a 100-year flood event. While not formally defined in the NFIP regulations or mapped as a flood zone, the area between Zone VE and within the AE zone with limited wave activity is called the Coastal A Zone (see Figure 3-3). This area is subject to flood hazards associated with floating debris and high-velocity flow associated with waves and debris that can erode and scour building foundations and, in extreme cases, cause foundation failure according to FEMA.

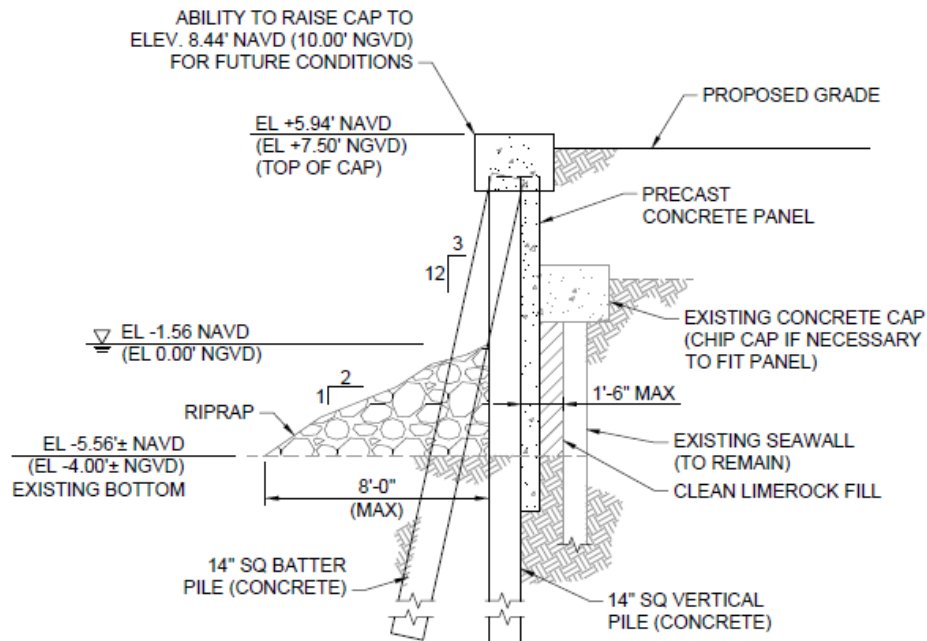
Figure 4-1: Concrete Seawall with Batter Pile Typical

Concrete pile and panel seawalls, whether in conjunction with batter piles (Figure 4-1) or tie-backs (Figure 4-2), are widely used and accepted throughout South Florida. Based on the geotechnical conditions outlined in this report, construction of concrete seawalls is expected to range in cost from \$2,200 to \$3,100 per linear foot. This cost does not include permitting but does include the cost of the riprap.

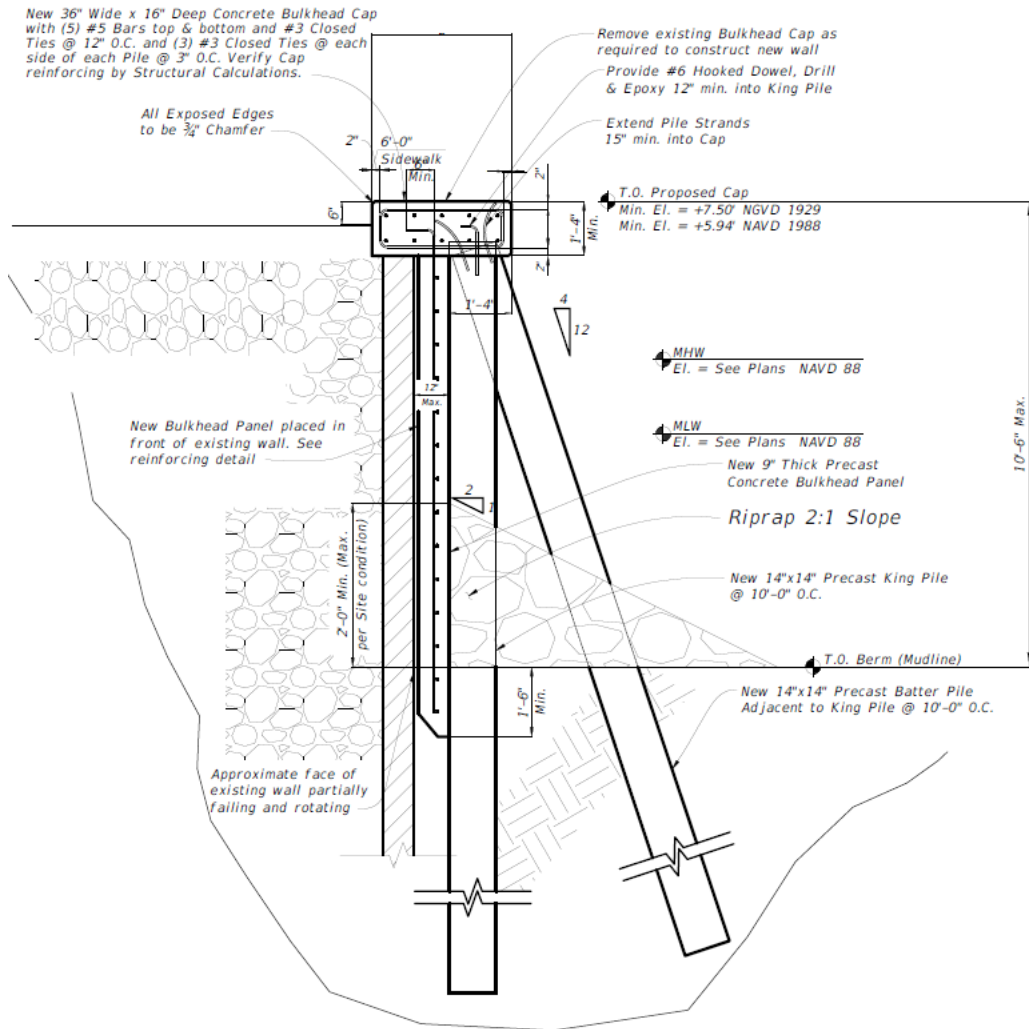
Figure 4-3: University of Miami's GFPR Concrete Seawall with Batter Pile (Courtesy of University of Miami's College of Engineering)

The Glass Fiber Polymer Reinforced (GFPR) Seawall, pioneered by University of Miami's College of Engineering, is similar in design to the standard concrete seawalls shown in Section 4.1, with the exception of the use of GFPR instead of the standard steel rebar and tie rods. It also has the ability to use concrete made with seawater versus freshwater, thus improving the sustainability of this design. Seawall components made with seawater will need adequate upland area to perform concrete mixing and be cast-in-place. Precast elements are not available in seawater concrete, at this time. Figure 4-3 shows the GFPR concrete batter pile wall and Figure 4-4 shows the GFPR concrete wall with tie-backs. The use of GFPR instead of steel reinforcement increases the cost per linear foot by about 10 percent. Seawalls constructed with GFPR are expected to have a 50-year design life. The use of GFPR reduces the rate of corrosion. GFPR is already being used by FDOT in the design on concrete structures in highly aggressive environments. Appendix D contains additional information from University of Miami on the testing and design of the GFPR, as well as other progressive materials used in seawall design.

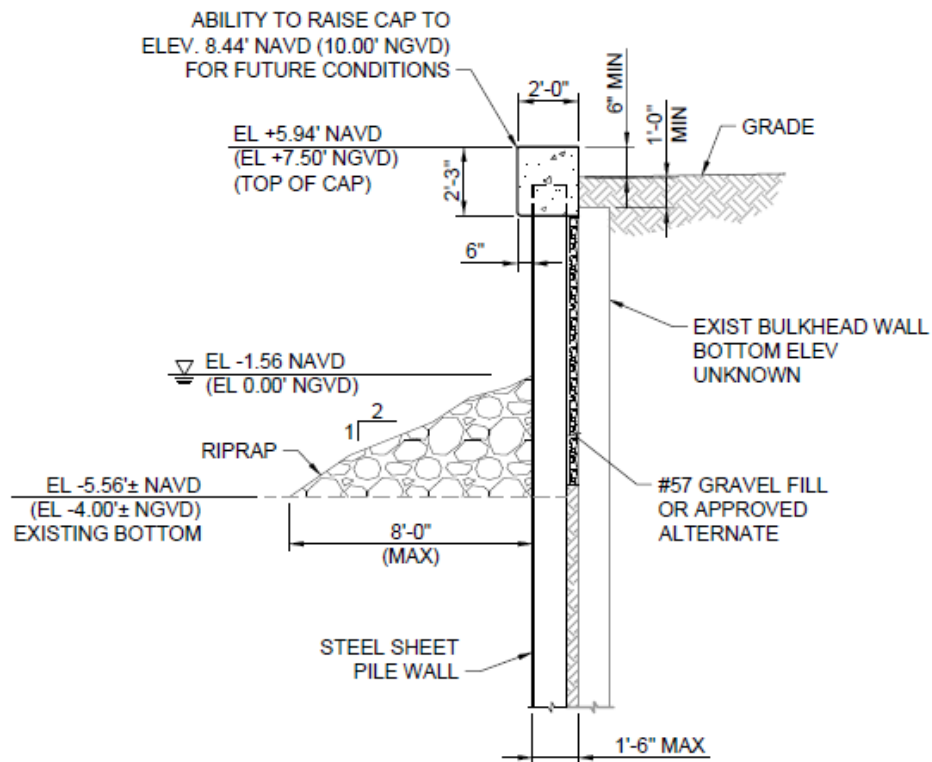
Figure 4-5: Cantilever Steel Sheet Pile Wall Typical

Sheet pile seawalls can be steel, composite, or vinyl. Steel sheet pile walls, with and without tie-backs, are often used in South Florida for their ability to penetrate the hard limestone layer without the need for predrilling (see Figure 4-5). Composite sheet piles (see Figure 4-6) are more widely used in other parts of the state; based on the geotechnical information obtained in Section 3.2 and the anticipated exposed height, they are a viable option for North Bay Village. Vinyl sheet piling is not applicable due to the exposed wall height. Construction of steel sheet pile walls is expected to range in cost from \$2,900 to \$3,800 per linear foot, while composite sheet pile is expected to range from \$1,800 to \$2,800 per linear foot installed. This cost does not include permitting but does include the cost of the riprap.

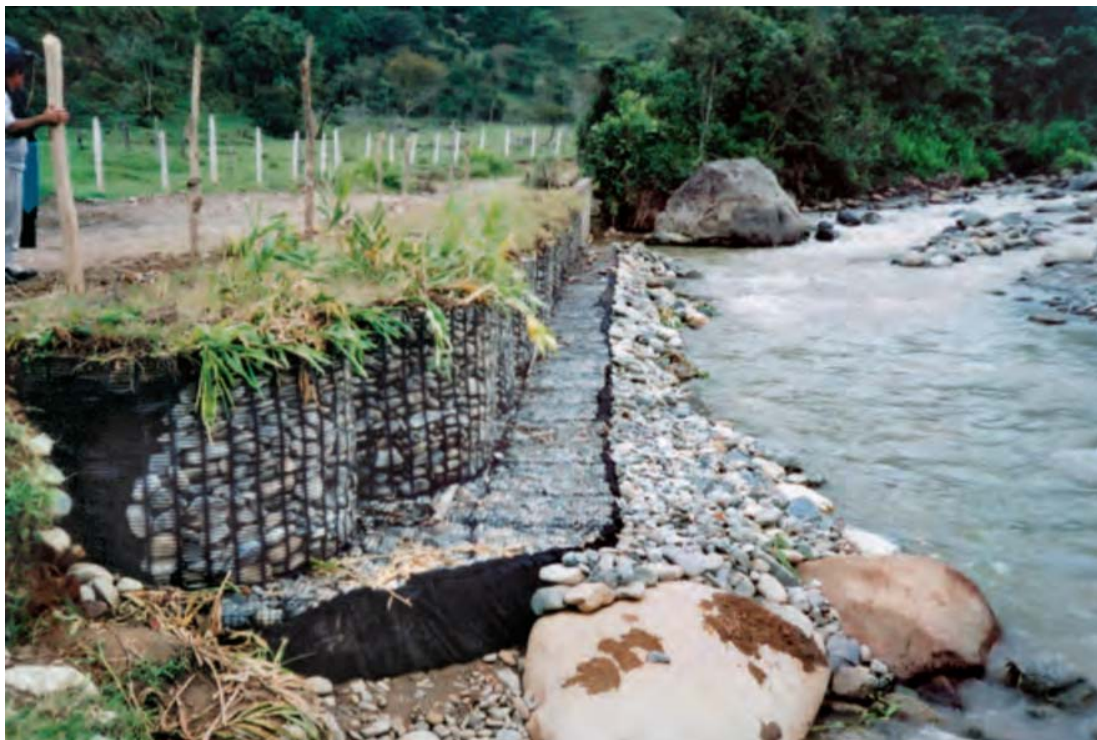
Figure 4-8: Tensar Triton Marine Cells (courtesy of www.tensarcorp.com)

Various additional living shoreline options are also available on the market today that utilize a smaller footprint than was historically feasible. For example, several geosynthetic vendors manufacture grid systems for marine applications (see Figure 4-8). Vegetated Reinforced Soil Slopes can also be installed (see Figure 4-9).

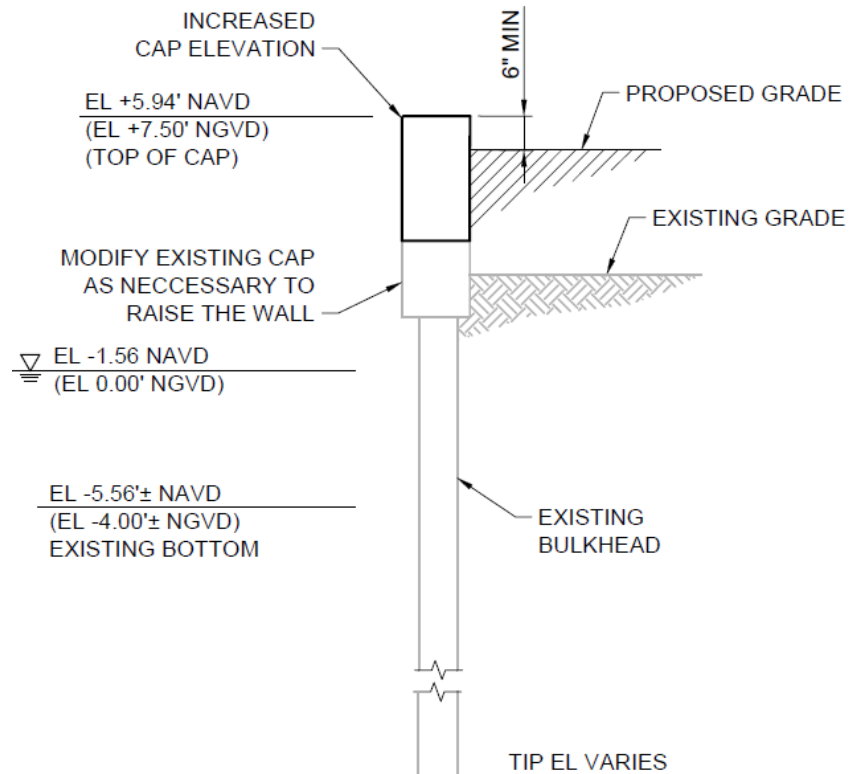
Figure 4-10: Existing Wall with Raised Cap Typical

In addition to seawall replacement, it may be possible to raise the existing seawall in select locations throughout the Village to meet the new required height of 5.94 ft NAVD (7.50 ft NGVD). Individual owners will need to obtain a full structural evaluation from an engineer prior to design and approval of raising any existing seawall. Figure 4-10 is a cross section of a typical section with a raised cap.

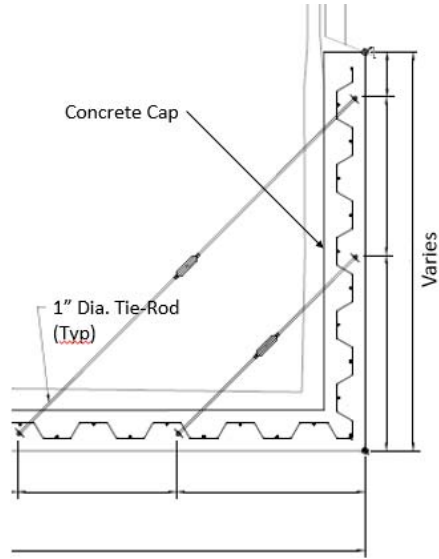
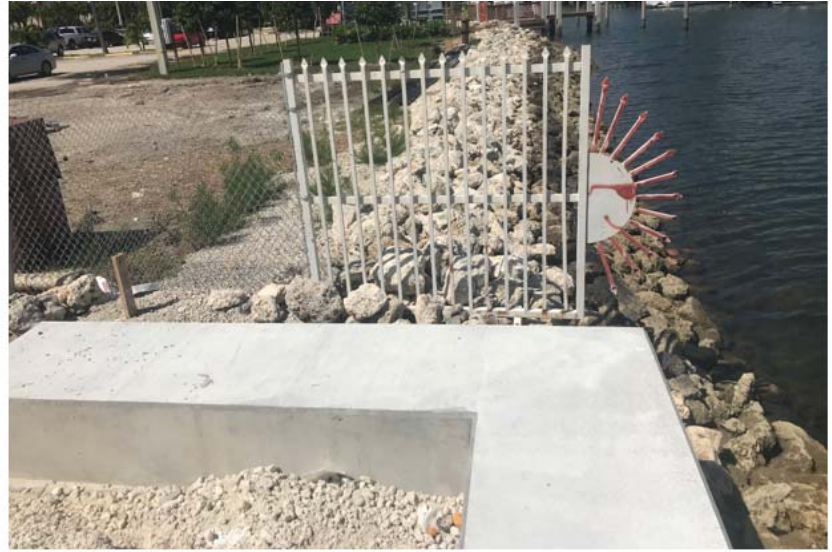
Figure 4-11: Typical Return Wall with Tie-rods and Concrete Cap Plan View and Photo

Individual property owners will be required to tie-in to the surrounding seawalls as they raise or replace the existing walls. Return walls may be required in some locations. Return walls at the 90-degree section of the seawalls that turn into one's property when an adjacent wall cannot be tied into. This will need to be analyzed on a case-by-case basis. Figure 4-11 shows a typical return wall with a concrete cap.

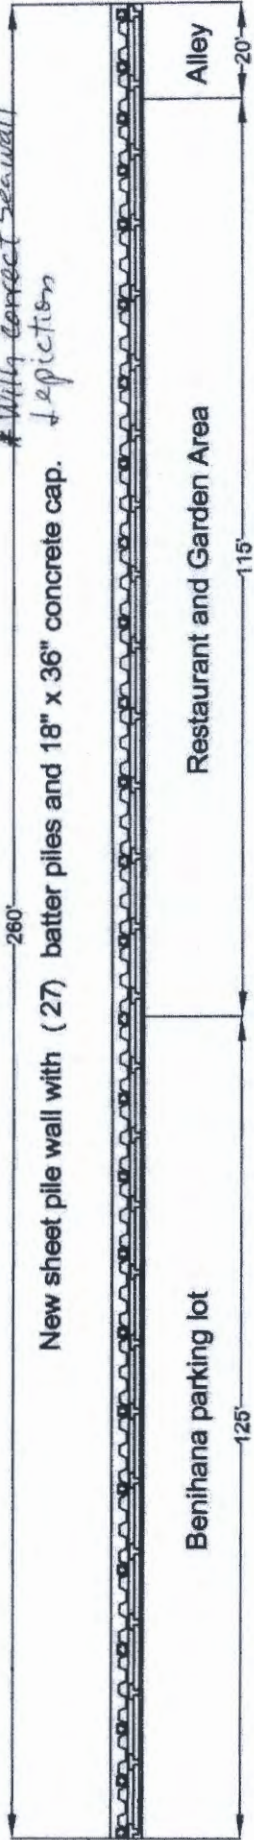
Proposed Site Plan n.t.s.

New sheet pile wall shall be located within 18" of existing seawall panel

* With correct seawall depiction

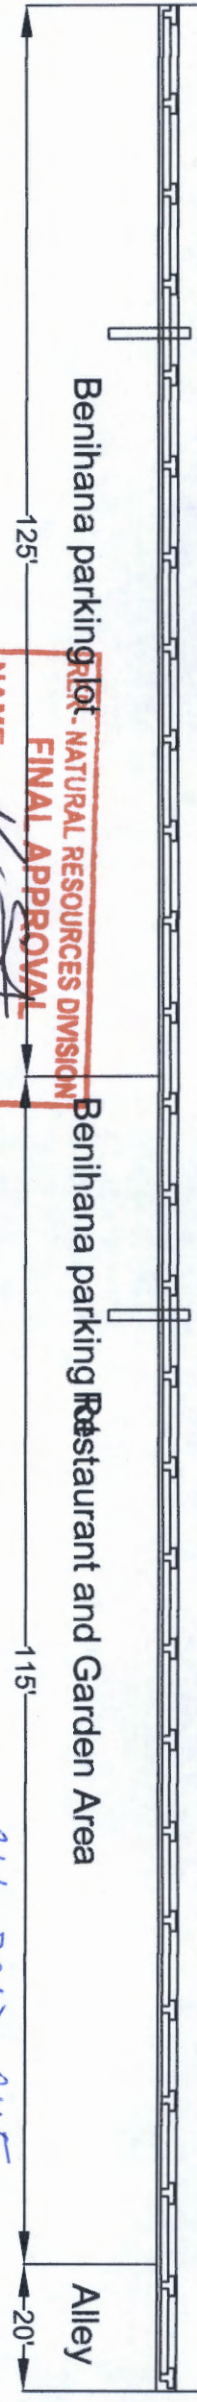
Existing Site Plan n.t.s.

Existing T-pile, panel wall with cap and CMU wall on top of cap (remove portions as necessary otherwise they remain)
 8" drain pipe (to be cut, capped and sealed))
 8" drain pipe (to be cut, capped and sealed)

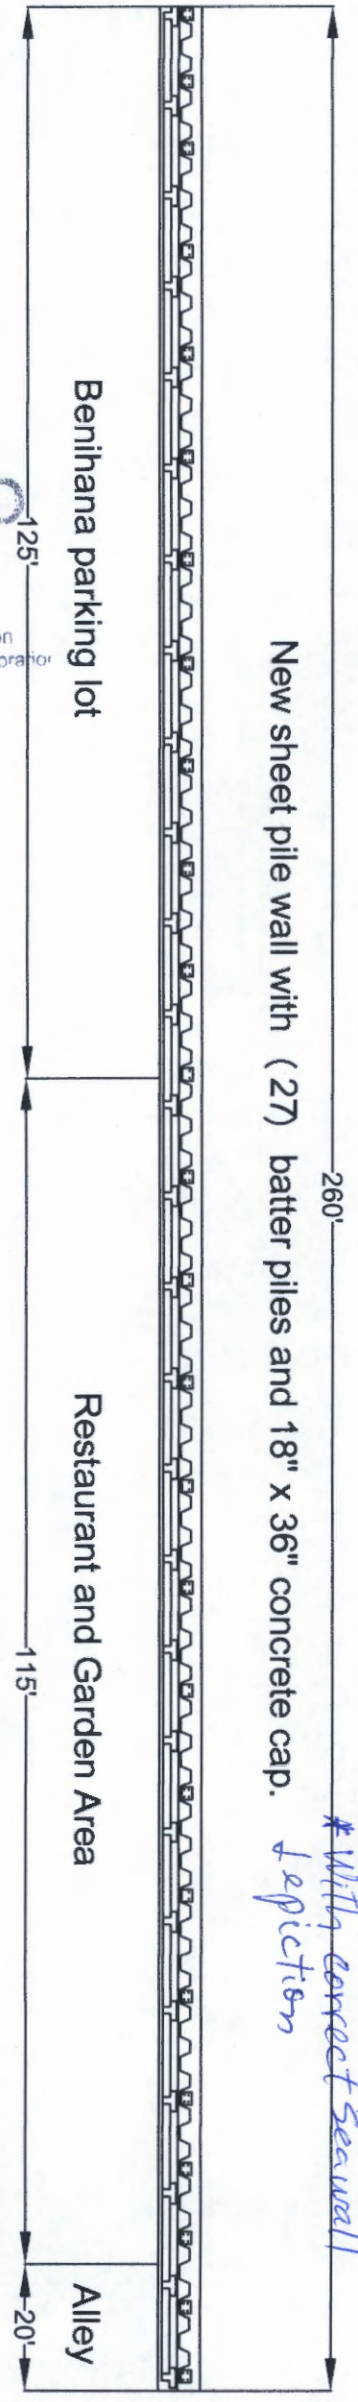
Proposed Site Plan n.t.s.
RECEIVED
 JUN 30 2017
 DERM Coastal Resources Section
 Natural Resources Regulation & Restoration
 Division (NRRRD)

New sheet pile wall shall be located within 18" of existing seawall panel

New sheet pile wall with (27) batter piles and 18" x 36" concrete cap.
**With correct Seawall depiction*

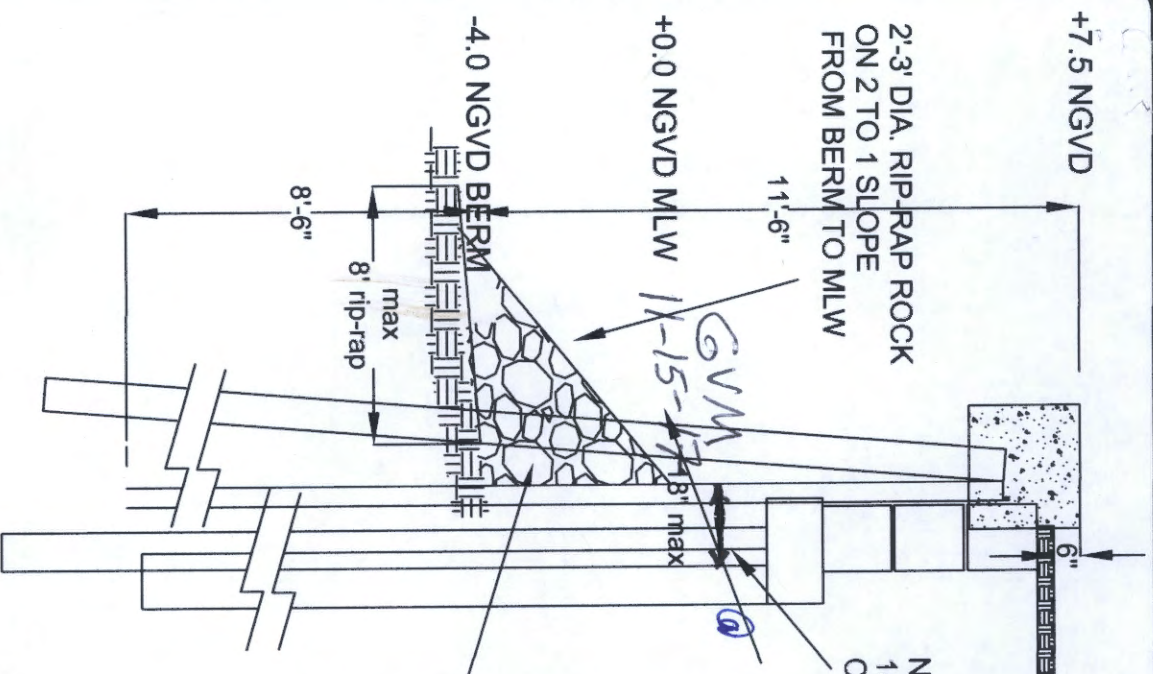
EXISTING WALL MADE OUT OF CMU BLOCK ON TOP OF T-PILE PANEL WALL TO BE REMOVED AS NEEDED

NEW WALL TO BE PLACED WITHIN 18" OF EXISTING SEAWALL PANEL CHIP EXISTING CAP IF NECESSARY TO FIT PANEL

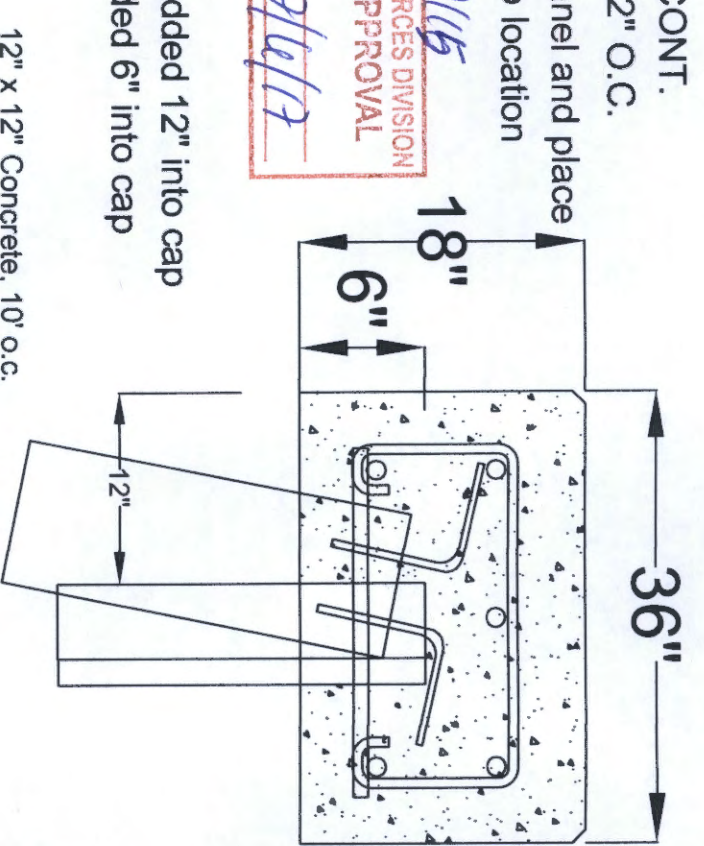
CAP DETAILS n.t.s.

(5) #5 BARS CONT.
#4 STIRRUPS, 12" O.C.
Burn hole thru panel and place #8 at each stirrup location

Panel embedded 12" into cap
Pile embedded 6" into cap

12" x 12" Concrete, 10' o.c. pile (Cap. 34 Kips) on 18 deg batter driven min. 15' embedment. Min. 20 ton bearing capacity. Extend pile prestressed strands 24" into slab or epoxy dowel (4) #5 into piles.

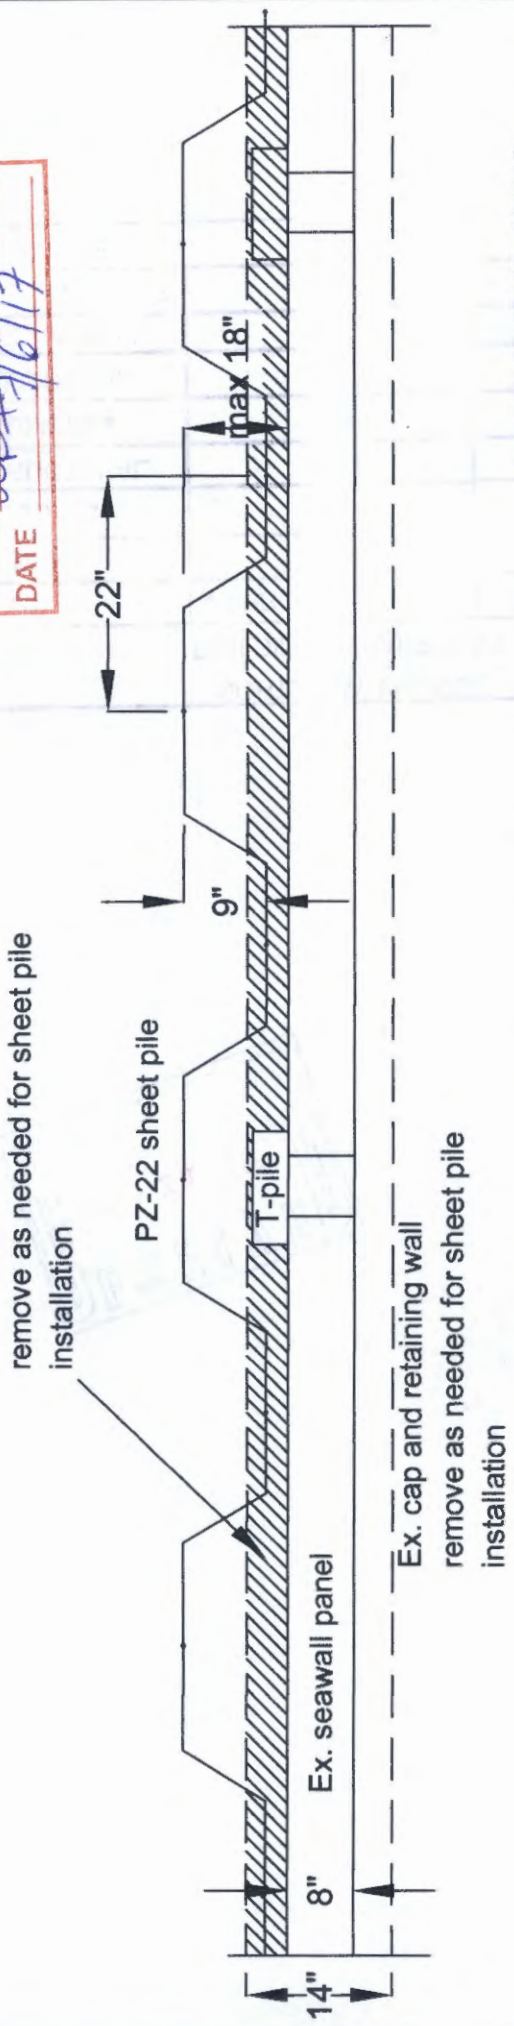
Placement of sheet pile panels within 18" of ex. seawall panel

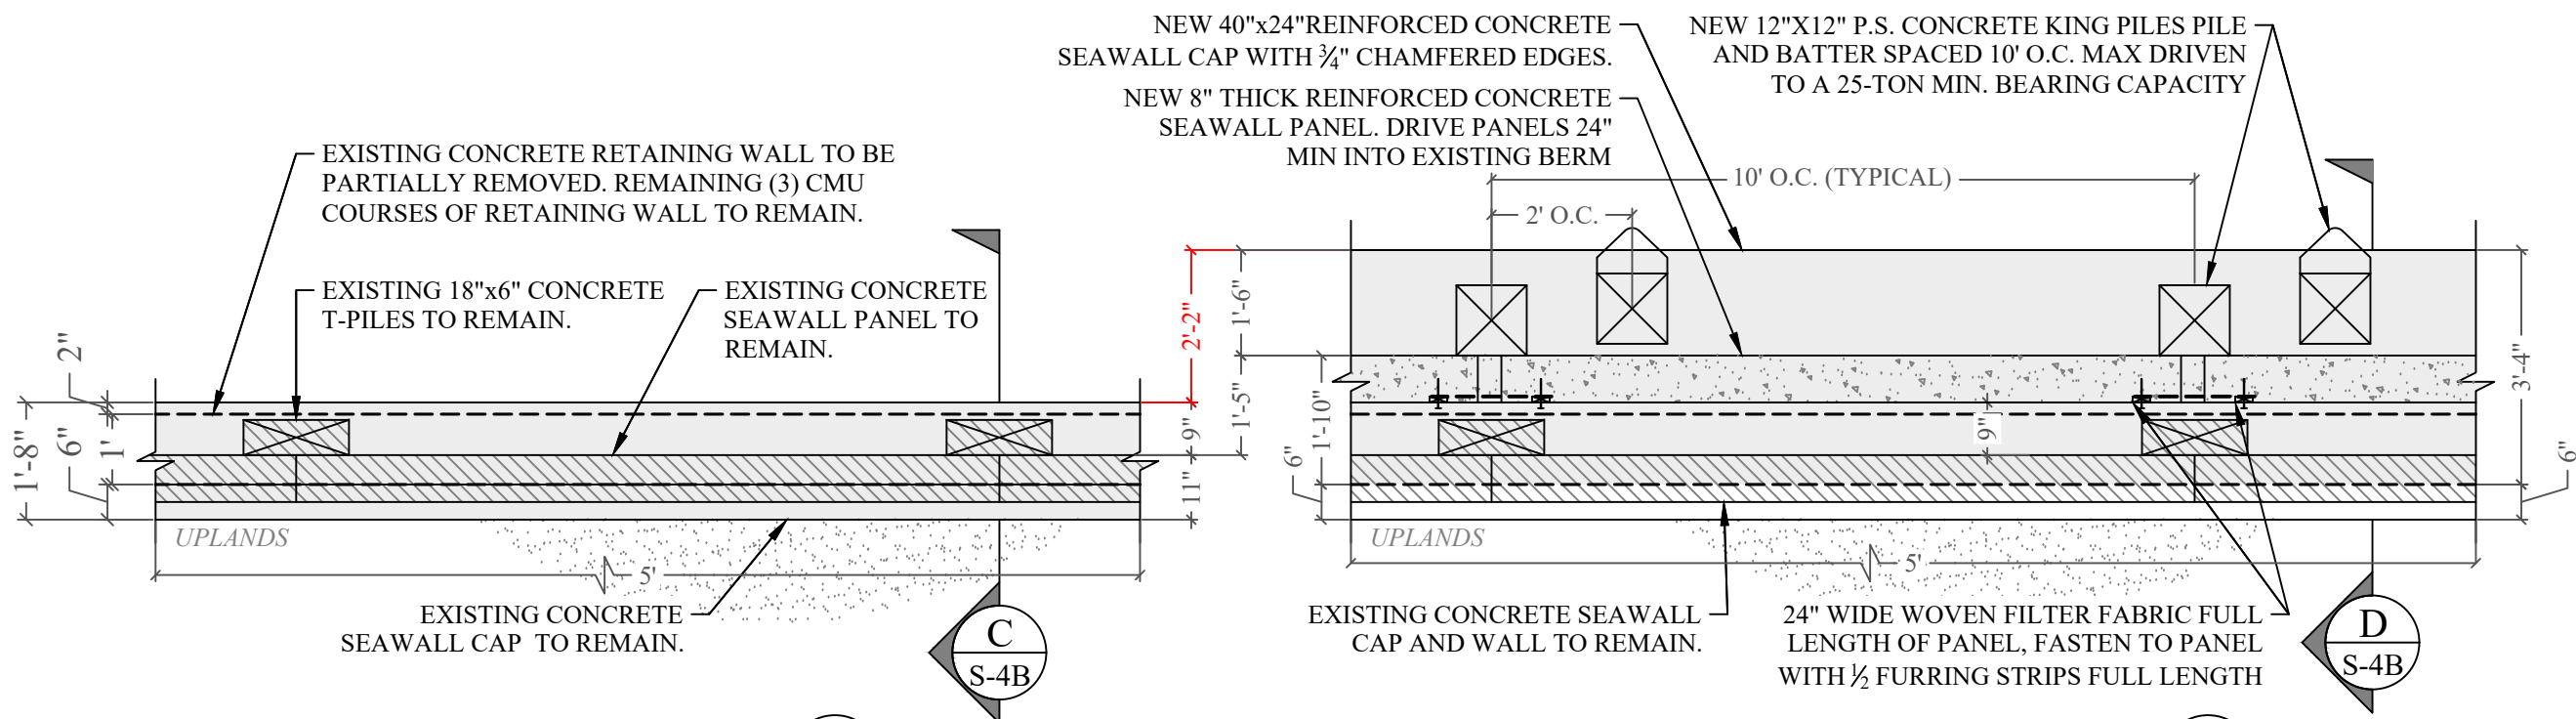
EXISTING SEAWALL CONDITION 3
 DETAIL (TYP.)
 SCALE: 3/8" = 1'-0"

PROPOSED SEAWALL CONDITION 4
 DETAIL (TYP.)
 SCALE: 3/8" = 1'-0"

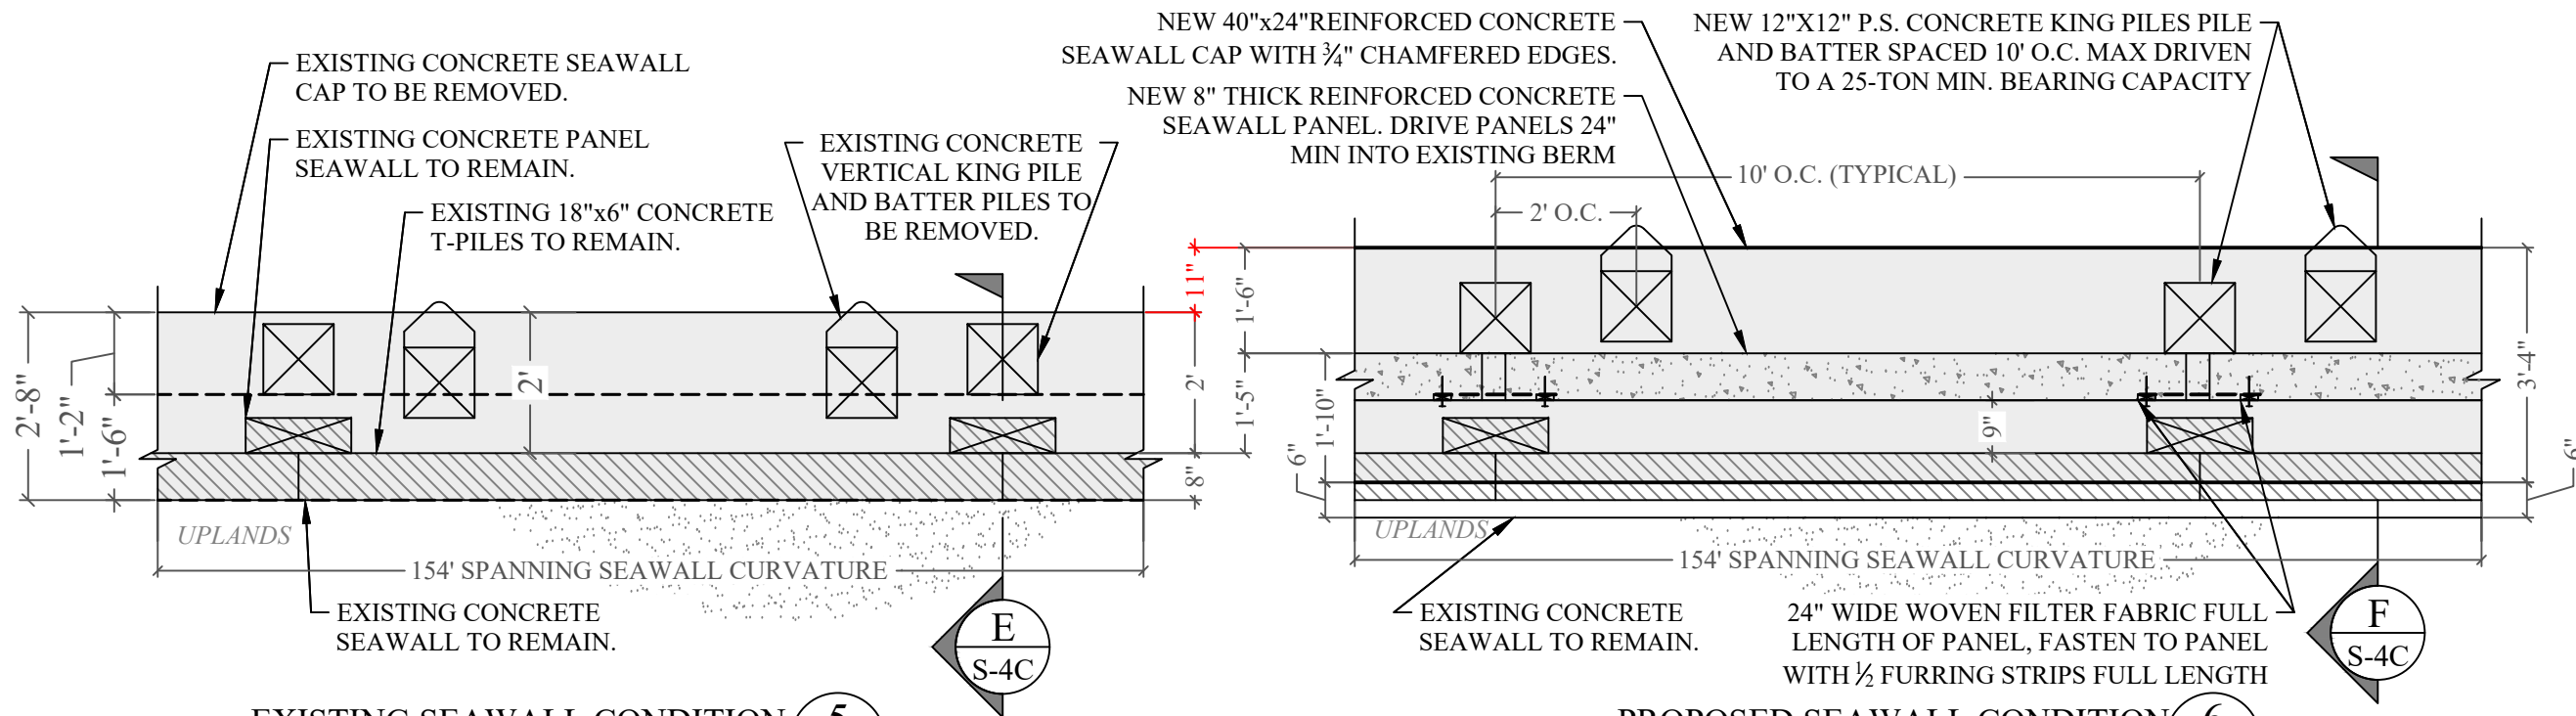
EXISTING SEAWALL CONDITION 5
 DETAIL (TYP.)
 SCALE: 3/8" = 1'-0"

PROPOSED SEAWALL CONDITION 6
 DETAIL (TYP.)
 SCALE: 3/8" = 1'-0"

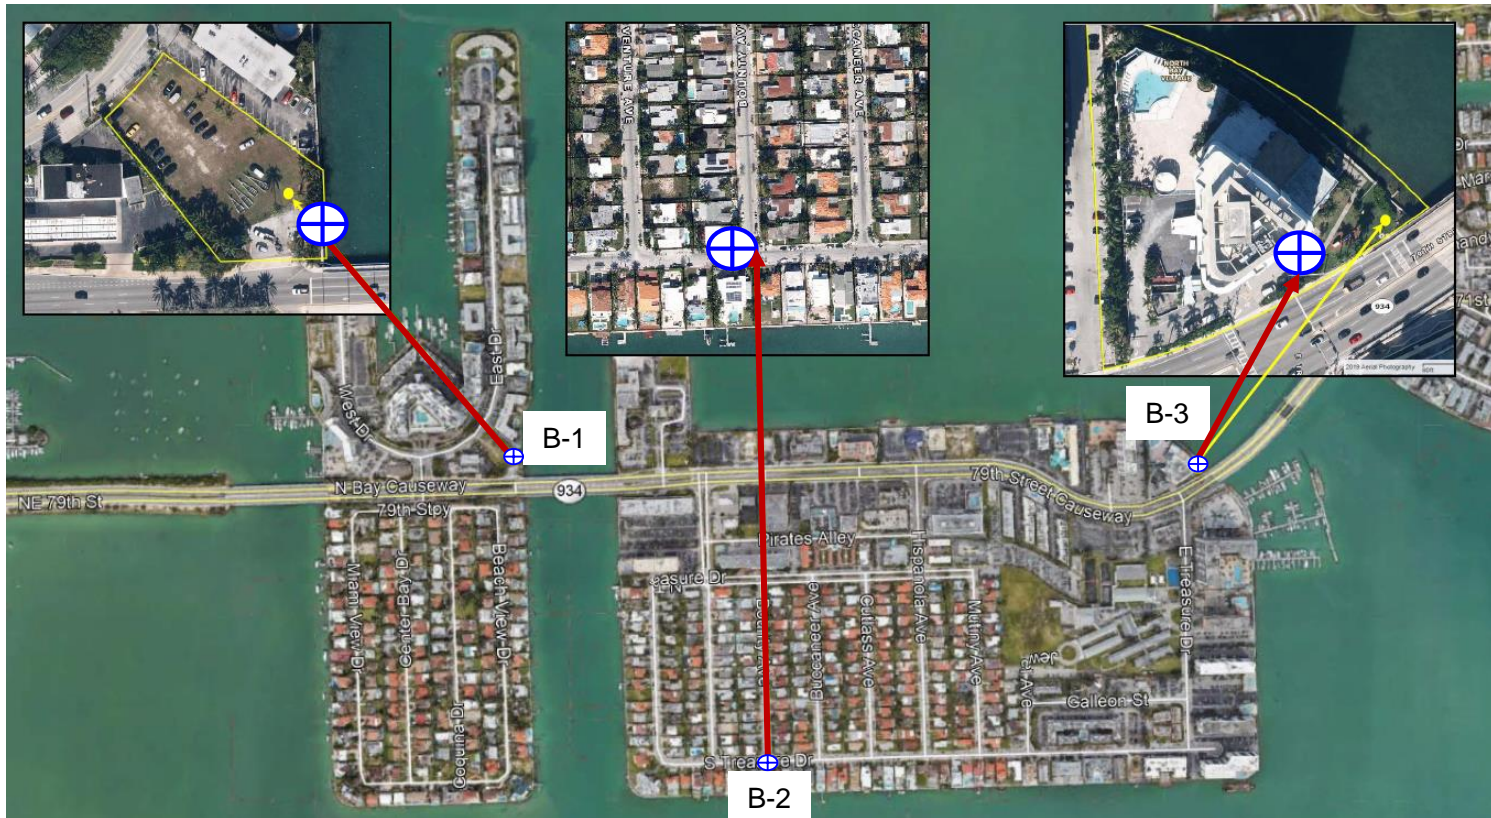
FIG
2

⊕ *Approximate Boring Location*

BORING LOCATION PLAN – FIGURE 2

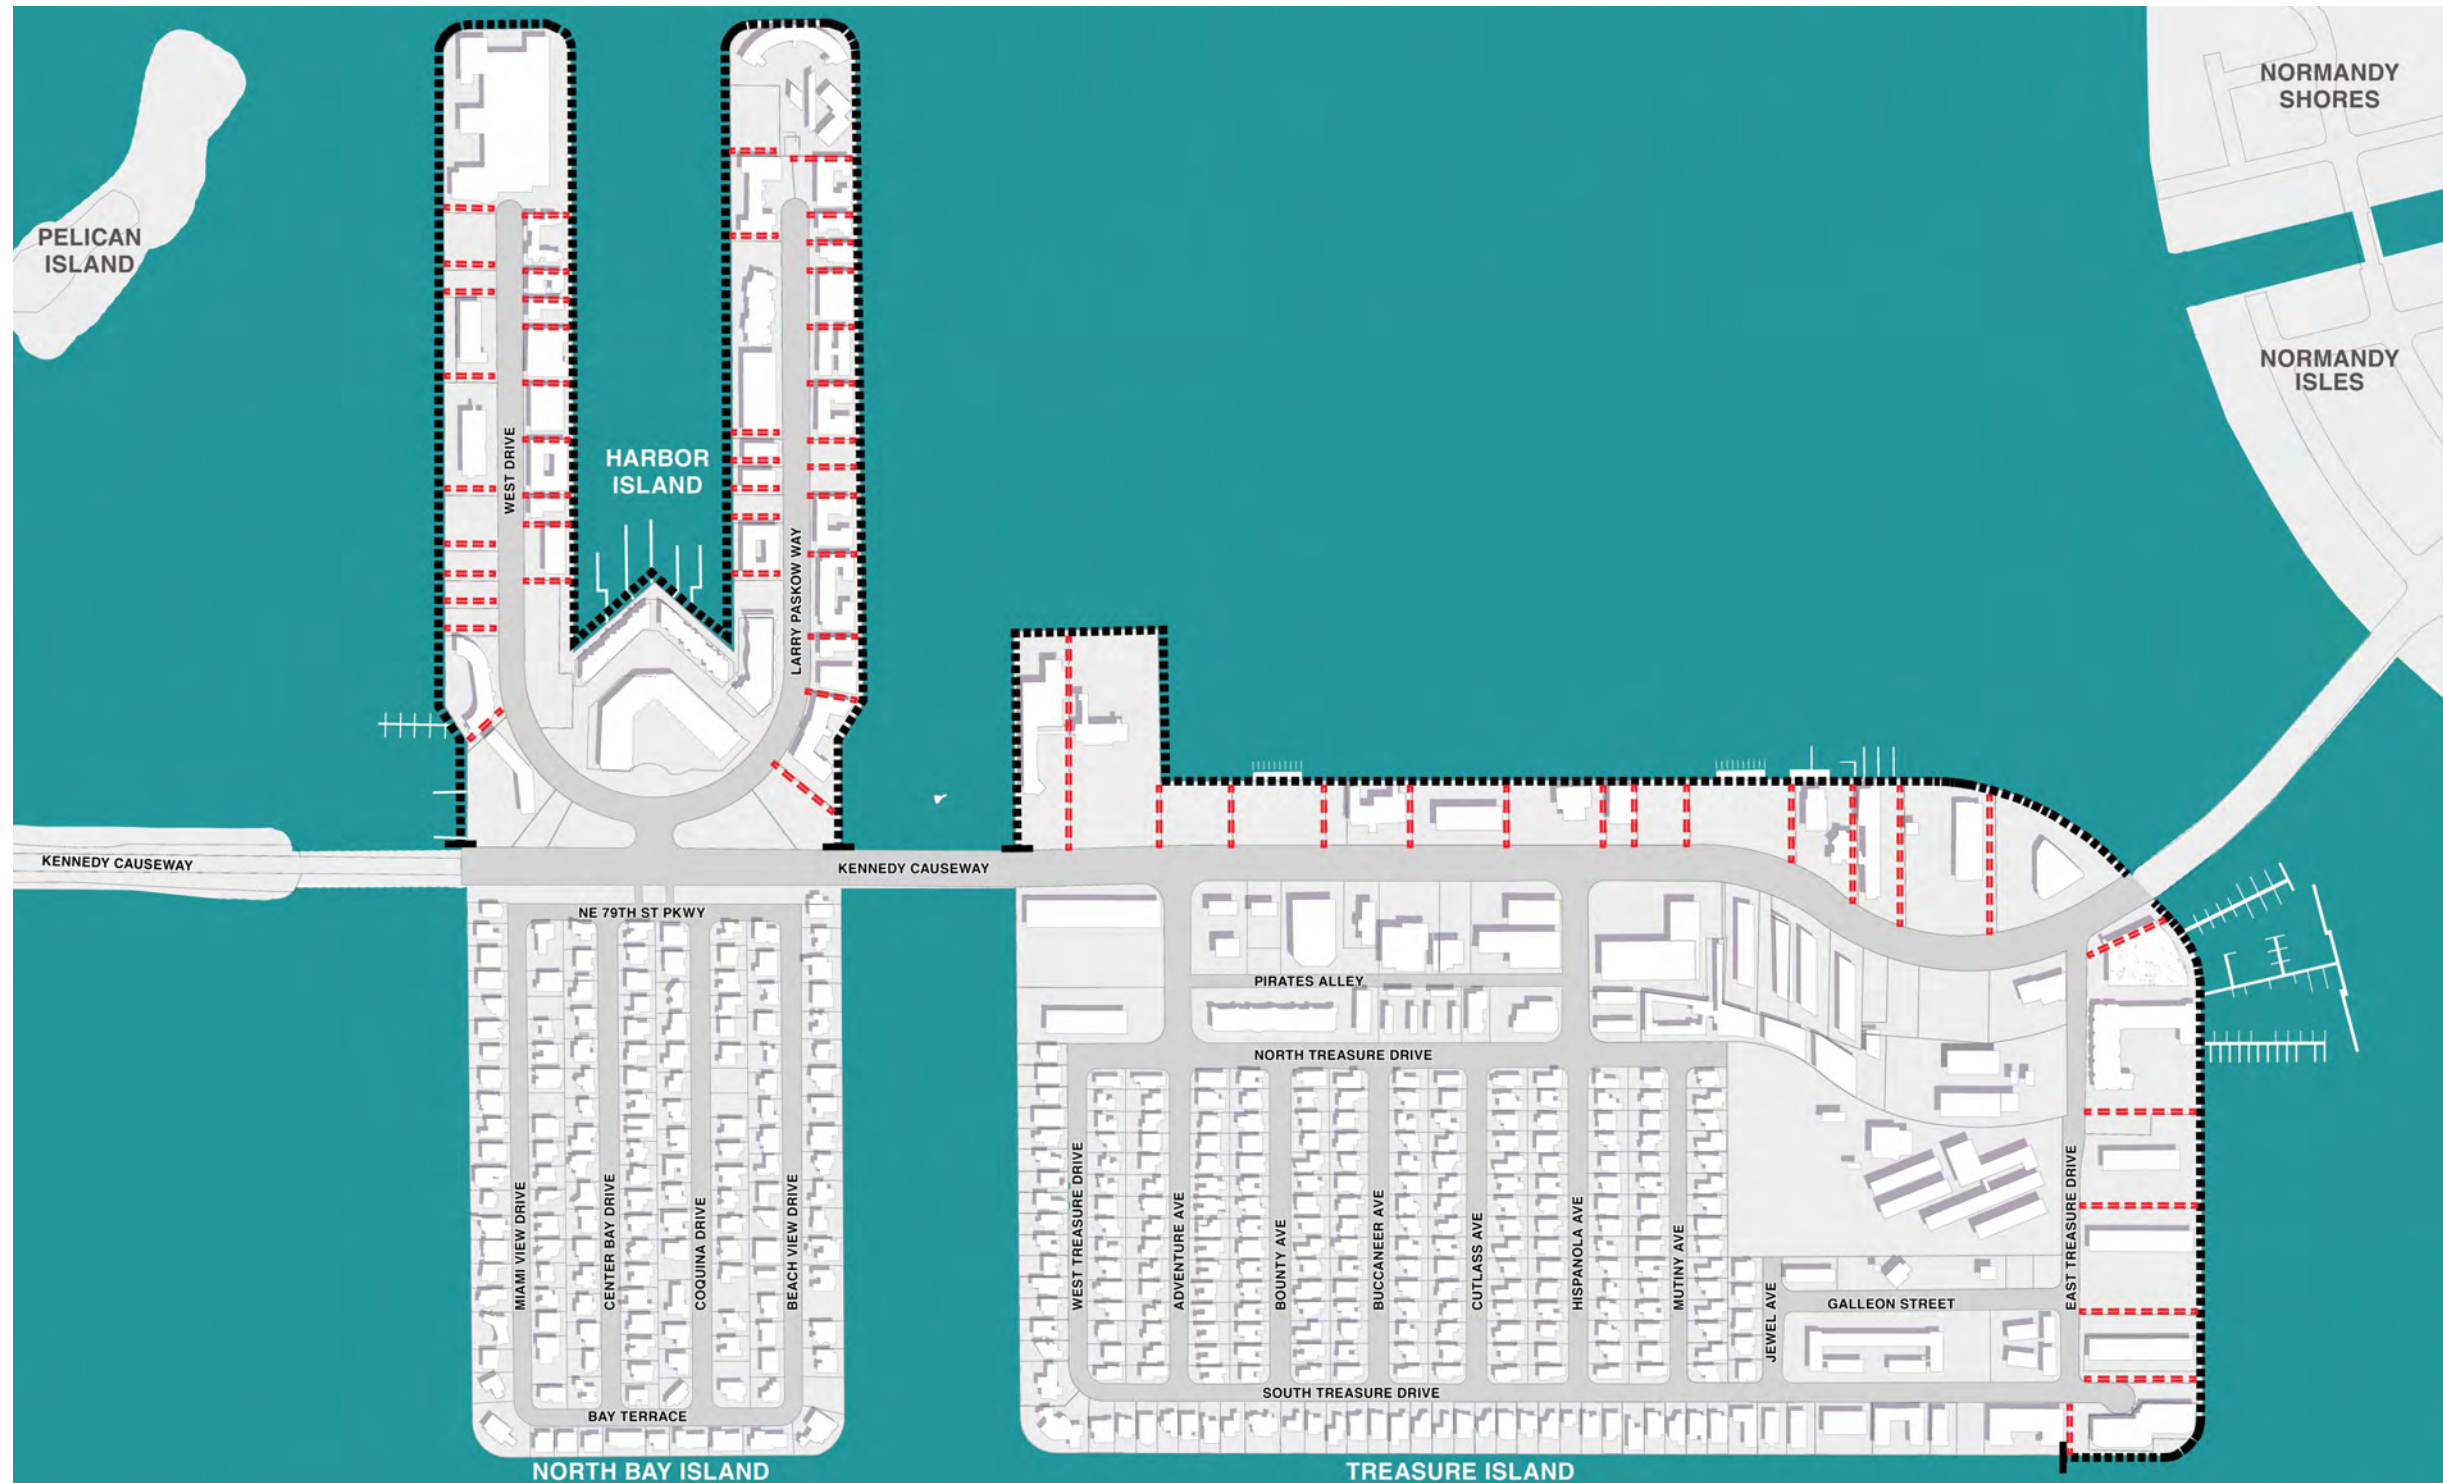
Shoreline Walkway – Segment lengths when completed (approximate)

- Treasure Island north of Kennedy 0.81 miles (4,296 FT)
- Treasure Island south of Kennedy 0.45 miles (2,400 FT)
- Harbor Island 1.81 miles (9,567 FT)

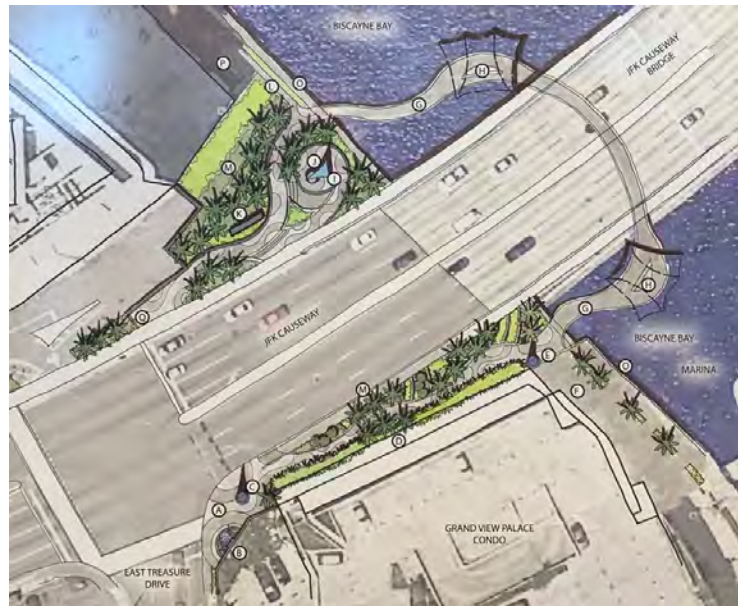
*Preliminary Design for Waterfront Pedestrian Bridge under the Causeway to connect future sections of the Island Walk.
Design by Kimley Horn.*

NBV secured funding for the design of a waterfront pedestrian bridge under the Causeway that would make a difficult connection between two portions of a future walkway.
