ORDINANCE NO. 2021-006

AN ORDINANCE OF THE MAYOR AND COMMISSION OF NORTH BAY VILLAGE, FLORIDA, AMENDING THE VILLAGE UNIFIED LAND DEVELOPMENT CODE OF ORDINANCES BY CREATING SECTION 8.16, ENTITLED, “SEA WALL STANDARDS,” IN DIVISION 4, “SUPPLEMENTAL DEVELOPMENT STANDARDS,” CHAPTER 8, “ZONING”; ESTABLISHING SEA WALL DESIGN STANDARDS THROUGHOUT THE VILLAGE; PROVIDING FOR CONFLICTS; PROVIDING FOR SEVERABILITY; PROVIDING FOR INCORPORATION; PROVIDING FOR IMPLEMENTATION; AND PROVIDING FOR AN EFFECTIVE DATE

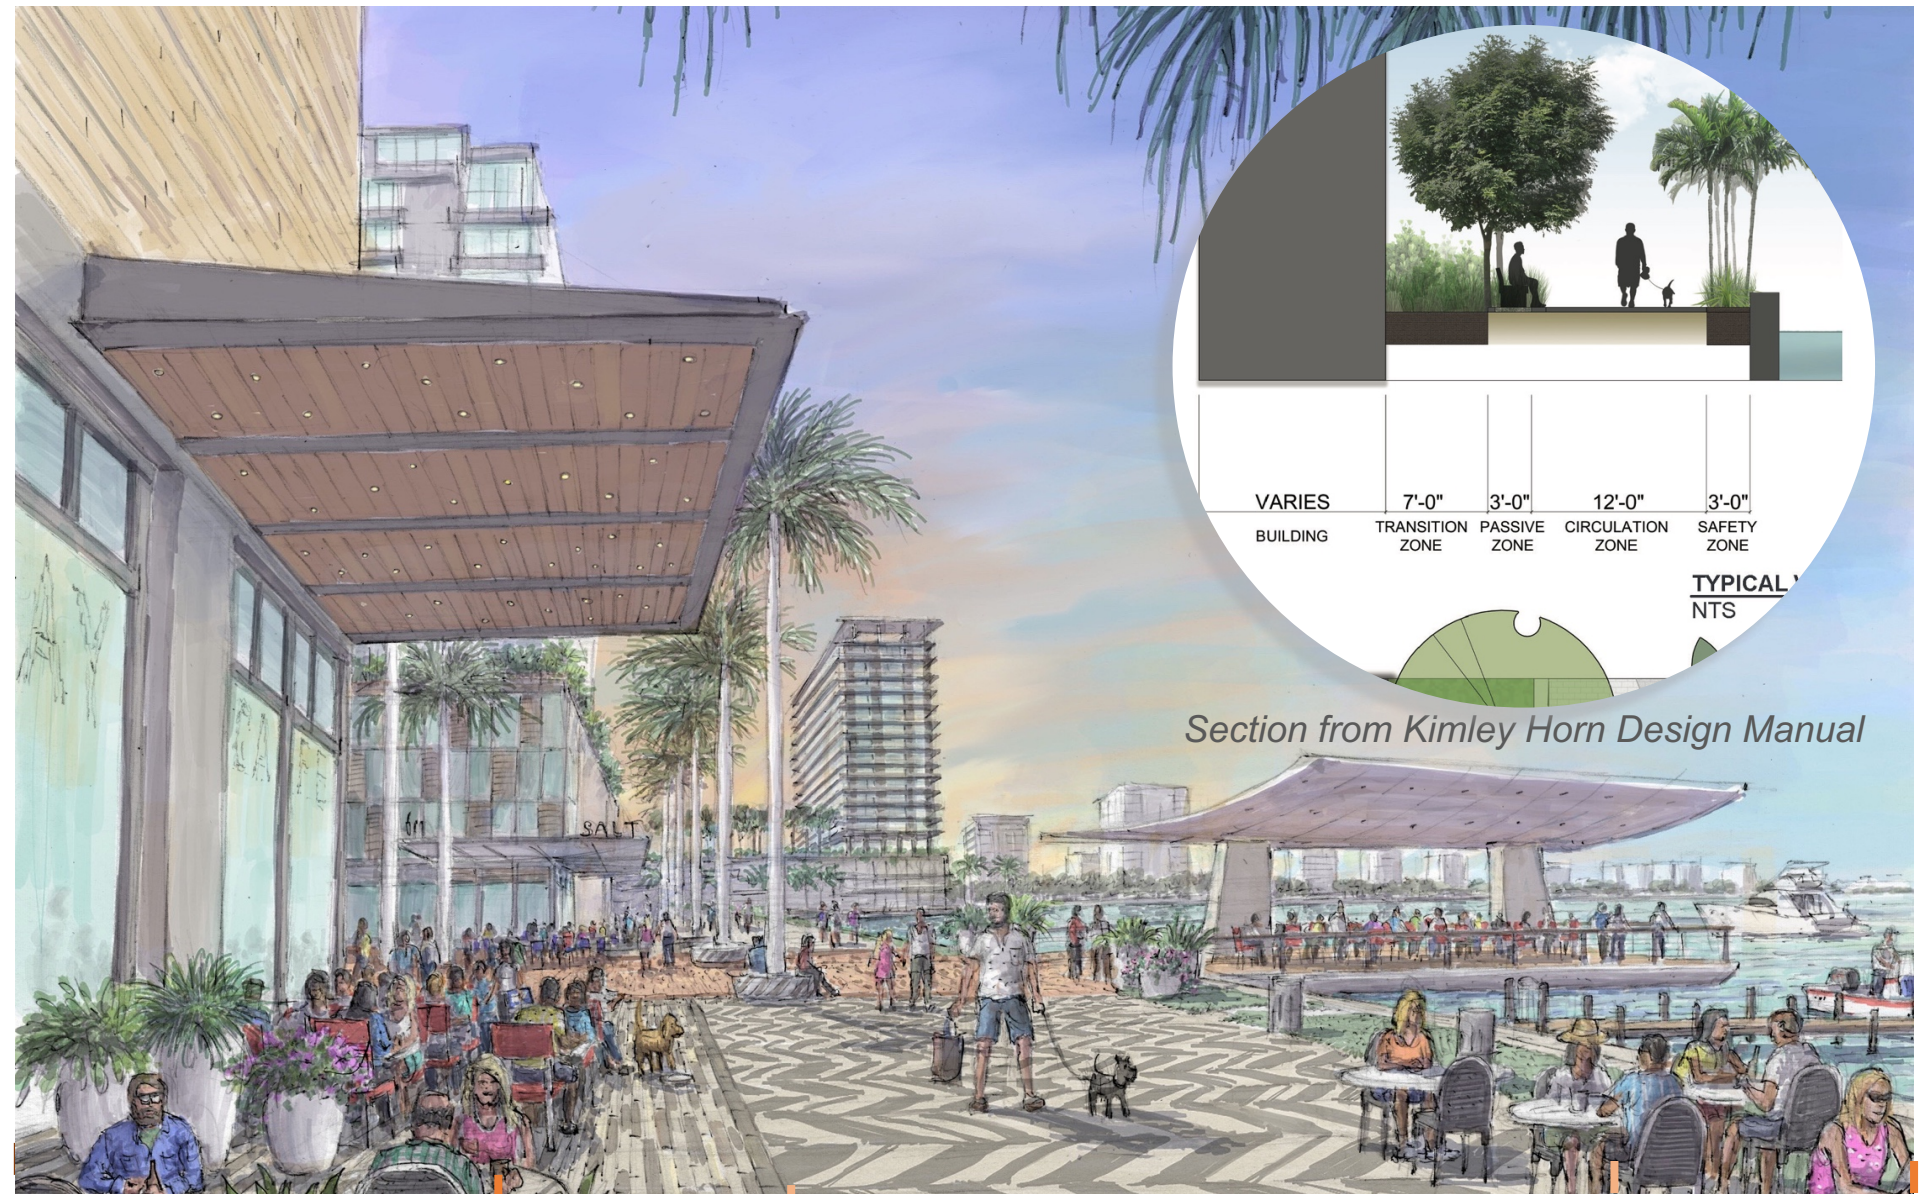
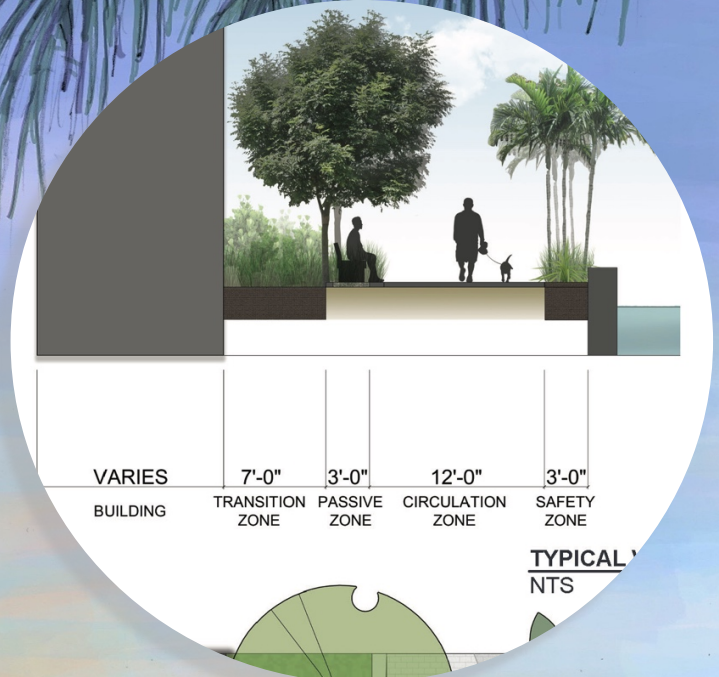
Section from Kimley Horn Design Manual

On the land side of the Circulation Zone, there is a **Passive Zone** that is at least 3 feet wide for benches, low planters, trees, light fixtures, and benches. Benches must face the water. It connects the Circulation Zone to the Transition Zone.

The remainder of the 25-foot setback is the **Transition Zone**. Though not technically part of the easement, it is continuous with the Island Walk and typically flush with it. The Transition Zone can be paved or landscaped, and it can be treated as an extension of the Passive Zone or the Circulation Zone. It should feature active frontages, ideally with restaurants and retail. It may be differentiated from the easement by its paving material, but this is not required.

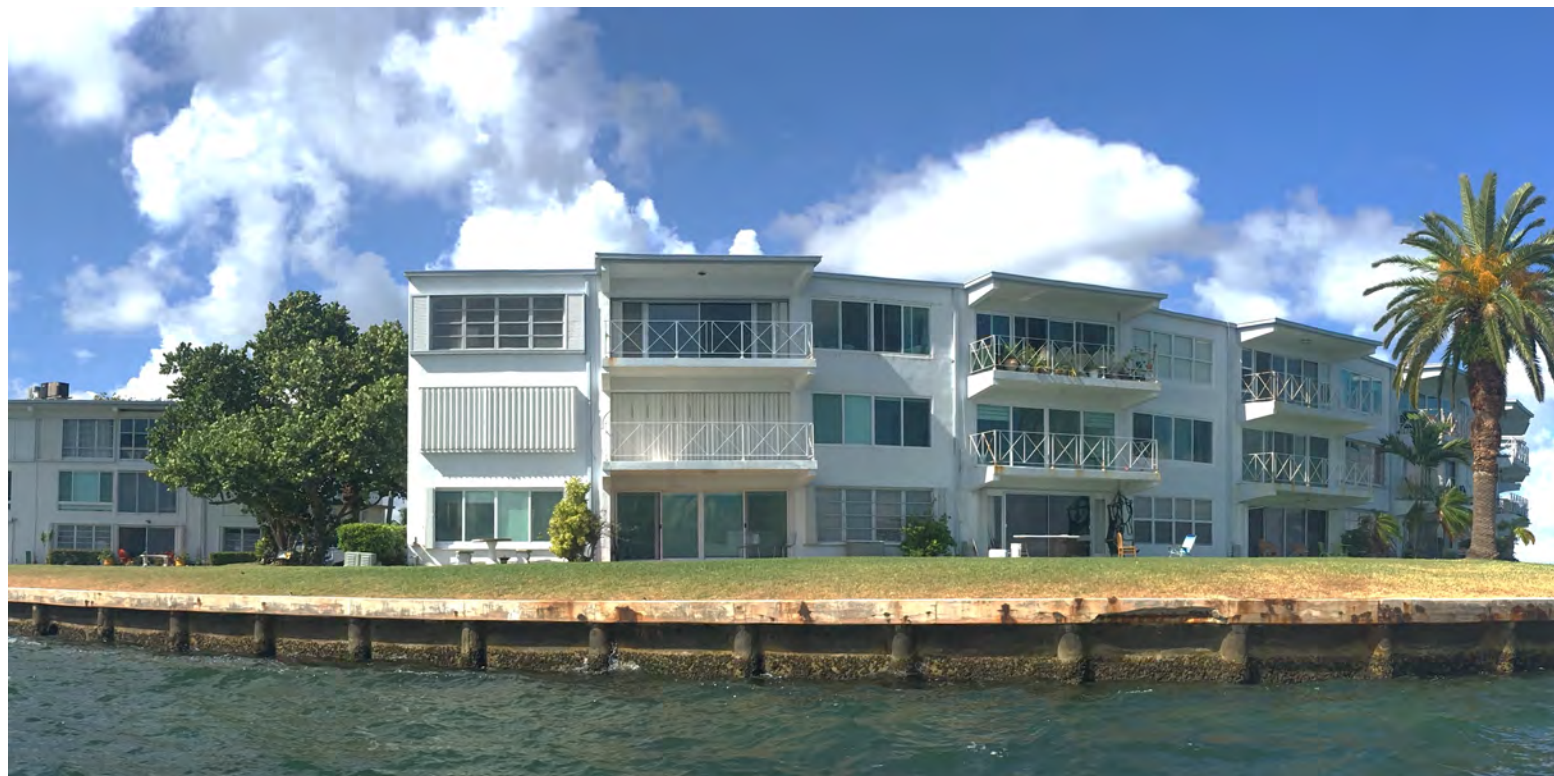
Current Condition of Seawalls

As such, the seawalls were designed primarily to keep land in – not to keep water out. Most of them are aging – the life-expectancy is approximately thirty years – and most are not high enough for the levels of ever-rising king tides, let alone for storm surges. The vast majority are on private property. In short, most need to be repaired or replaced.

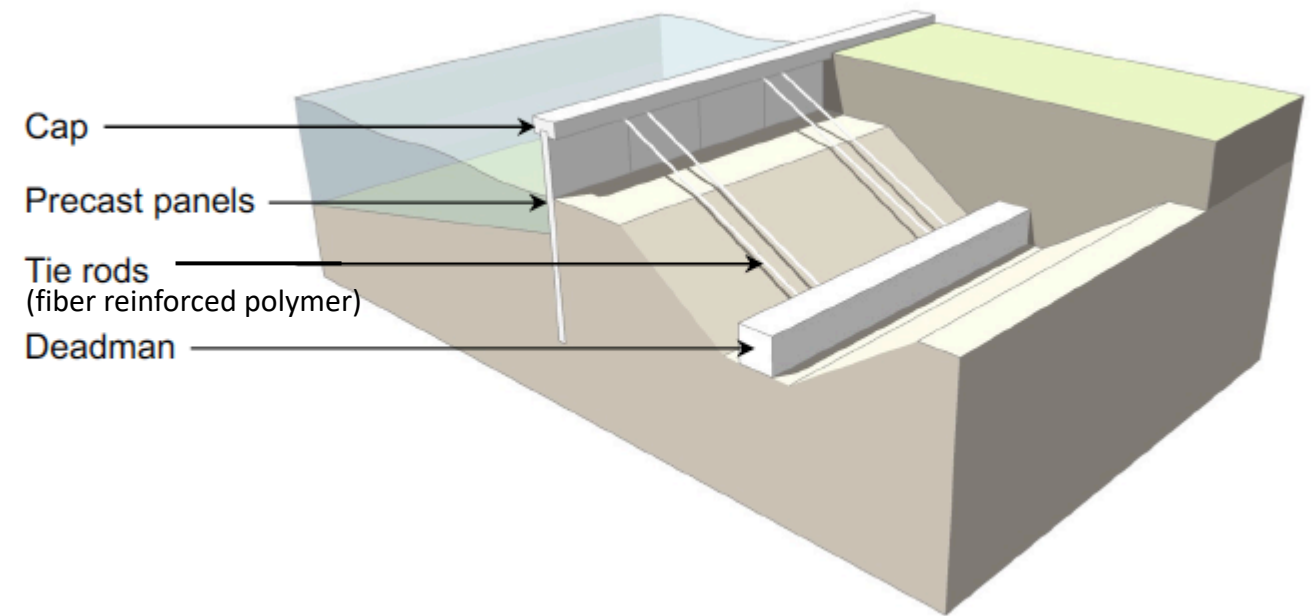
Seawall with tie rods

Illustrated here is an updated version that makes use of an innovative building material, namely non-corrosive fiber reinforced polymer materials pioneered by the Civil, Architectural, and Environmental Engineering Department at the University of Miami. One of the major advantages of this material is that it contains little or no steel, a material that is prone to rusting, especially in a salt-water environment. The Department generously provided engineered design drawings to NBV for use by residents seeking to replace their aging seawalls. This design served as the basis for the 3D illustrations by DPZ on the following pages.

EAC Consulting has been engaged by the Village to devise new seawall standards. They will provide several options, one of which will rely on tie rods and specify the aforementioned specialized material. However, it is worth noting that, over time, many tie rods have been severed to accommodate swimming pools, leading to the premature failure of these walls.

3D illustrations by DPZ are based on designs by the Civil, Architectural, and Environmental Engineering Department at the University of Miami. These drawings are for illustrative purposes only. Dimensions and specifications are recommendations only. DPZ is not responsible for errors. EAC Consulting has been engaged by NBV to devise new standards for seawalls and the Island Walk. EAC Consulting is solely responsible for their final recommendations, which are pending.

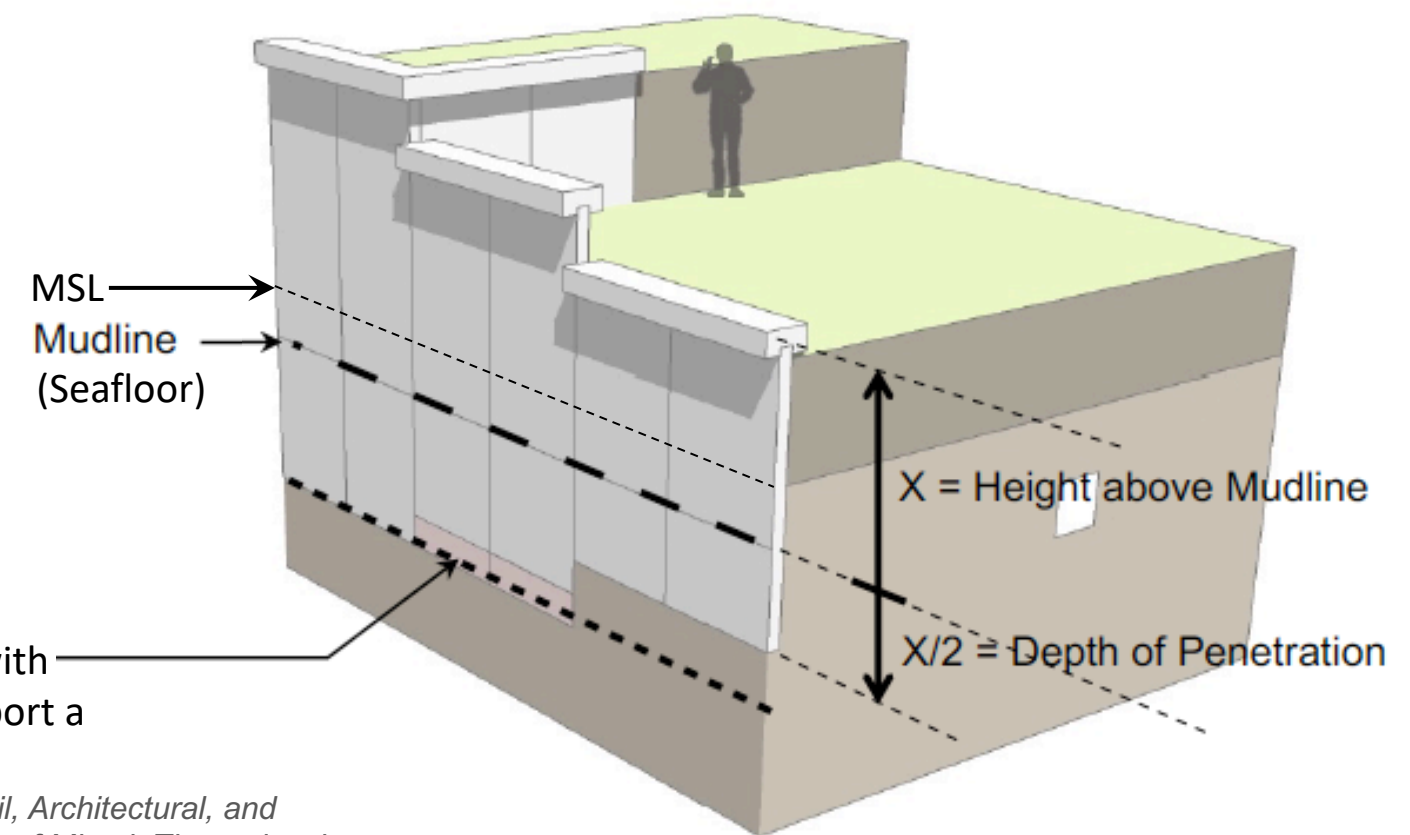
Seawall foundations

New seawalls in NBV will be required to be structured to allow future increases in height.

New seawalls shall be built with foundation adequate to support a full-height seawall

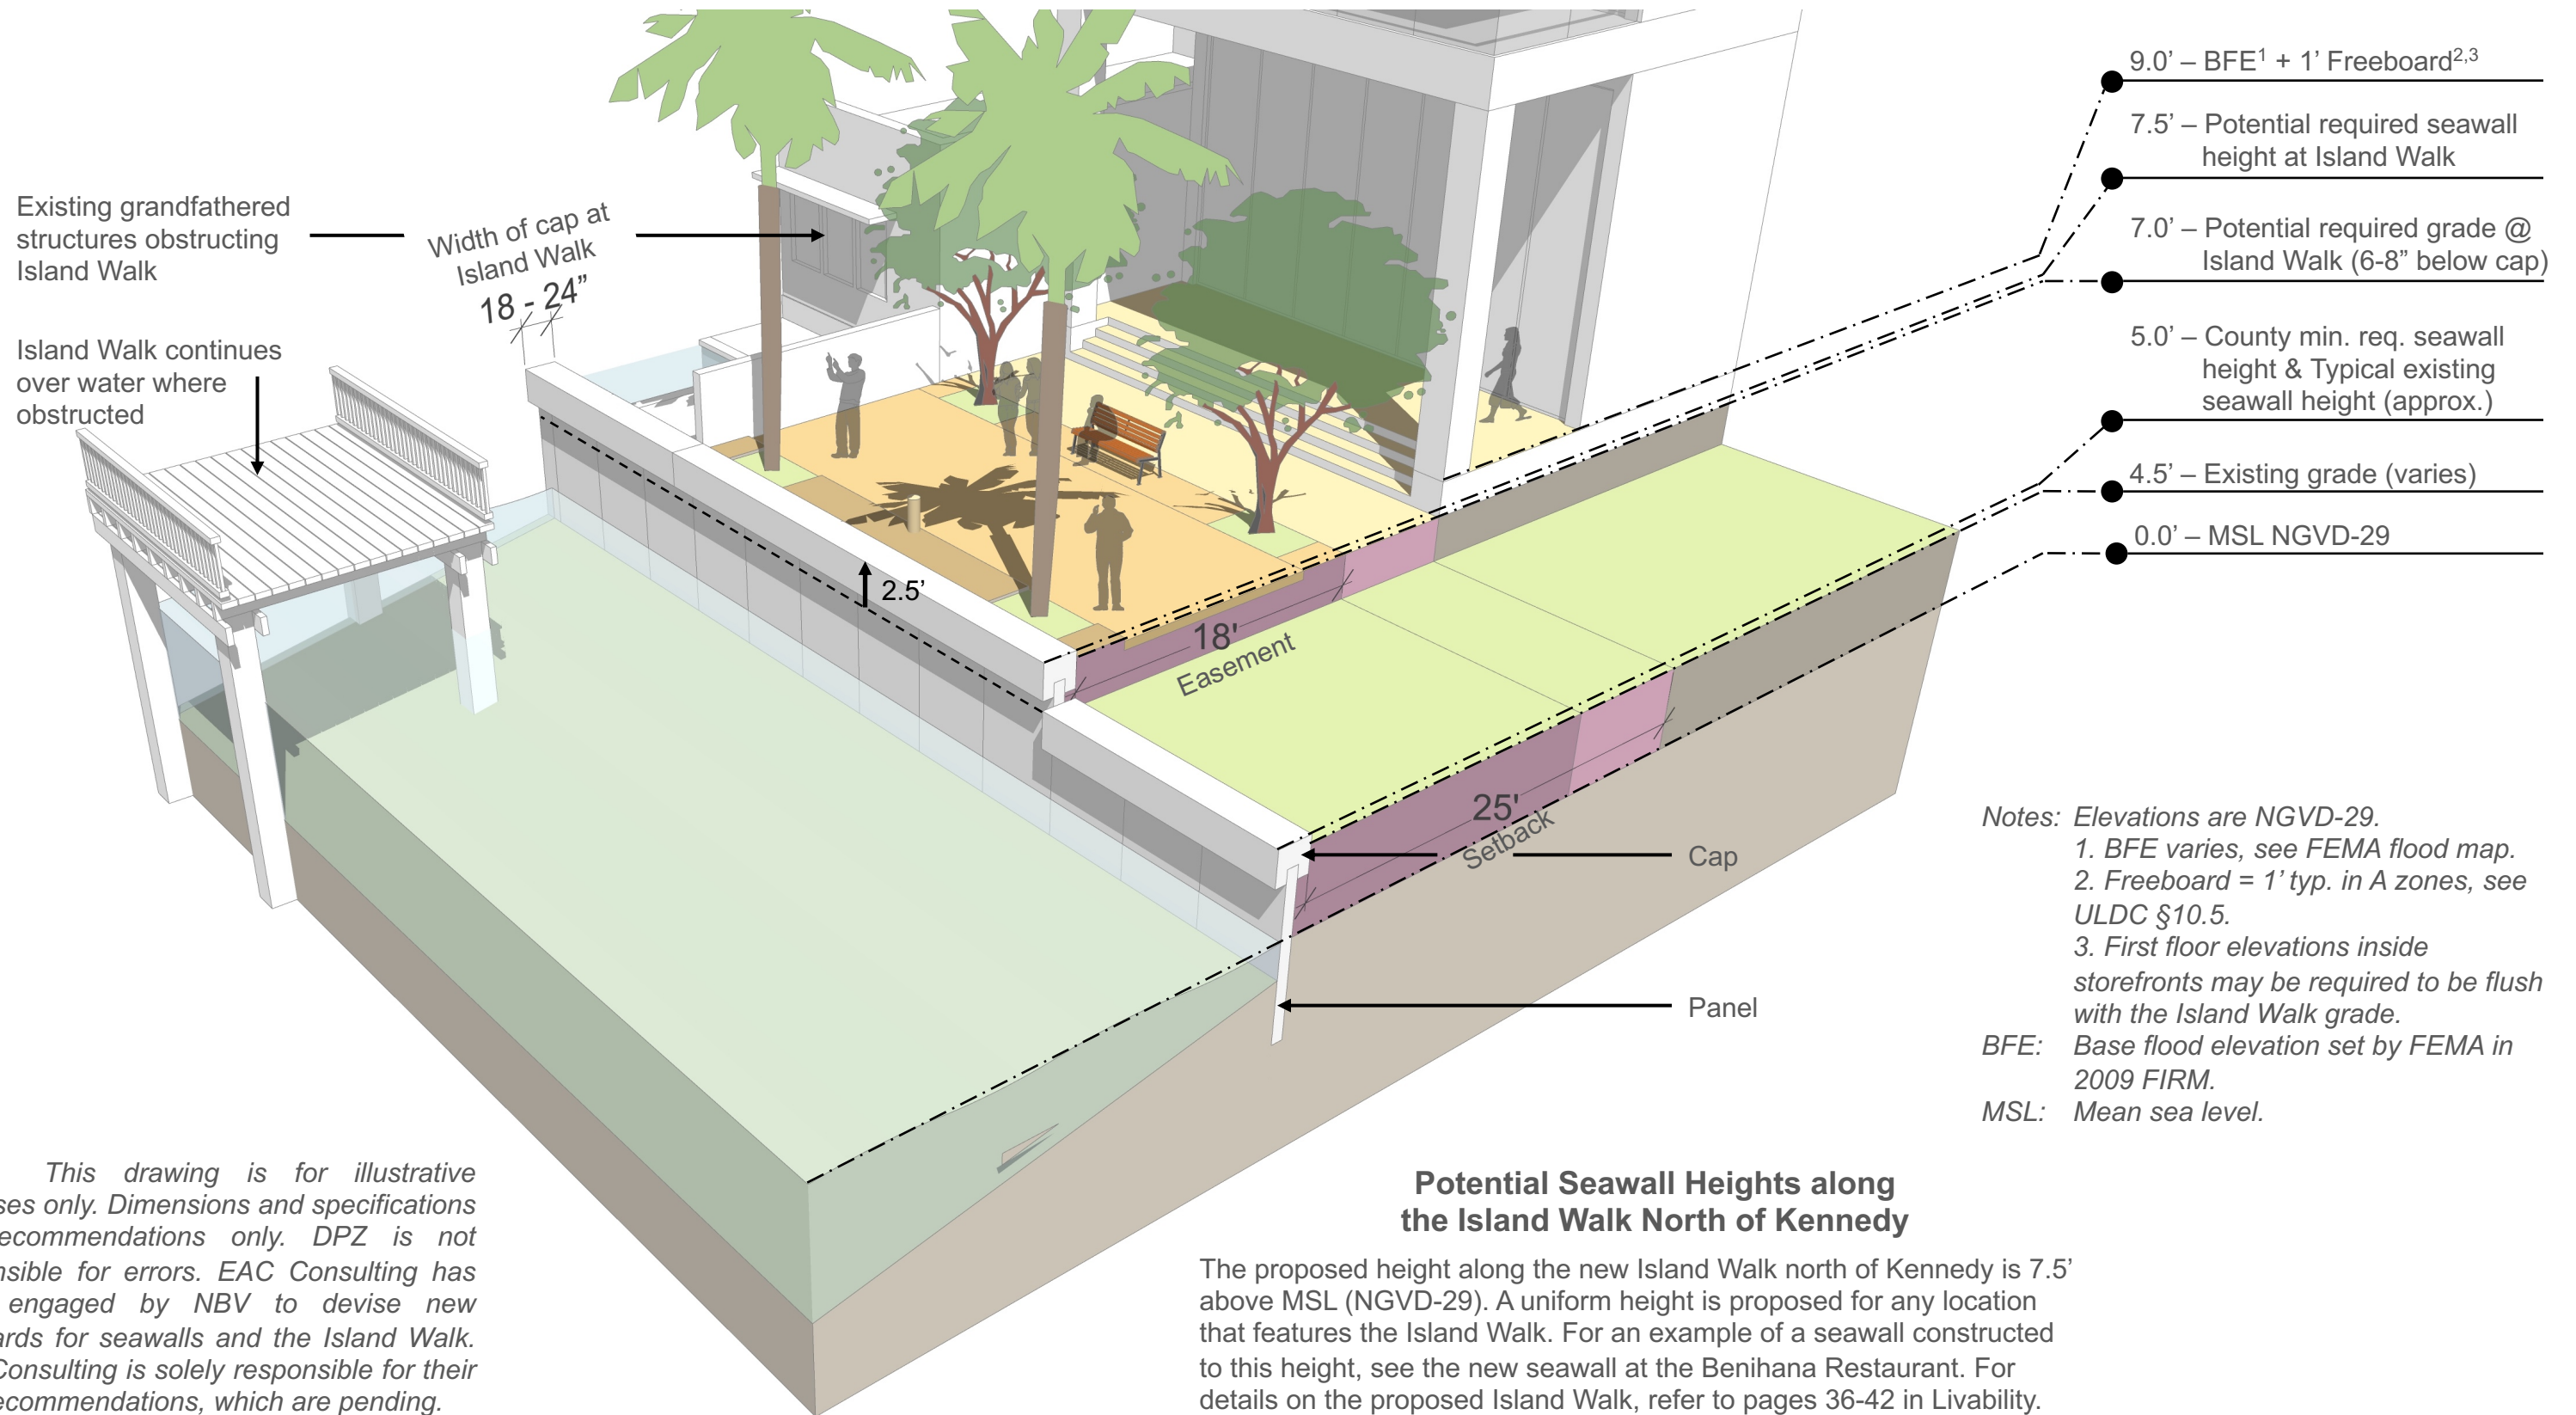
STRONG SEAWALLS AND ISLAND WALK NORTH OF KENNEDY

Notes: Elevations are NGVD-29.
 1. BFE varies, see FEMA flood map.
 2. Freeboard = 1' typ. in A zones, see ULDC §10.5.
 3. First floor elevations inside storefronts may be required to be flush with the Island Walk grade.
 BFE: Base flood elevation set by FEMA in 2009 FIRM.
 MSL: Mean sea level.

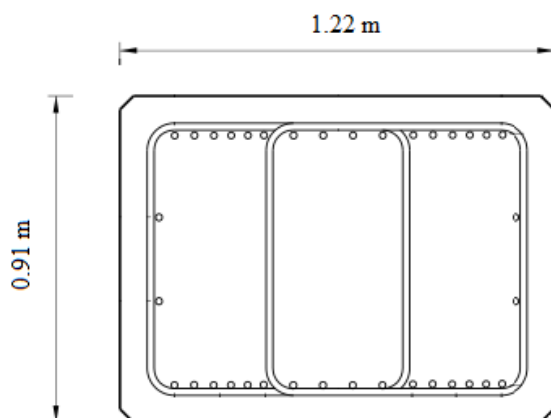
Figure 2. Transversal section of the pile cap of the Halls River Bridge.

The study focuses on the GFRP-RC pile cap of the Halls River Bridge currently under construction in Homosassa, FL (Rossini et al., 2018a) (Figure 2). The element is deemed representative of large under-reinforced

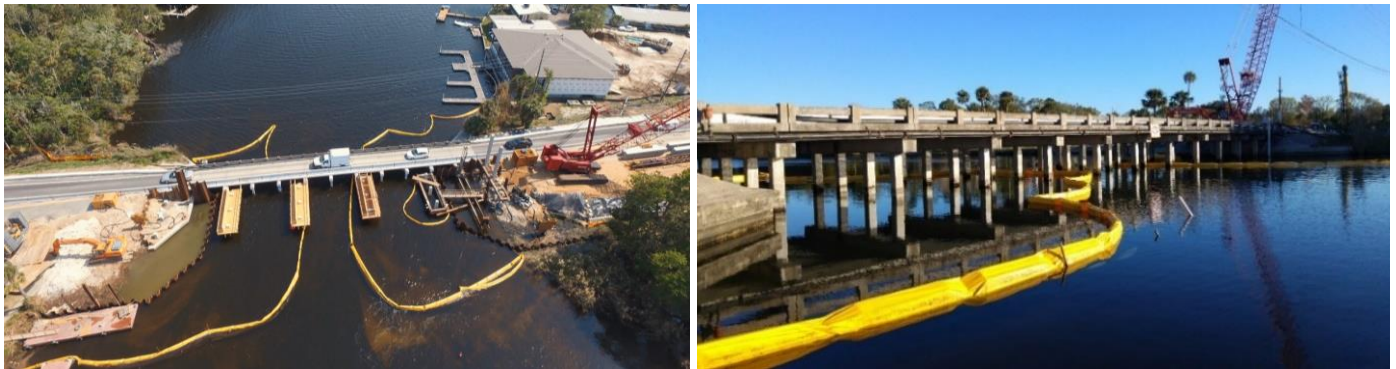
Figure 1. Halls River Bridge under construction (a) and existing bridge before demolition (b). [Courtesy of Astaldi Construction Corporation]

The HRB comprises a number of innovative material and structural solutions targeting a reduced environmental impact and an extended service life of 100+ year (Cadenazzi et al., 2018a). The structure includes CFRP-PC bearing piles, CFRP-PC/GFRP-RC sheet piles, hybrid HSCS-PC/GFRP-RC sheet piles, GFRP-RC pile bent caps and bulkhead caps, a GFRP-RC bridge deck, GFRP-RC traffic railings, GFRP-RC approach slabs and a 20 m long GFRP-RC gravity wall. The original design implemented Hillman Composite Beams (HCB), consisting of a composite GFRP shell encasing a steel-reinforced concrete shallow tied-arch and lightweight filling foam. This complex structural solution was developed under the National Cooperative Highway Research Program's Innovations Deserving Exploratory Analysis (NCHRP-IDEA) program and selected by FDOT for further exploration (Cadenazzi et al. 2018b). An alternative GFRP-RC solution that provides equivalent strength and performance is shown in this study.

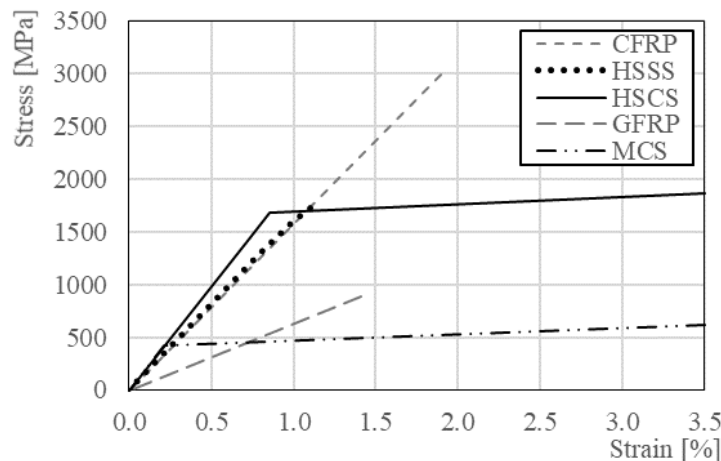
Figure 2. Mechanical properties of various reinforcement materials.

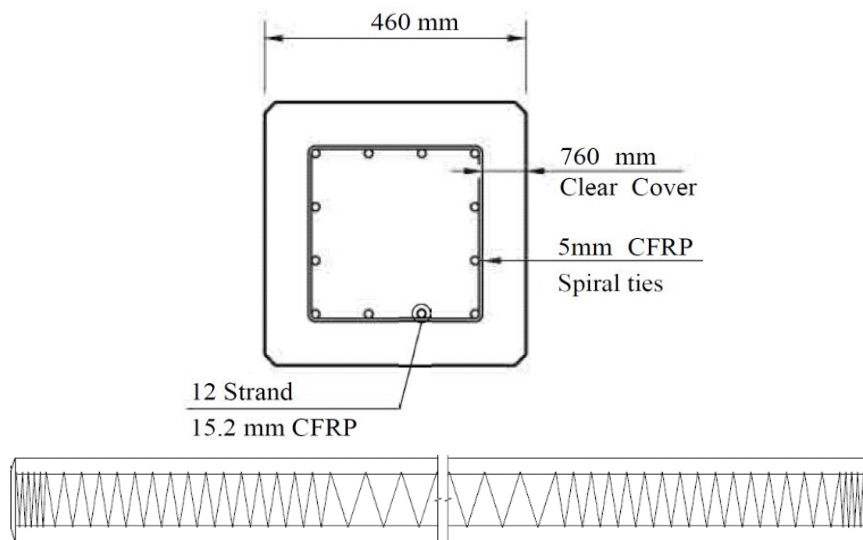
Figure 3. Bearing pile cross section (a) and lateral view (b).

The piles were designed to be driven by impacting hammer to a depth of 19 m, for a total length of 21 m. Unexpected geotechnical conditions forced driving the three piles of one of the intermediate bents to a depth of 46 m requiring splicing of additional segments (Cadenazzi et al., 2018b). MSS M25 bars were used as dowels, whereas CFRP dowels are undergoing validation to be ready for the second construction phase. Figure 4 shows pile driving and splicing.

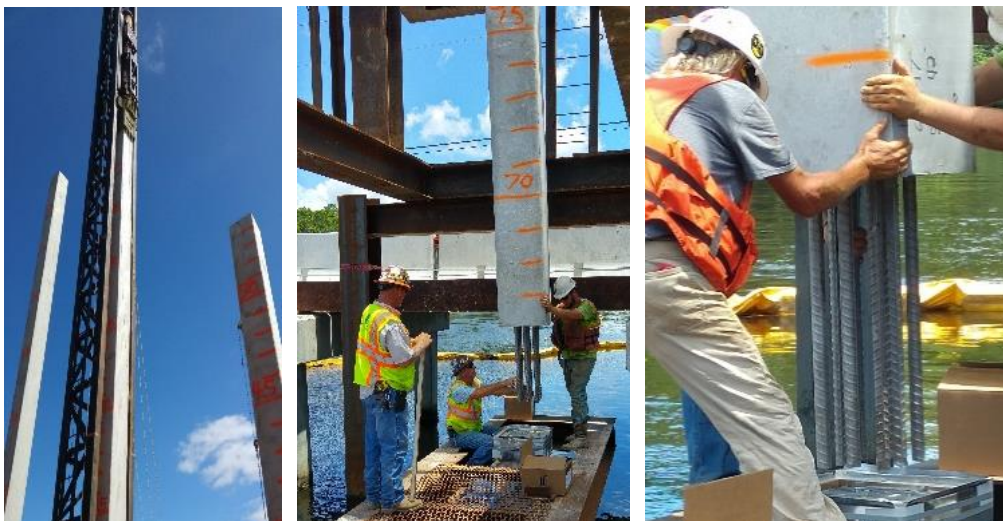
Figure 4. Bearing pile driving and splicing operations.

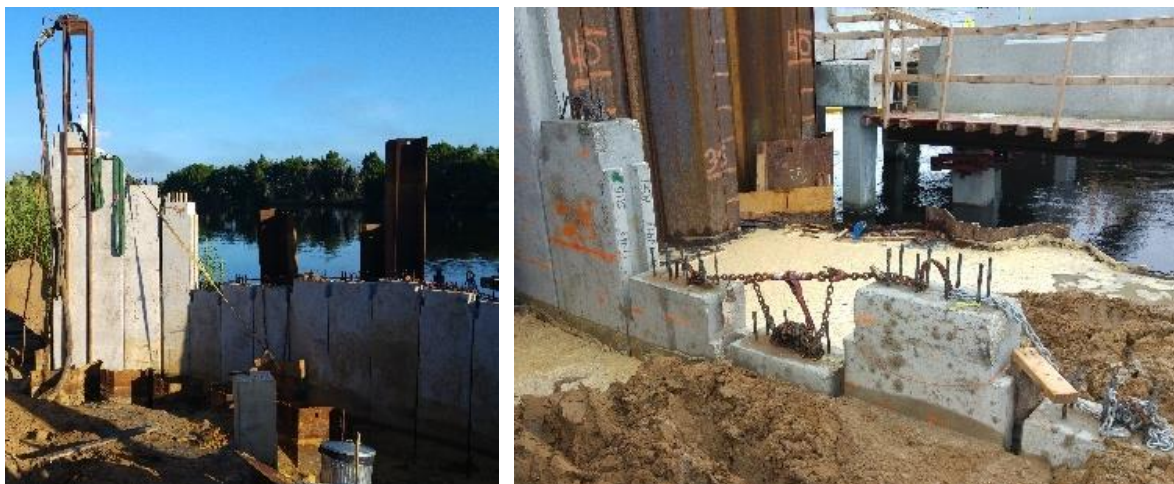
Figure 6. Sheet piles during installation

The sheet piles were designed for installation by water-jetting to a depth of 8 m for a total length of 9 m in a cantilever configuration. The unexpected presence of a layer of hard limestone reduced the installation depth to approximately 4 m for relevant portions of the wall. To guarantee the required strength and stiffness to the retaining wall, an anchored sheet pile variant was adopted. The sheet piles were cut to length and the cut-off portions were installed as deadmen. The sheet pile bulk head cap was connected to the deadmen through MSS bars mildly tensioned using screw couplers (Cadenazzi, 2017). Figure 6 shows the installation of the sheet piles.

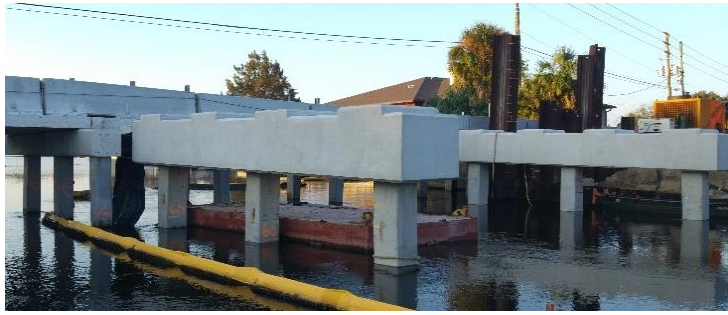
Figure 7. Pile bent cap after demolnding.

The Halls River Bridge comprises 6 GFRP-RC cast-in-place pile bent caps of rectangular cross section having a width of 1.22 m and a depth of 0.91 m (Figure 7). Each bent cap is under-reinforced with failure controlled by FRP rupture. Design is governed by service considerations, as typical for the case of GFRP-RC. Since the provisions for this type of element are particularly conservative, new provisions have been proposed for the next generation of design guidelines.

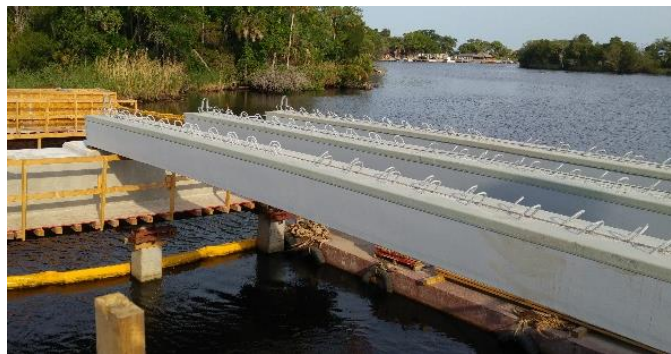
The Halls River Bridge comprises 45 Hillman Composite Beams (HCB) consisting of a composite GFRP shell encasing a steel-reinforced concrete shallow tied-arch and lightweight filling foam (Figure 9). This complex structural solution is reinforced with 18 galvanized unstressed steel strands of 12.7 mm diameter and connected to the deck through galvanized steel connectors. The composite shell is intended to enhance durability of the RC structural core (Aboelseoud & Myers, 2016). Corrosion of the galvanized steel connectors in a more aggressive environment is an unaddressed concern.

Figure 10. HCB during installation.

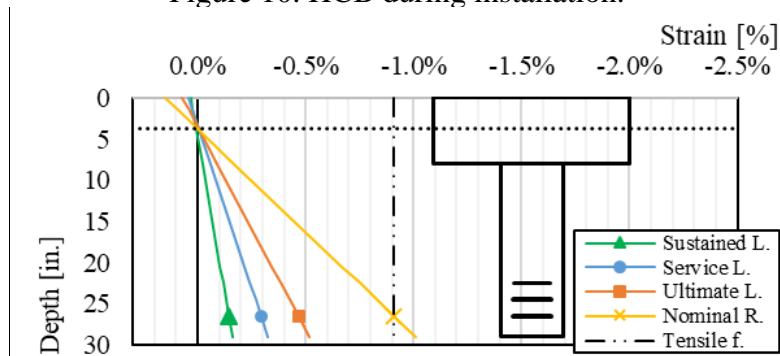
An alternative GFRP-RC precast solution is discussed in this section, designed to ensure the same level of strength and performance in addition to validated durability performance (ASTM, 2017a). Maintaining the original rectangular section of the HCB with a width of 590 mm and a depth of 530 mm, a total of 18 M25 GFRP bars is sufficient to resist against a factored moment of 1085 kN-m. The girder is connected to the deck through M13 GFRP shear connectors in the shape of closed stirrups spaced 50 to 200 mm. The member complies with the AASHTO BDGS-GFRP 2nd edition (AASHTO, 2018), whereas design according to the first edition of the guideline is not permitted. Figure 10 visualizes the level of strains in the member under different loading conditions. Given the conservativeness of the strength reduction factor for FRP-controlled failures (ϕ_f), the strains under Ultimate Load (Ultimate L.) lay below the flexural failure threshold defined as Nominal Resistance (Nominal R.) by a margin of about 50%.

Figure 10. GFRP-RC girder sectional analysis. Geometry not to scale.

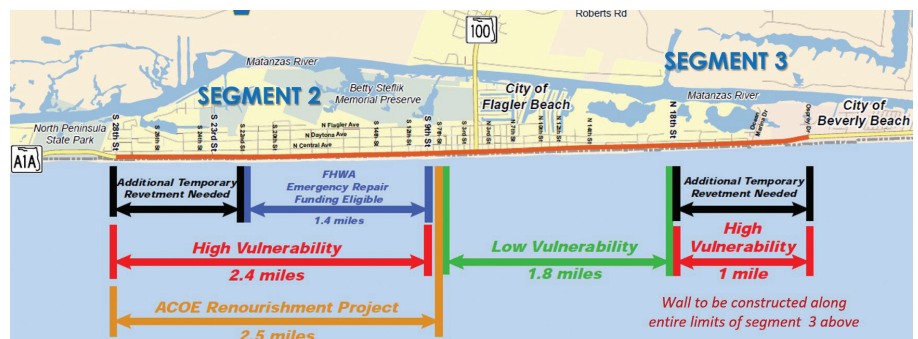
Fig. 1: The secant-pile seawall/bulkhead project described in this article is located within Segment 3, an area that is considered highly vulnerable to hurricane surge flooding

To ensure the restored highway remains in service in the event of a similar future storm, a protection and support system is under construction in the stretch indicated as Segment 3 in Fig. 1. The project consists of a GFRP-reinforced concrete secant-pile seawall/bulkhead designed to provide support for the highway in the event the adjacent sand dunes are lost during a major storm. Figure 2 illustrates the seawall with a reestablished dune that helps to preserve the character of the local environment, including the “Old Florida” feeling of Flagler Beach.

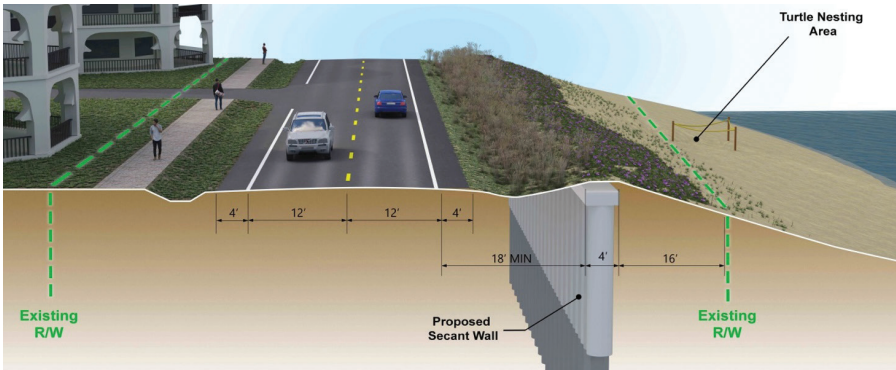
Fig. 2: A schematic rendering of the SR A1A secant-pile seawall/bulkhead project with dune reestablishment and existing right-of-way (r/w) limits

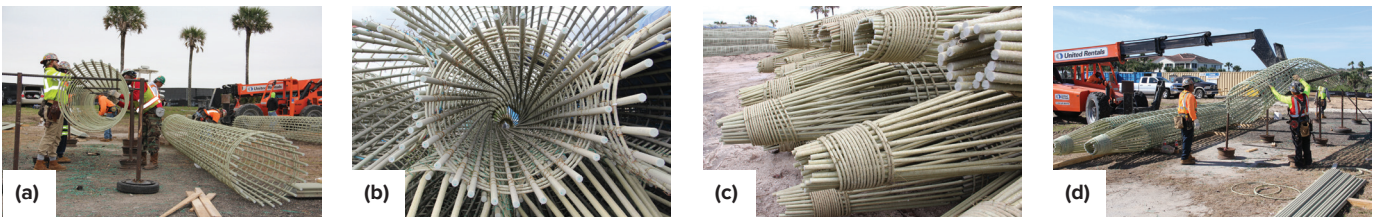
Fig. 3: The seawall was constructed using GFRP cages: (a) cage assembly was completed in the field; (b) a conventional bar layout was used in the upper sections of a cage; (c) a special pile-toe assembly was used in the lower section of each cage; and (d) assembled cages were moved from the assembly stands using a telescopic forklift

The secant-pile construction sequence involved drilling and placing secondary piles (piles reinforced with only a single GFRP bar) on Day 1 and Day 2 of a 3-day rotating cycle. On Day 3, primary piles (those reinforced with 25 No. 8 GFRP bars, spiral hoops, toe-assembly, and ties) were drilled and placed. This placement sequence resulted in an interlocked and relatively homogeneous deep foundation wall-type system (shown in Fig. 5). Additionally, due to the fact that primary piles (piles with the full reinforcing GFRP bar cages) are cut into the secondary piles (those with only a single, central GFRP bar), all the reinforcing GFRP cages are provided with full cover.

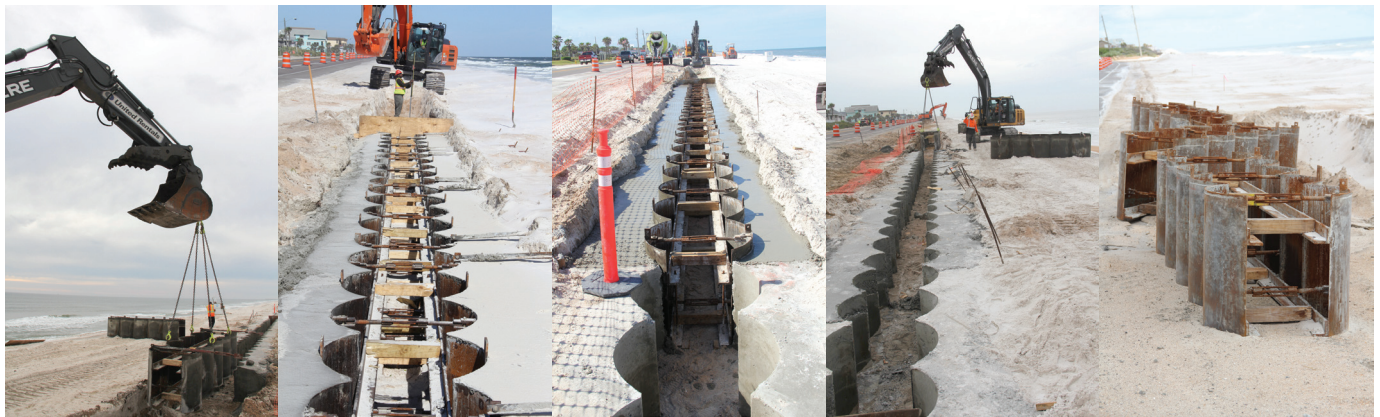
Fig. 4: Construction of the guide wall, a concrete template that was used to align and locate the seawall’s secant piles and provide positional restraint and the required verticality of the piles. The guide wall was removed prior to construction of the pile cap

The secant piles were located using a guide wall—a plain concrete template cast in a trench. Pile locations were set in the template using removeable, preassembled steel formwork (Fig. 4). In addition to helping define the verticality and top elevation of the secant piles, the template served as a removable form that exposed the upper reaches of the piles and allowed them to extend into the subsequently placed seawall/bulkhead pile cap.

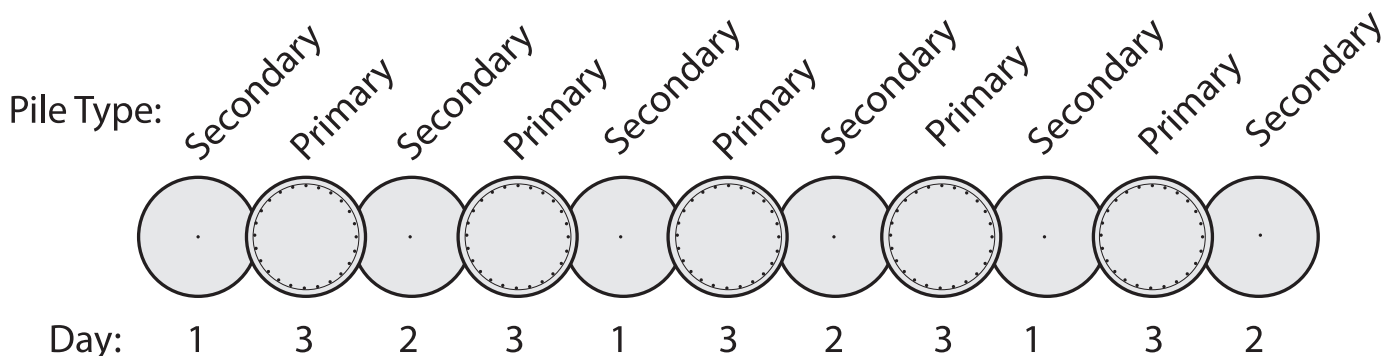
Fig. 5: The piles were placed in a sequence that ensured that the primary piles could be drilled into and interlocked with the secondary piles

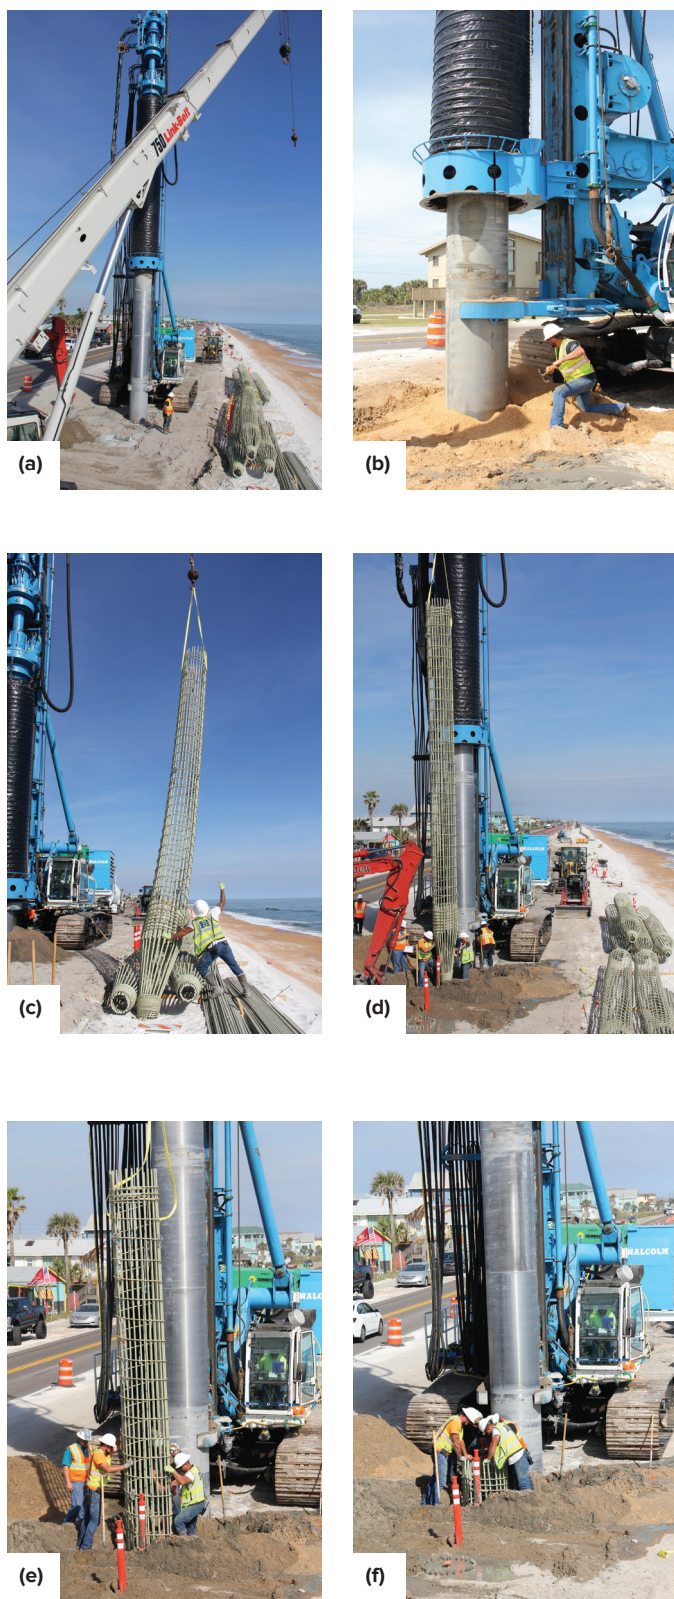
Fig. 6: A specialized drill rig was used to install the secant piles using the cased auger-cast method. The installation sequence comprised: (a) drilling; (b) soil removal and grouting; (c) GFRP cage lifting; (d) cage alignment; (e) cage insertion into the grout; and (f) final cage positioning

The lightweight, flexible GFRP reinforcing cages in the primary piles allowed for smooth and rapid installation (Fig. 6).

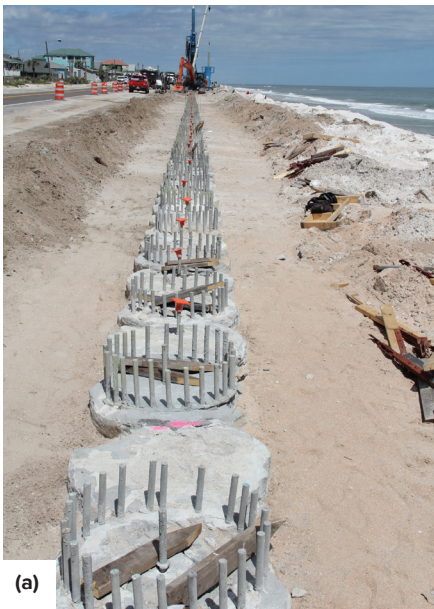
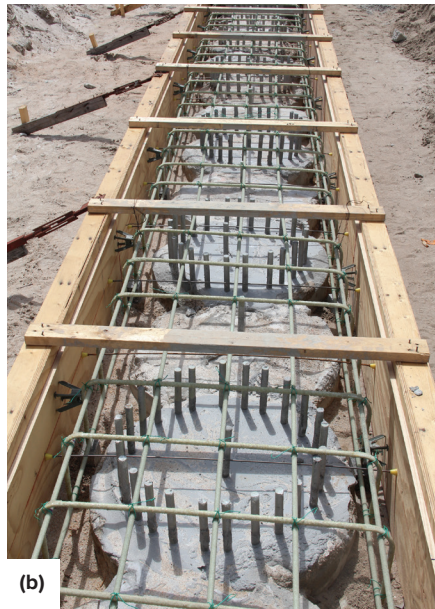
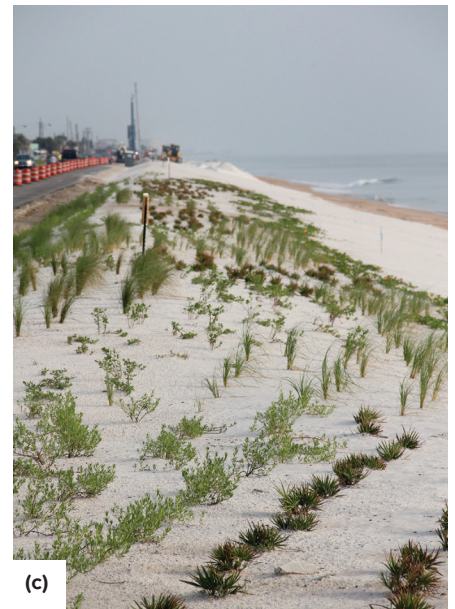
Fig. 7: After secant piles were installed: (a) the concrete guide wall was removed; (b) formwork and GFRP reinforcing bars were placed for the pile cap; and (c) a dune was constructed over the wall after the pile-cap concrete was placed and cured, and the pile-cap formwork was removed

Figure 7 shows the installed secant piles, continuous pile-cap construction, and dune reestablishment over the constructed secant-pile seawall. The reestablished dune will minimize the environmental and aesthetic impacts of the protective structure.

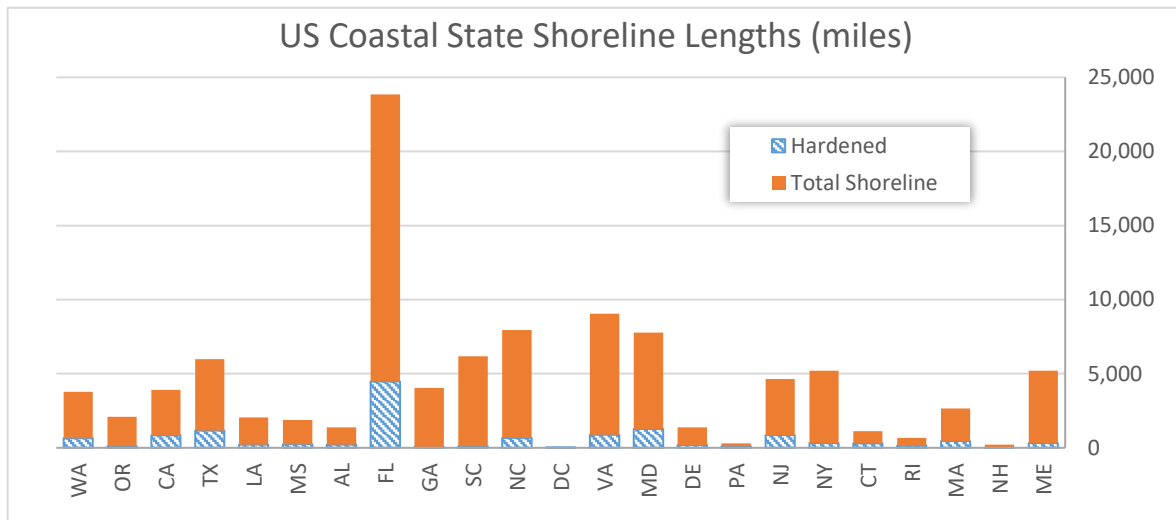
Fig. 3 Stacked bar graph showing total lengths of hardened shoreline and the significance of Florida shoreline compared to other states. *Louisiana (LA) does not include extensive bayou shoreline length. (NOAA source data reported in Gittman & al. (2015))

Figure 3 shows a summary of the lengths and the relative significance of this historical shoreline hardening for the State of Florida compared to the rest of the country.

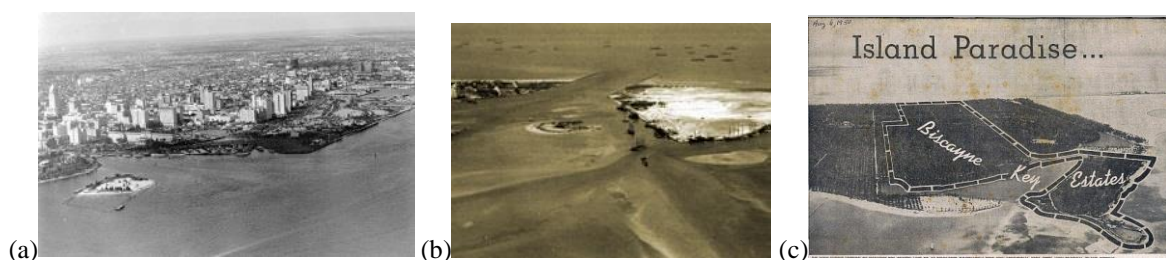
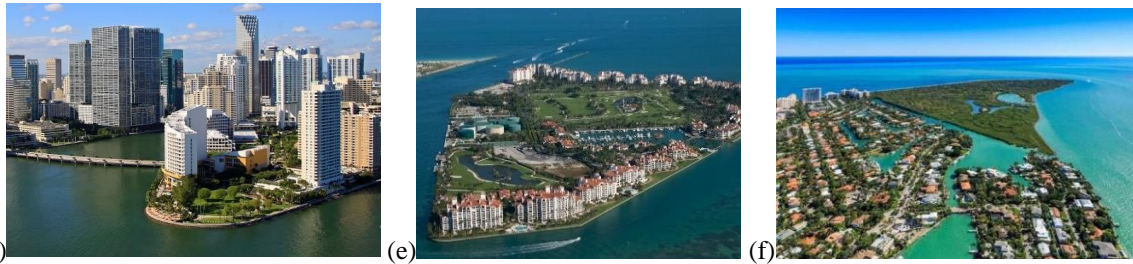
Fig. 5 Examples of RC seawall-bulkhead usage for land development on Florida's east coast: (a) Brickell Key, 1928 (b) Fisher Island, 1920's (c) Key Biscayne ^[1], 1950's (d) Brickell Key ^[2], 2011 (e) Fisher Island, 2015 (f) Key Biscayne, 2015.

RC seawall-bulkheads were used extensively in Florida to create and protect land with valuable waterfront views usually in combination with dredge-and-fill operations. Well known examples include Brickell Key, Fisher Island and Key Biscayne in Miami (Figure 5); Marco Island, Charlotte Harbor and Punta Gorda Isles in southwest Florida (Figure 6); Davis Island and Pinellas county barrier islands in the Tampa Bay region (Figures 1 & 7).

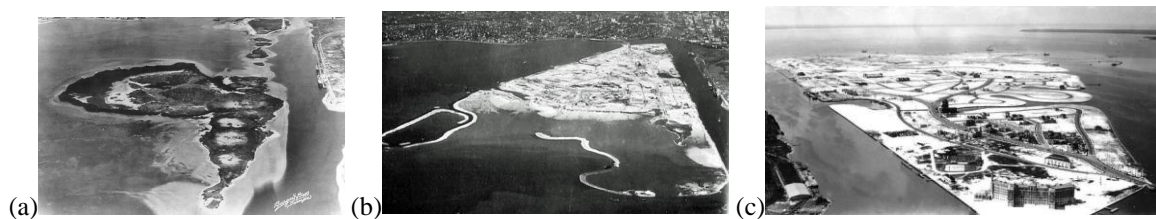
Fig. 7 Davis Island, Tampa Bay reclamation using RC seawall-bulkheads: (a) 1924; (b) 1925; (c) 1926. (Photographs courtesy of the Burgert Bros.)

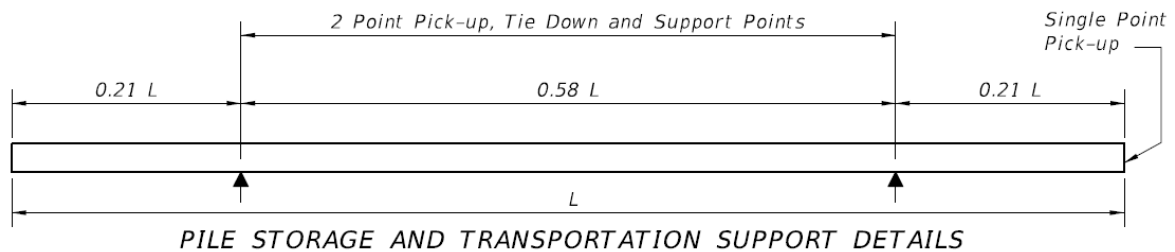
Fig. 10 Schematic of typical lifting points for handling, storing, transporting and installation of prestressed concrete sheet piles, FDOT *Index 6040*, 2017.
