ORDINANCE NO. 2021-006

AN ORDINANCE OF THE MAYOR AND COMMISSION OF NORTH BAY VILLAGE, FLORIDA, AMENDING THE VILLAGE UNIFIED LAND DEVELOPMENT CODE OF ORDINANCES BY CREATING SECTION 8.16, ENTITLED, “SEA WALL STANDARDS,” IN DIVISION 4, “SUPPLEMENTAL DEVELOPMENT STANDARDS,” CHAPTER 8, “ZONING”; ESTABLISHING SEA WALL DESIGN STANDARDS THROUGHOUT THE VILLAGE; PROVIDING FOR CONFLICTS; PROVIDING FOR SEVERABILITY; PROVIDING FOR INCORPORATION; PROVIDING FOR IMPLEMENTATION; AND PROVIDING FOR AN EFFECTIVE DATE

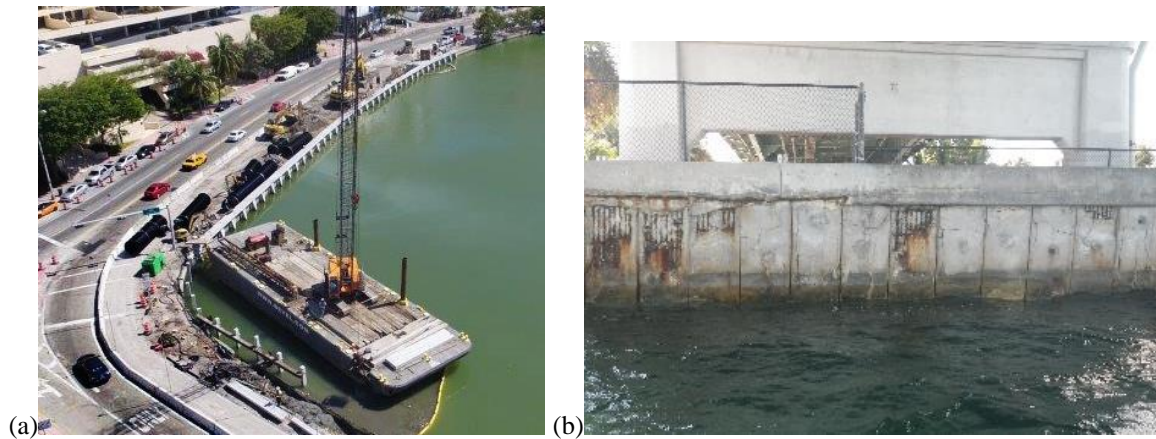
Fig. 11 (a) Miami Beach seawall-bulkhead and road raising project ^[1]; (b) North Miami Beach deteriorated seawall due to corrosion.

There are several other concrete bulkhead systems utilized in South Florida due to the shallow limestone geology in that region. The most common is the soldier pile and panel system, which is especially popular with the cities of Miami and Miami Beach. Figure 11 shows an active installation from a recent City of Miami Beach project. This project is part of a \$400M initiative combating “sunny day” flooding from high tide and storm surge which pushes seawater into streets and neighborhoods, a trend the city expects to continue.

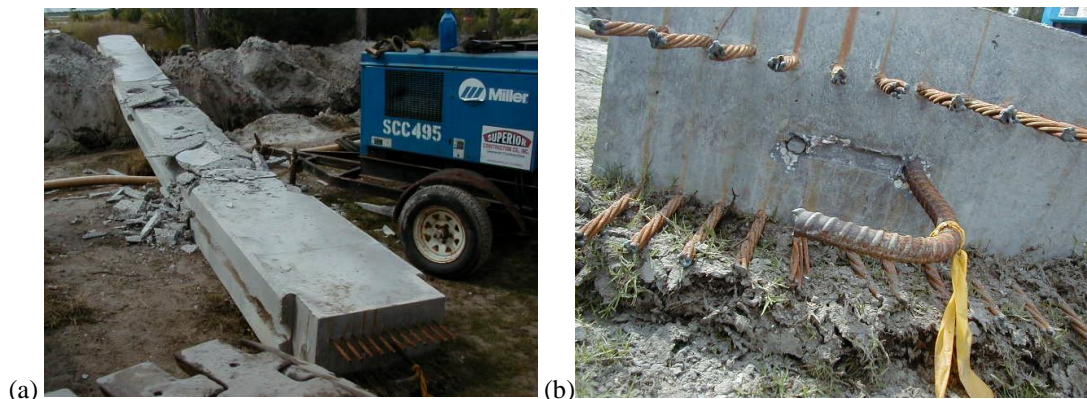
Fig. 12 (a) 16-inch (400mm) thick concrete sheet pile dropped during installation; (b) fractured steel lifting loop due to mishandling heavier precast element.

This strategy results in significant increase in the cross-sectional flexural modulus, since the surface tensile stress is a function of the square root of the section thickness. A disadvantage of this approach is that handling weight increases proportionally requiring larger crane capacities and shipping costs. Also the handling length capacity only increases slightly with thickness since the self-weight flexural stress is a function of the square of the sheet pile length. This approach was utilized by the first author for a bridge project in 2001 along State Road A1A over Ft George River Inlet (Nolan 2001). The exposed maximum wall height was 23-feet (7 m) in combination with tie-back anchors using a prestressed sheet pile section thickness of 16-inches (405mm). Figure 12 shows one of the heavier sheet piles that was dropped during installation, due to the unfamiliarity of the contractor with handling such large sections.

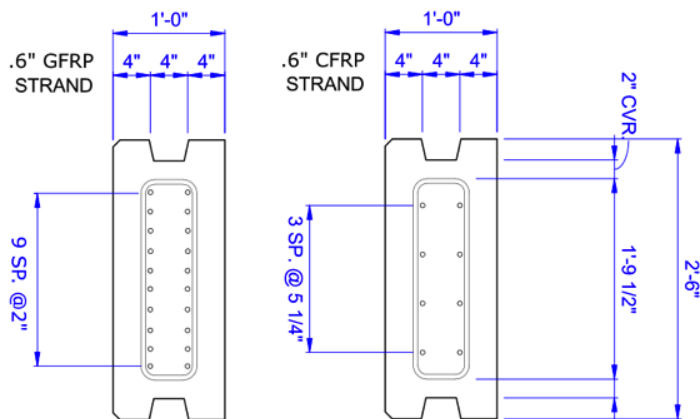
Fig. 13 (a) GFRP-PC sheet pile concept (b) CFRP-PC sheet pile design for Halls River Bridge project.

The application of glass FRP (GFRP) to mild-prestress concrete sheet piles is currently under investigation (Rossini & al. 2018b). Glass fiber is an economical alternative to carbon fiber in applications that do not require a high level of concrete pre-compression. Limiting the amount of the initial prestressing could overcome most of the constructability issues observed with CFRP tendons which require complex and expensive anchors, while the reduced cost of glass makes it a competitive and durable alternative to standard steel strands.

An NCHRP Highway IDEA project (MILDGLASS) was funded in 2018 to further refine this technology. At the current prototype stage, the design of a 30x10-inch (762x254mm) sheet pile prestressed with two rows of eleven strands each is realistic. The concrete pre-compression would be limited to 700 psi (4.83 MPa) which is consistent with current FDOT corrosion-resistance prestressed concrete sheet pile standards (FDOT 2016b). The proposed GFRP-PC solution shows the potential of becoming an economical alternative to steel-PC in the near future. The goal is to eventually allow for the design of 30x12 inch (762x305 mm) sheet piles using two rows of 10 strands each (Figure 13). Parallel research within the SEACON project is confirming the excellent GFRP durability performance in marine environments (Khatibmasjedi & al. 2017).

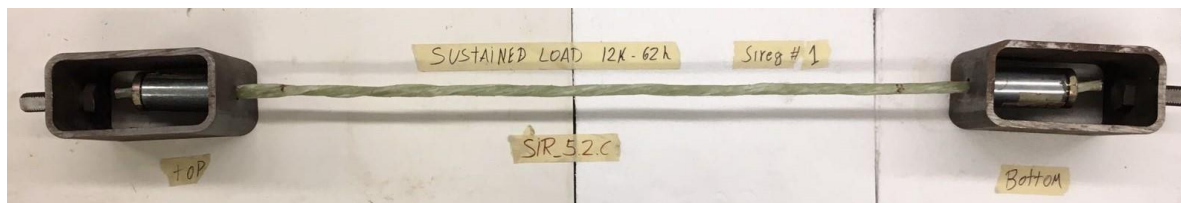
Fig. 14 GFRP strand prototype with steel chucks and cross-heads, ready for test.

The initial research effort focused on tensile testing of GFRP 7-cord twisted strand prototypes anchored to the cross-heads of the testing frame with conventional steel prestress chucks (Figure 14 and 15). The aim was to verify prototype compatibility with construction techniques traditionally applied to steel-PC.

Samples have been tensile tested up to failure in load control to better reproduce the actual jacking load applied on site. Two different failure modes have been experienced, happening at the same level of applied load, either local slipping or local rupture at one of the chucked ends. Results are showing a quality-controlled production able to guarantee an instantaneous jacking stress of more than 12 kip (45% of nominal ultimate capacity). Creep and relaxation tests are currently undergoing and are confirming the ability of the material to sustain a sufficient level of load, without experiencing damages or excessive losses.

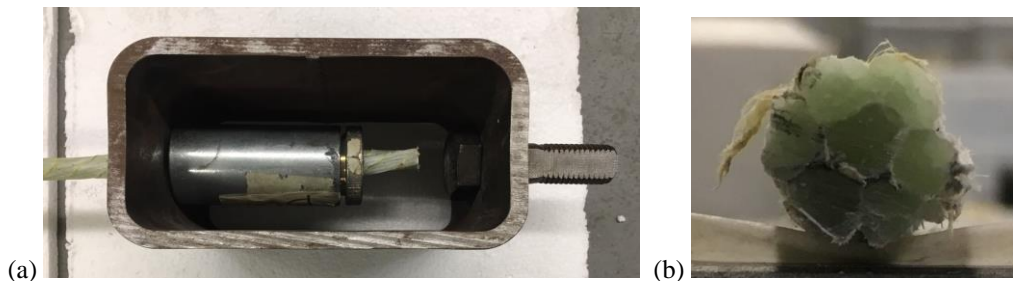
Fig. 15 (a) Steel chuck installed on strand prototype, within frame cross-heads; (b) Cross section of GFRP 7-cord twisted strand.

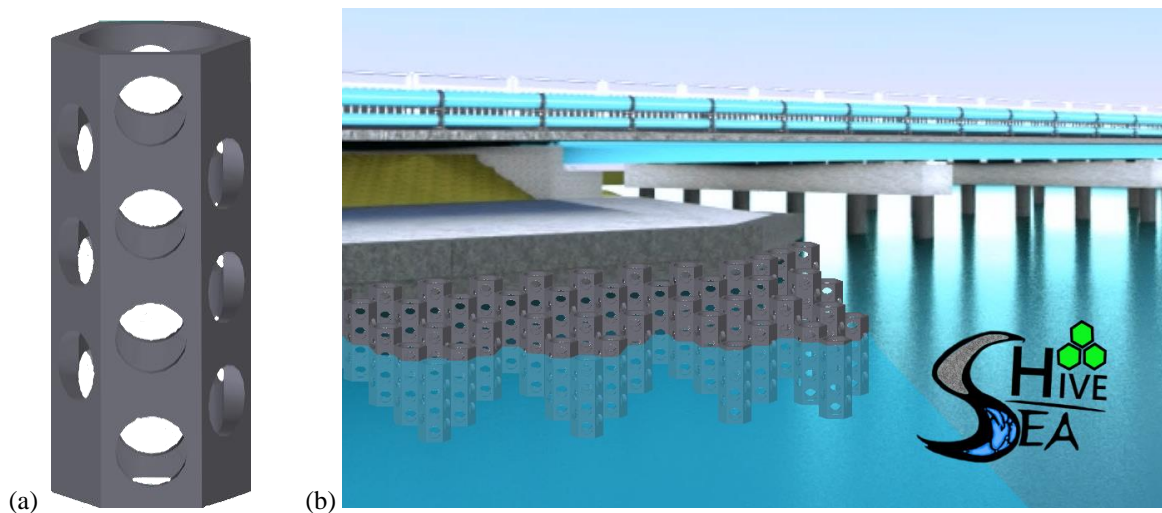
Fig. 16 (a) Prototype hextube; (b) Typical revetment application for bulkhead-seawall.

Another collaboration between the University of Miami and FDOT involves the development of engineer precast concrete revetment (Rhode-Barbarigos 2018). The proposed project focuses on developing a novel efficient, cost-effective and ecofriendly modular shoreline protection system based on perforated precast hexagonal tubes (hextubes). The hextubes can be produced with traditional pipe or precast/prestress techniques. Typically fibre-reinforced, with low alkalinity concrete and/or reduced use of portland cement, and no chloride limits (sea-concrete) concrete. Non-corrosive reinforcing (GFRP, BFRP or CFRP) is proposed for deep stacked installations or high wave energy locations and to improve compatibility with marine life and sustainability. The size and shape of the hextubes will be adapted to increase wave energy dissipation. The outer form of the hextubes has a faceted surface, which will facilitate stacking and interlocking stability, while perforations in these faces will provide passage for flow of water under surging or breaking waves, and allow for dissipation of wave energy (see Figure 16). In a system configuration, voids can also form interconnected channels providing habitat and protection for marine life.

The SEAHIVE system could be applied to the protection of existing sheet pile and bulkhead solutions, or for the replacement of deficient shoreline protection systems. It can be also coupled with non-corrosive FRP-PC sheet piles and seawall-bulkheads for a complete resilient replacement package.

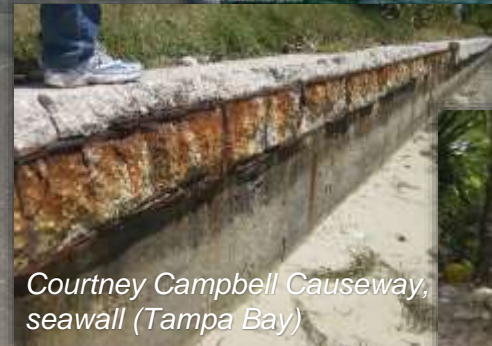
*Courtney Campbell Causeway,
seawall (Tampa Bay)*

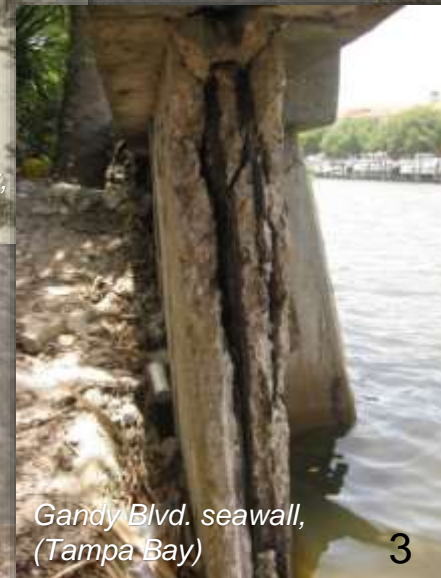
*Gandy Blvd. seawall,
(Tampa Bay)*

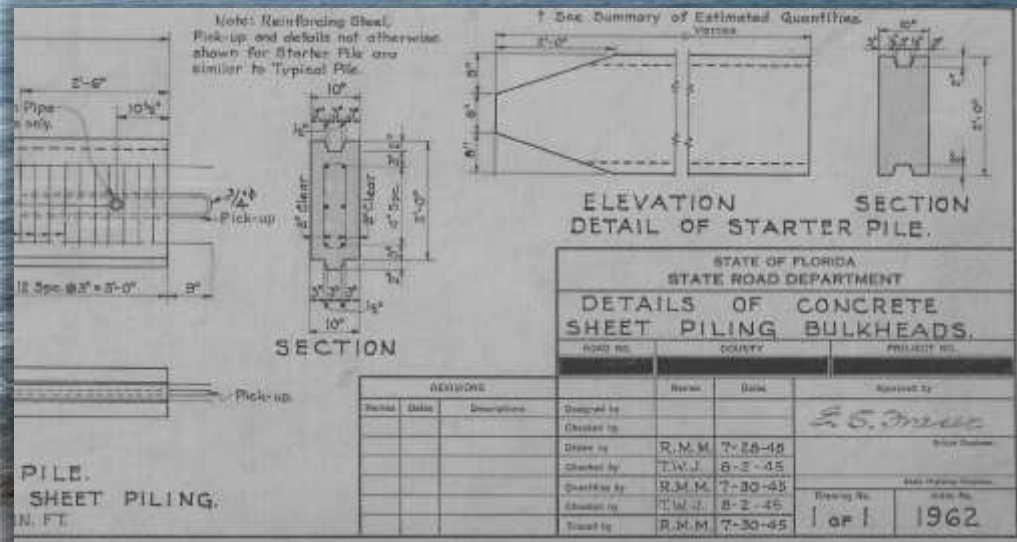
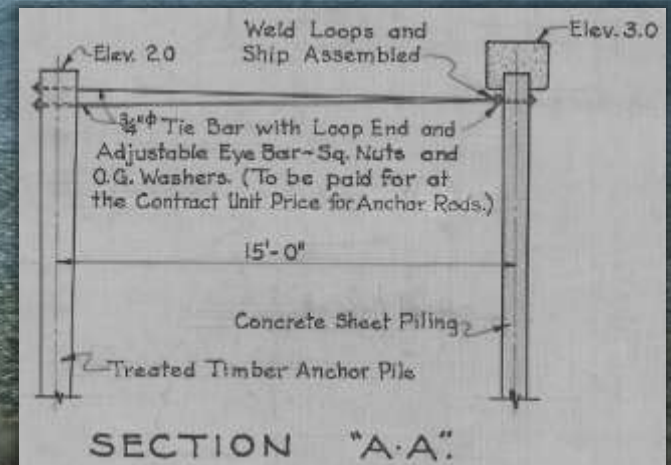
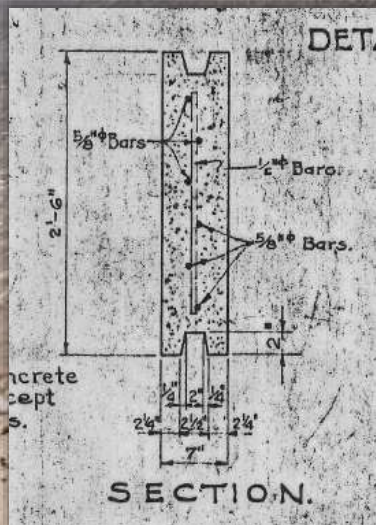
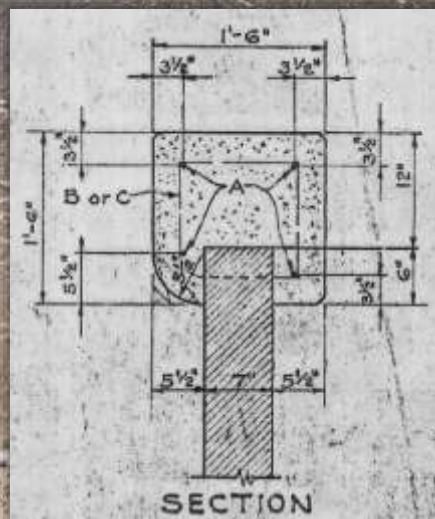
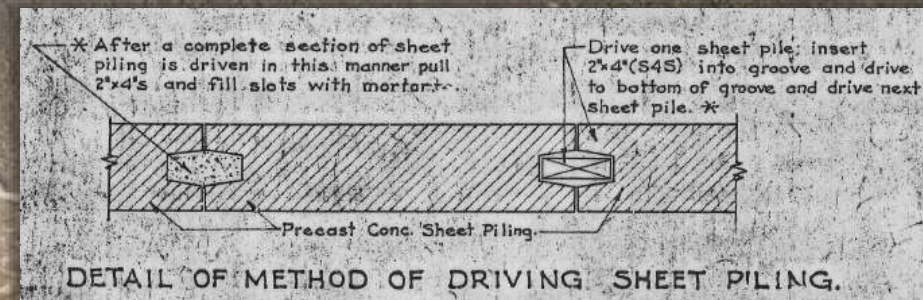
Images from 1945 (Index 1962) & 1946 (Index 2039) Standards.
Florida State Road Dept. (FDOT)

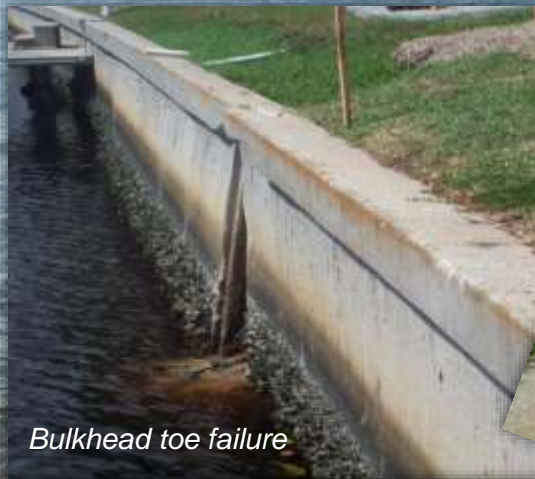
Bulkhead toe failure

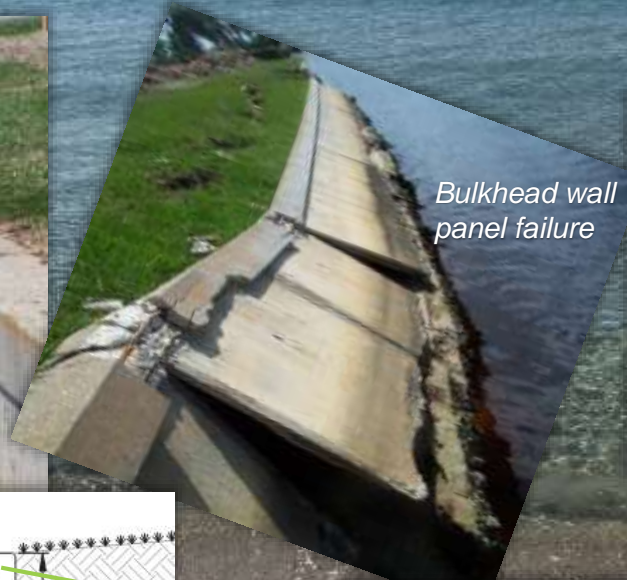
Bulkhead wall panel failure

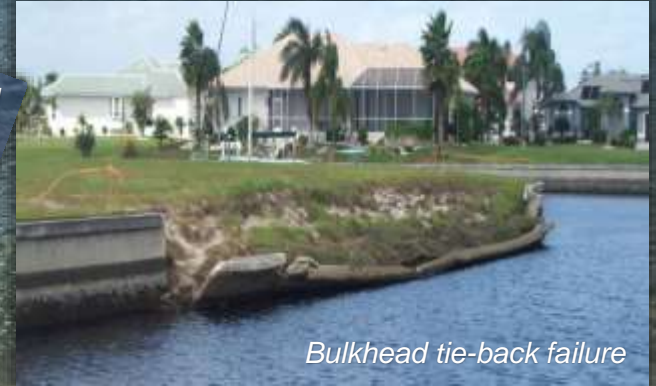
Bulkhead tie-back failure

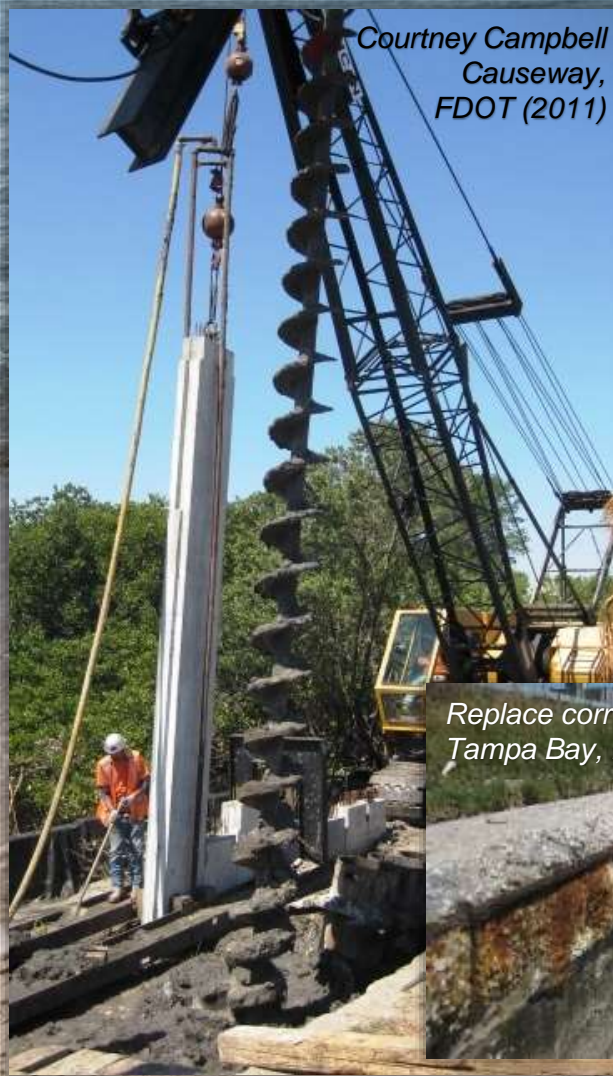
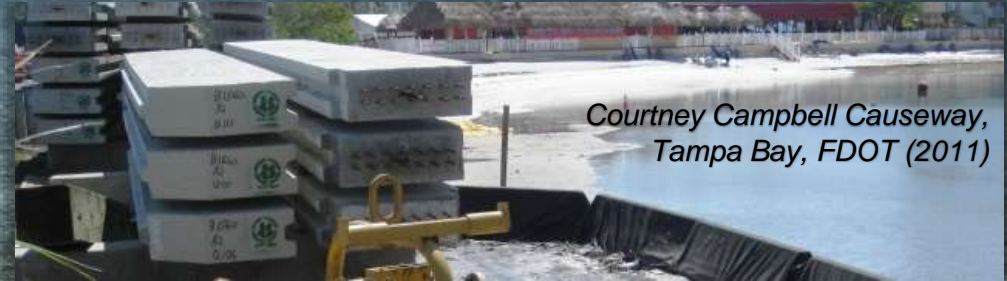
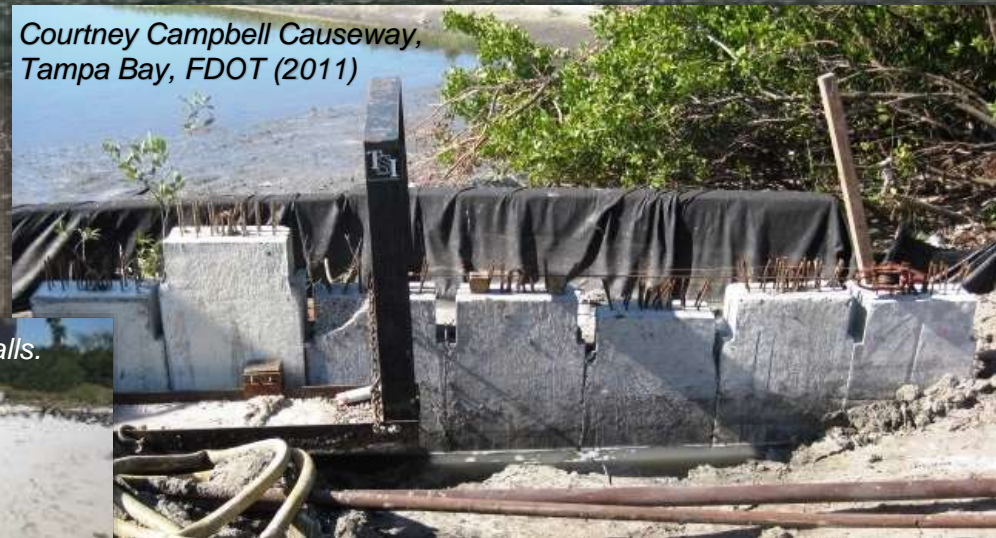
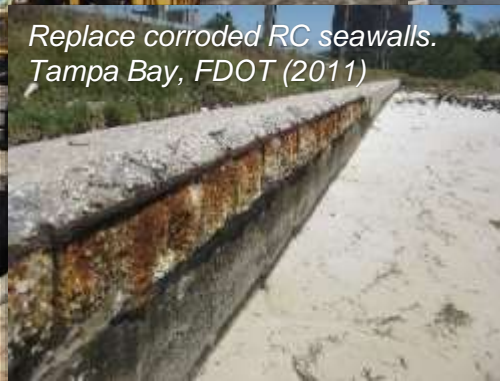
History of Seawall Development in Florida

Prestressed Concrete: since mid-1950's ...*better*

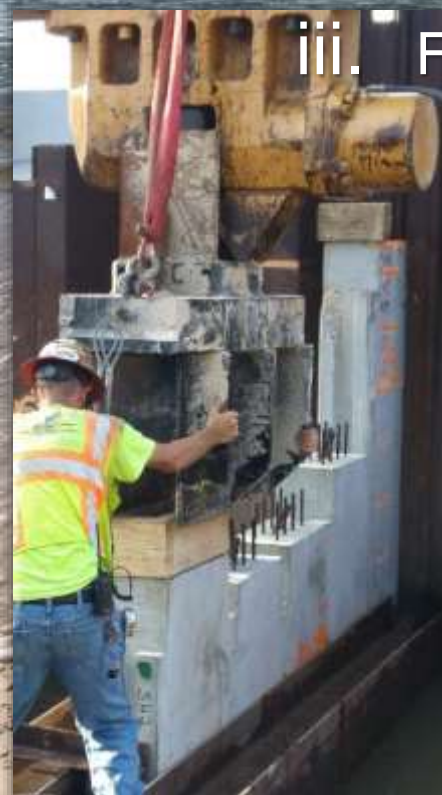
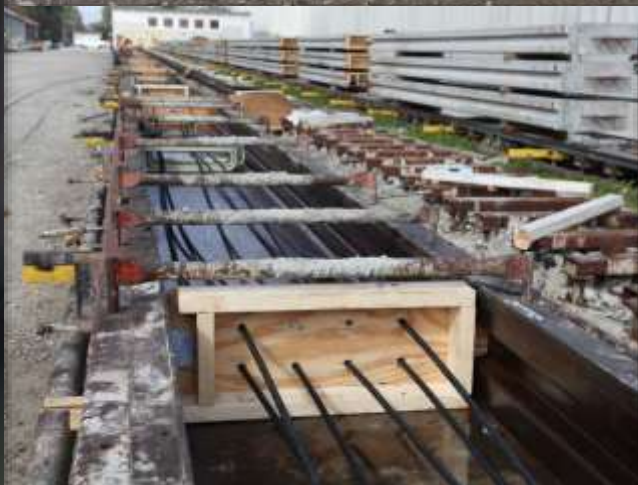
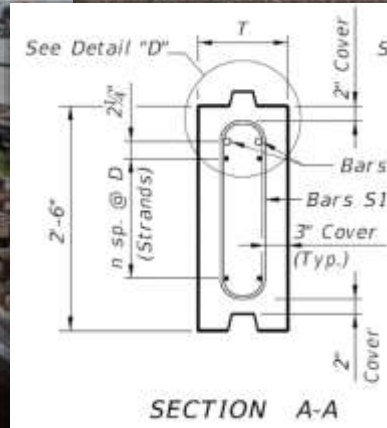
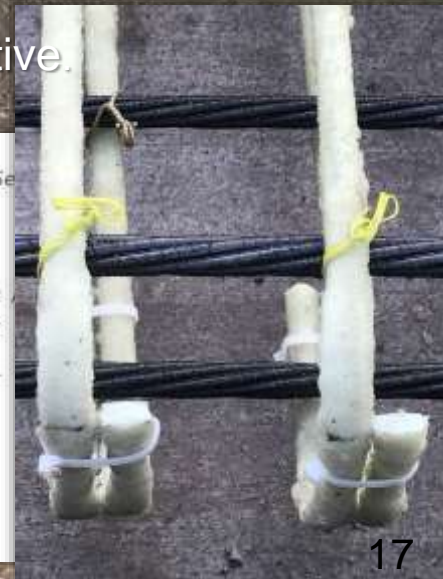
CFRP Prestressing, since 2014 ...best ?

- i. Design criteria for prestressing – **Fiber Reinforced Polymer Guidelines (FRPG)** – Chapter 3;
- ii. **Developmental Index D22440** (Nov. 2014)
 - (Halls River Bridge demonstration project);
- iii. **FDOT FY2017-18 Design Standards** (Nov. 2016)
 - Index 22440 series;
 - CFRP prestressing strands & GFRP stirrups;
 - Stainless Steel prestressed/reinforced alternative.

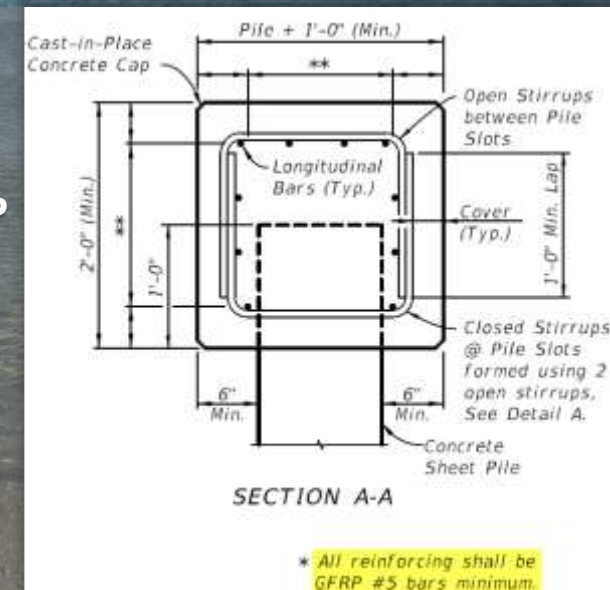
“Current” Seawall Deployment by FDOT

FDOT Standards 2018:

- i. C-I-P GFRP-RC Cap details for concrete sheet pile walls;
- ii. FDOT Specifications 415 & 932 (GFRP rebar)
- iii. Approved Producers List requirements via Materials Manual – Section 12.1 (Jan 2015);
- iv. Design criteria for rebar – Fiber Reinforced Polymer Guidelines (FRPG) – Chapter 2;
- v. Standard detailing - Structures Detailing Manual (SDM) - Chapter 19.5.1 and special GFRP Instructions IDDS-D22440 (Jan 2015).

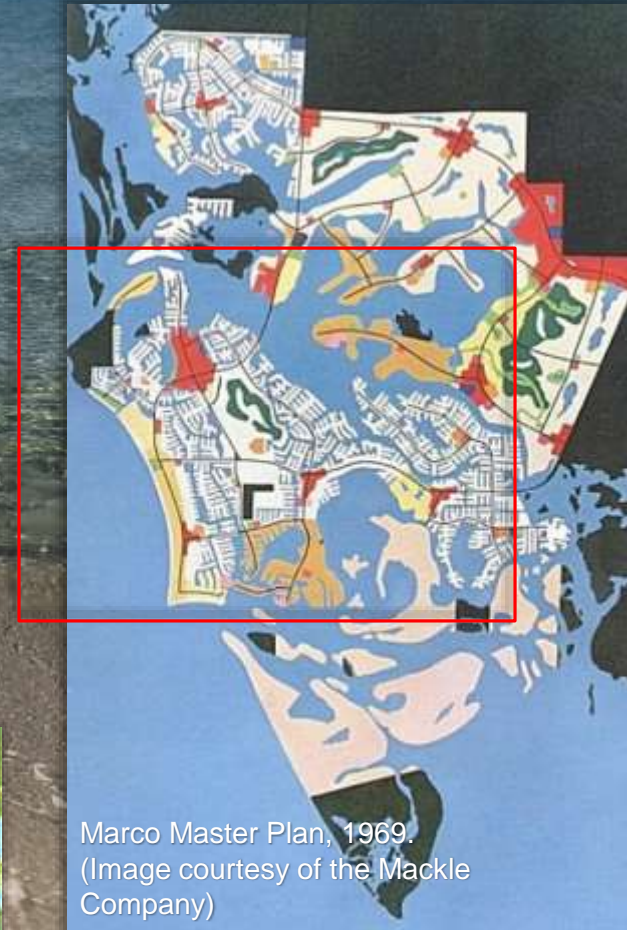
Marco Master Plan, 1969.
(Image courtesy of the Mackle Company)

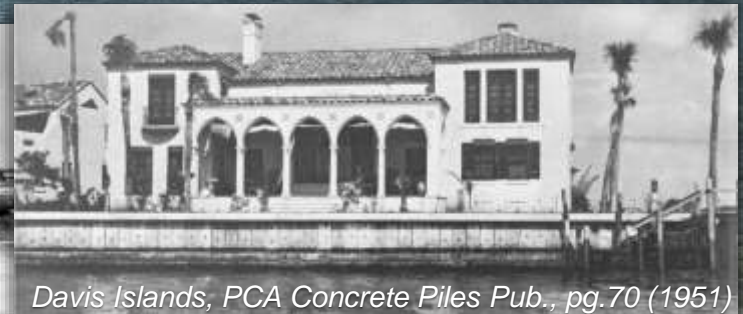
Davis Islands, PCA Concrete Piles Pub., pg.70 (1951)

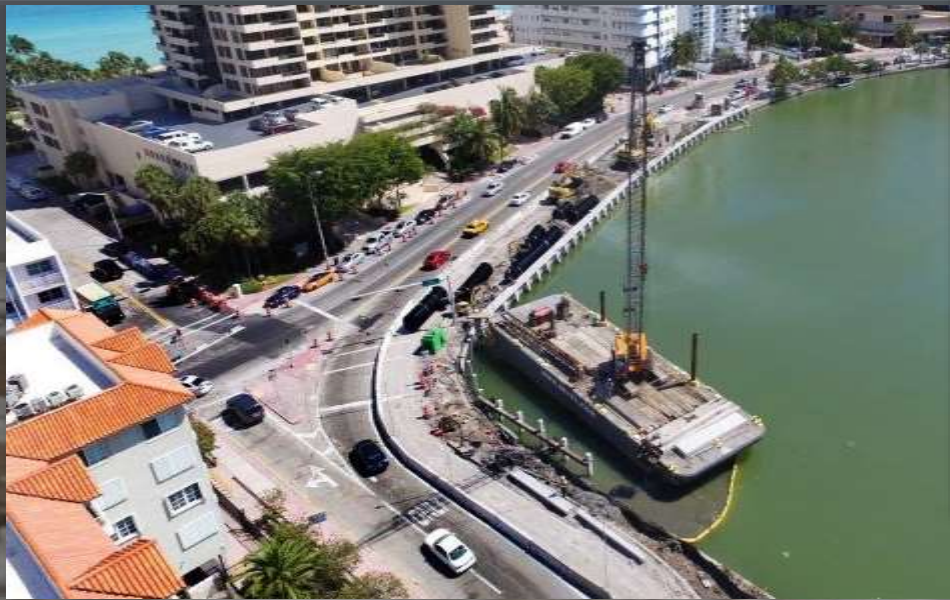
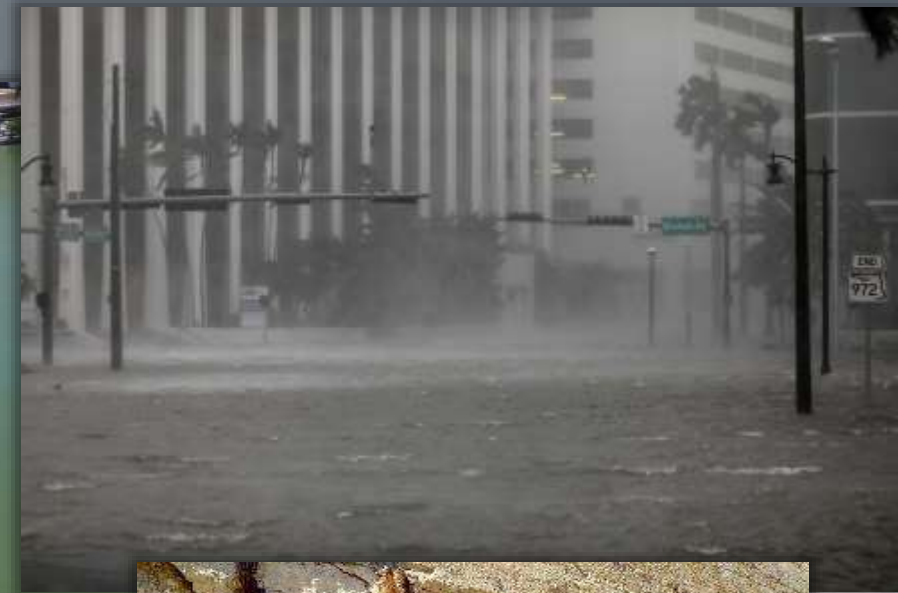
- (a) Miami Beach seawall bulkhead and road raising project. *(Photo / Bruce Mowry, city engineer (2017);*
- (b) Brickell Ave under water during Hurricane Irma (2017)
- (c) Inevitable corrosion of prestressing steel in concrete structures in marine environments;

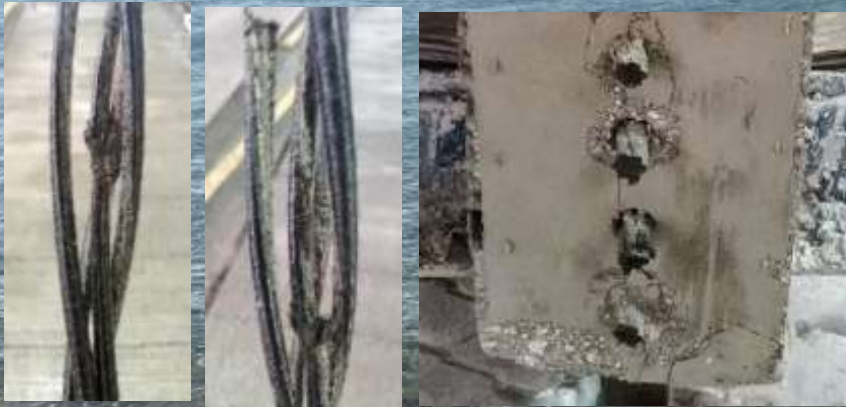
(a) & (b) CFRP strand failed during tensioning; (c) cracking following strands release.

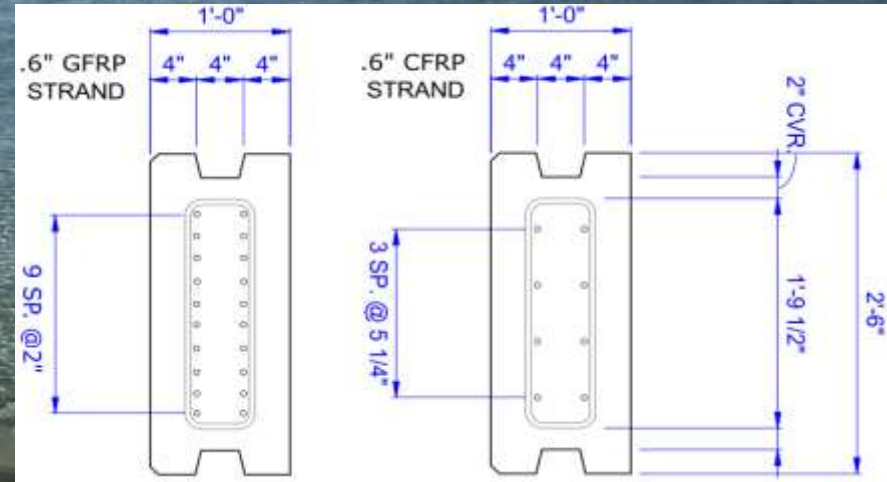
(a) GFRP-PC sheet pile concept (b) CFRP-PC sheet pile design for Halls River Bridge

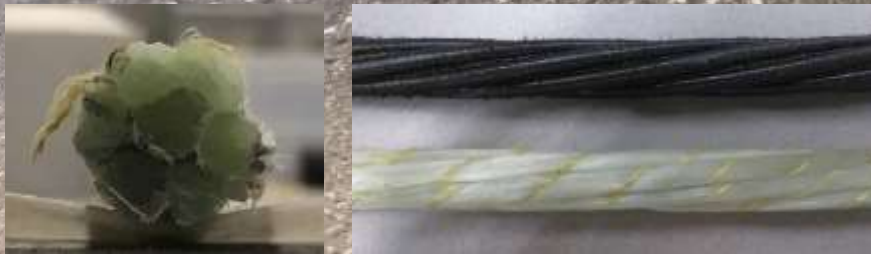
(a) GFRP strand prototype cross section; (b) compared to a CFRP alternative.

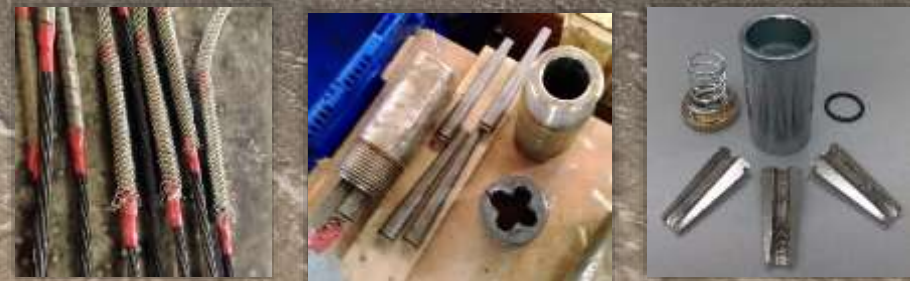
(a) & (b) Tensioning apparatus for CFRP; versus (c) standard steel HSCS chucks, for GFRP.

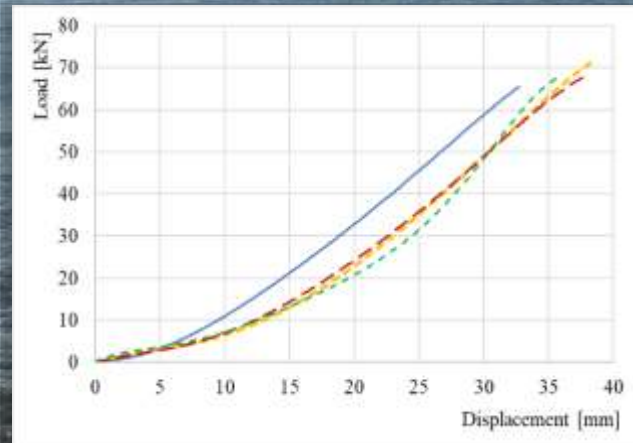
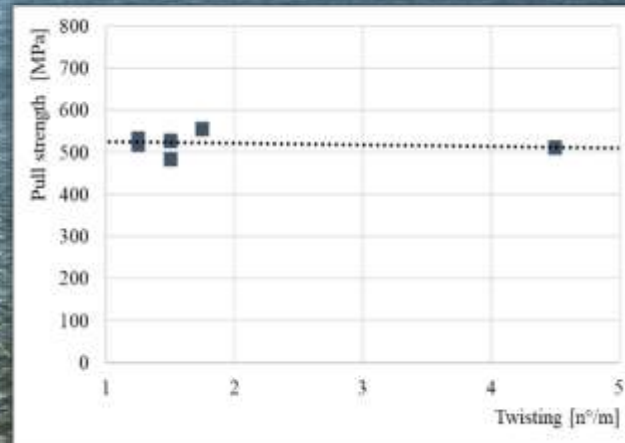
Pull test load-displacement diagrams (a), and pull strength at varying twist per meter (b).

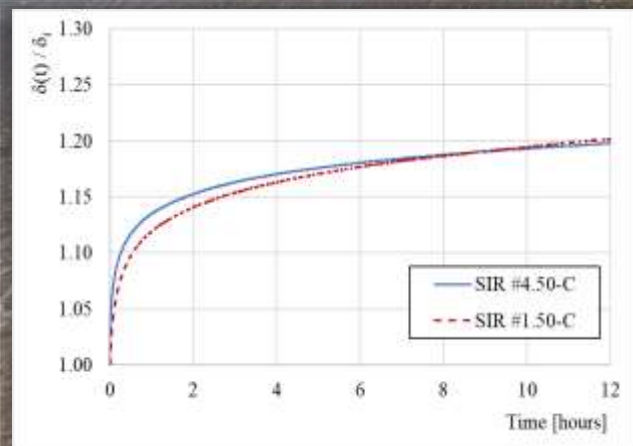
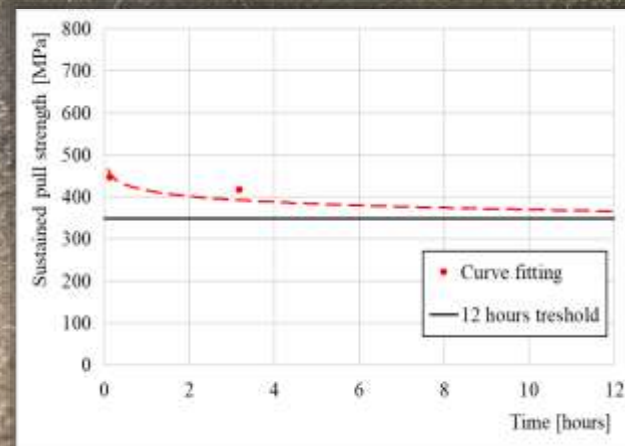
Creep displacement over initial value (a), and creep rupture logarithmic regression (b).

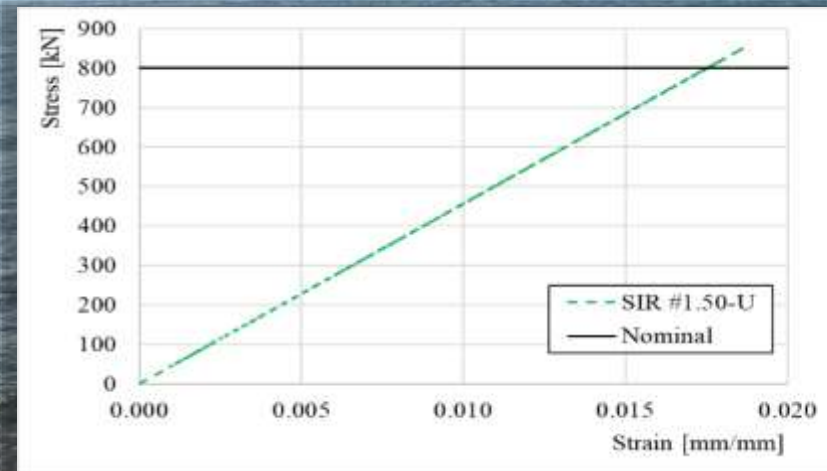
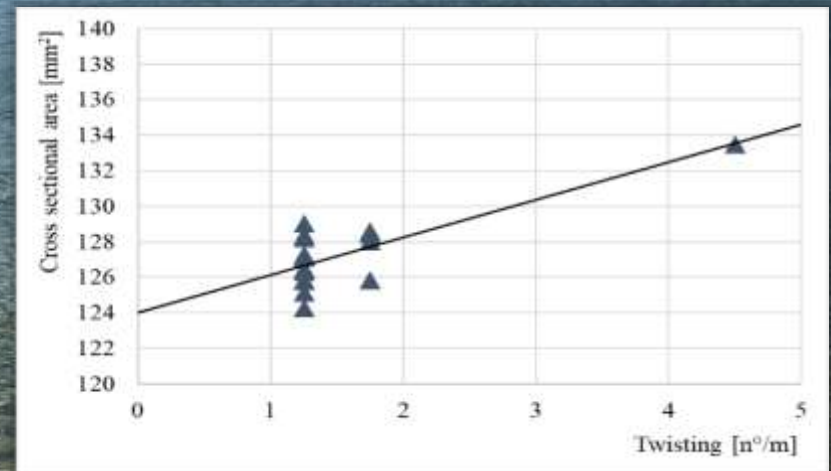
(a) Tensile test stress-strain diagram, (b) cross-sectional area at varying twist per meter.

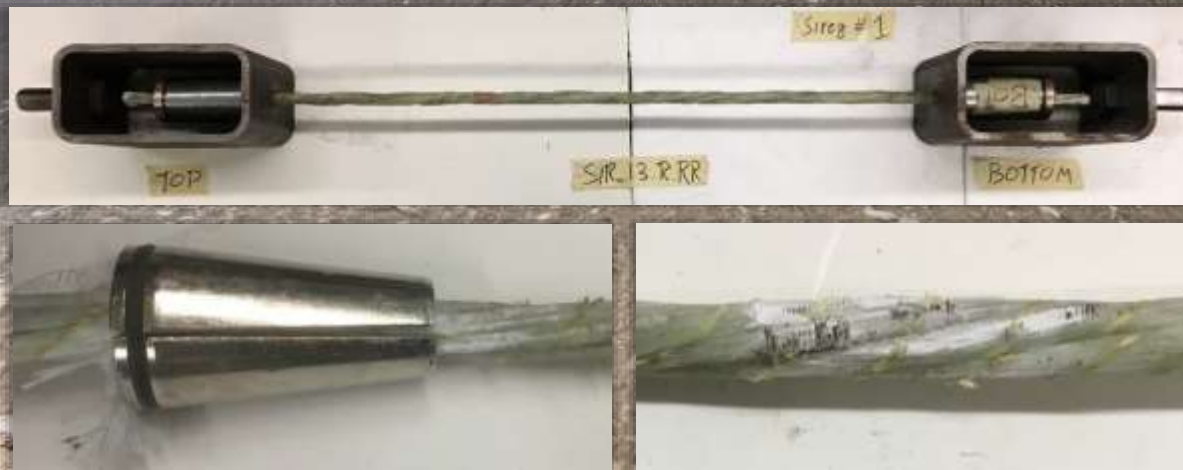
- (a) GFRP strand ready for pull test;
- (b) After tensile pull test at showing wedge grip;
- (c) and surface beneath wedge grip .

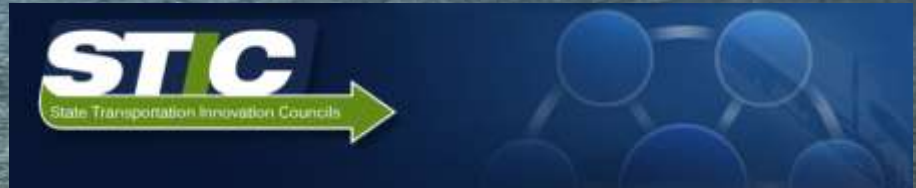
“Develop standard (guide) design specification, and standard material and construction specifications for basalt fiber-reinforced polymer (BFRP) bars for the internal reinforcement of structural concrete”

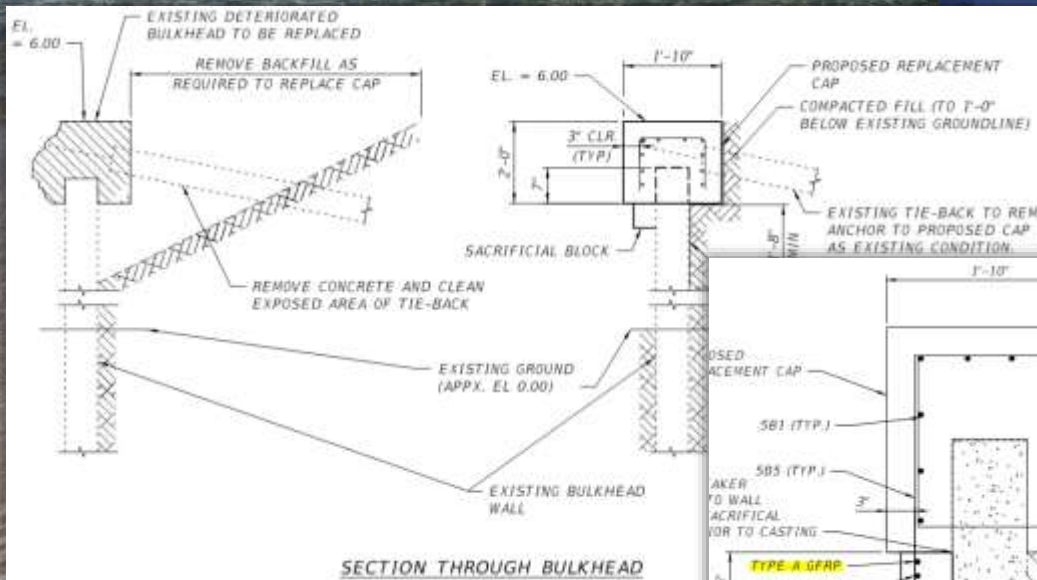
GFRP BAR TYPE CHART

TYPE A	SIZE 5 GFRP BAR COATED WITH GRANULAR MATERIAL AND WITH SURFACE INDENTATIONS/DEFORMATIONS CREATED BY HELICAL WRAPPING.
TYPE B	SIZE 5 GFRP BAR COATED WITH GRANULAR MATERIAL AND WITHOUT SURFACE INDENTATIONS/DEFORMATIONS.
TYPE C	SIZE 5 GFRP BAR COATED WITH POLYMER (NO GRANULAR COATING) AND WITH SURFACE INDENTATIONS/DEFORMATIONS CREATED BY SHAPING THE POLYMER COATING (NO EXTERNAL WRAPPING).
TABLE APPLIES ONLY TO REBAR IN SACRIFICIAL BLOCK

SECTION THROUGH BULKHEAD

914-415-105 GLASS FIBER REINFORCING POLYMER BAR

- Replacement of bulkhead cap with GFRP reinforced concrete;
- Addition of Test Blocks on underside of cap with three types of GFRP rebar surface treatments;
- FDOT State Materials Office to perform periodic sampling and monitoring.

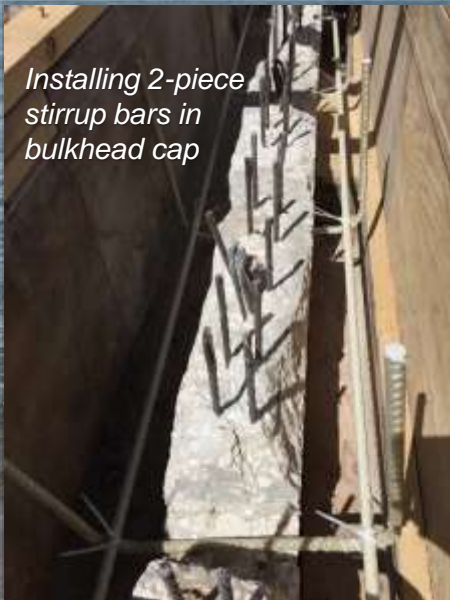
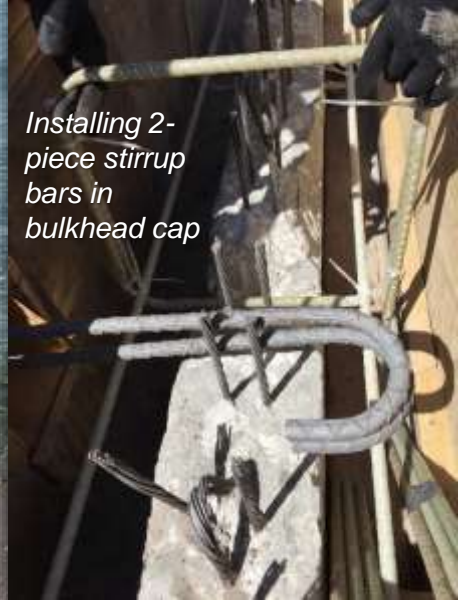
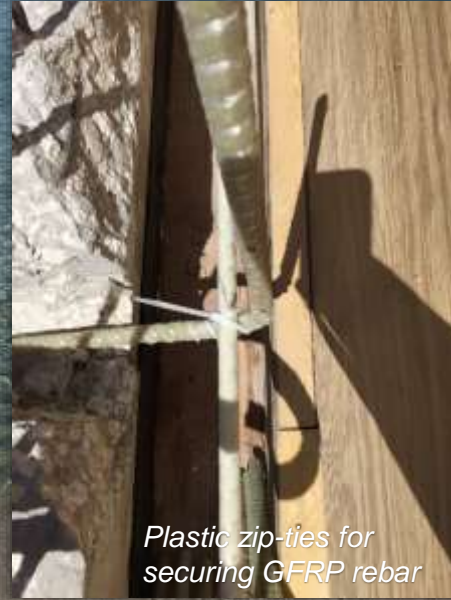
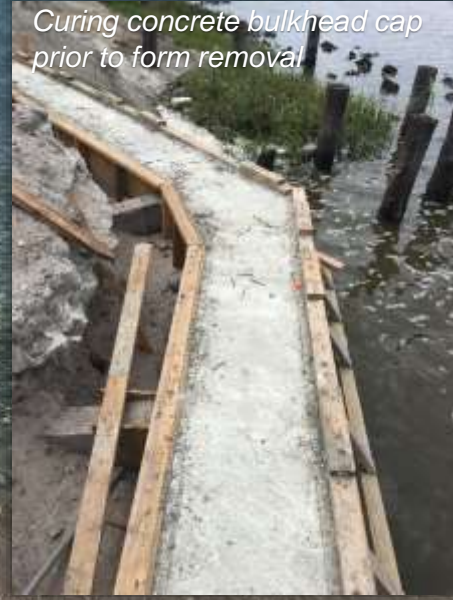
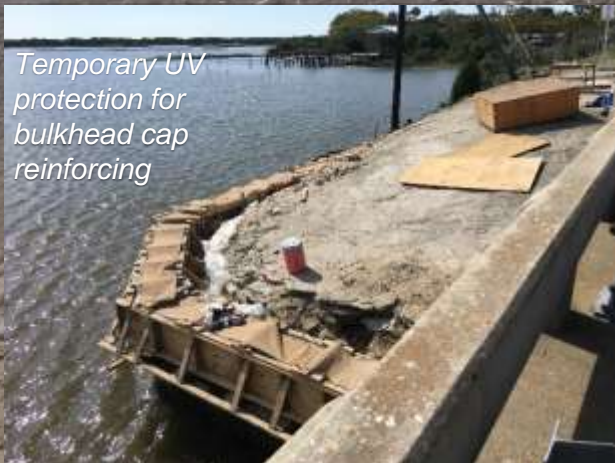
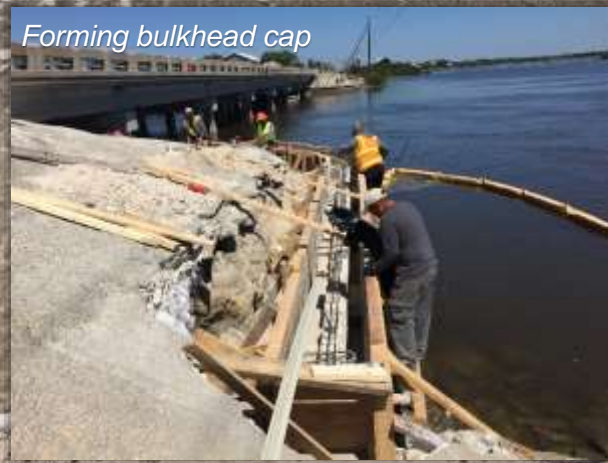
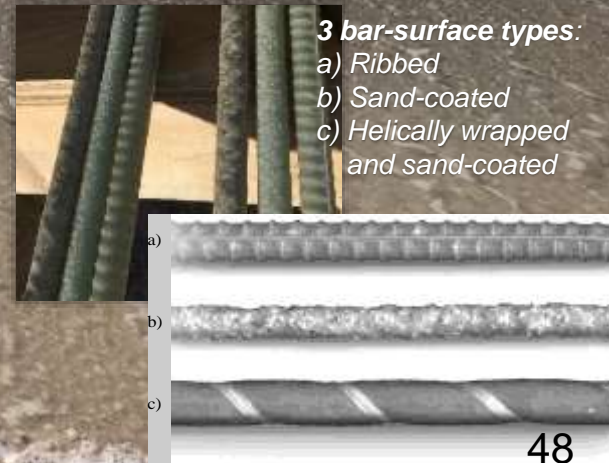
Project Example #1

Cedar Key SR24 Bulkhead Rehab.

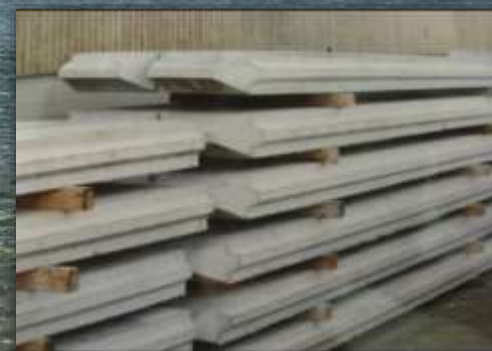
- 12"x30" Steel Reinforced : \$ 120 / ft.
- 12"x30" CFCC Reinforced : \$ 144 / ft.

(bid cost was \$265)

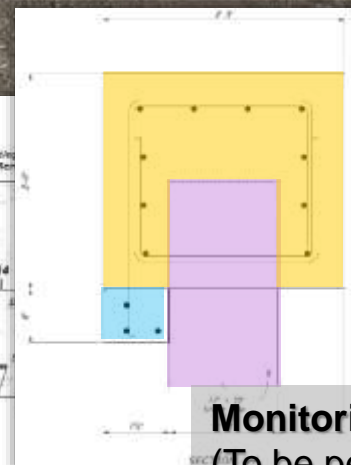
CFRP/GFRP Sheet Pile Walls

- GFRP
- CFCC
- Test Blocks

Monitoring Test Blocks
(To be periodically removed from under Bulkhead Cap)

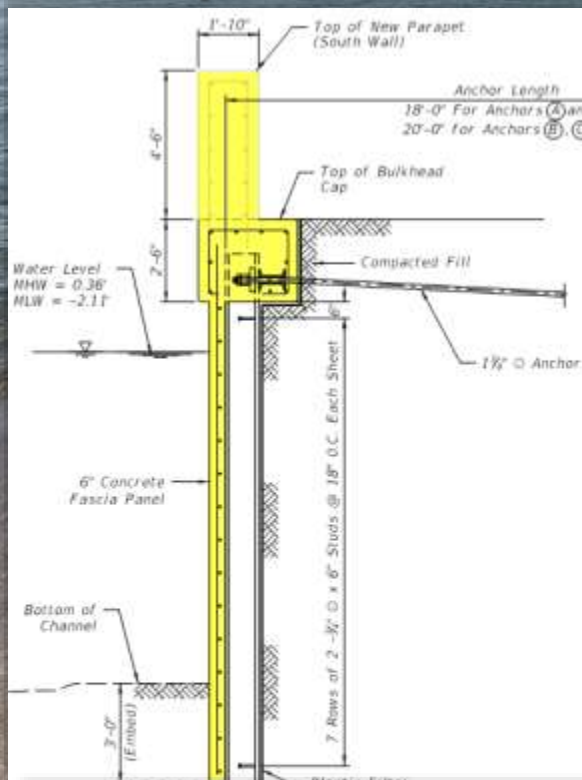
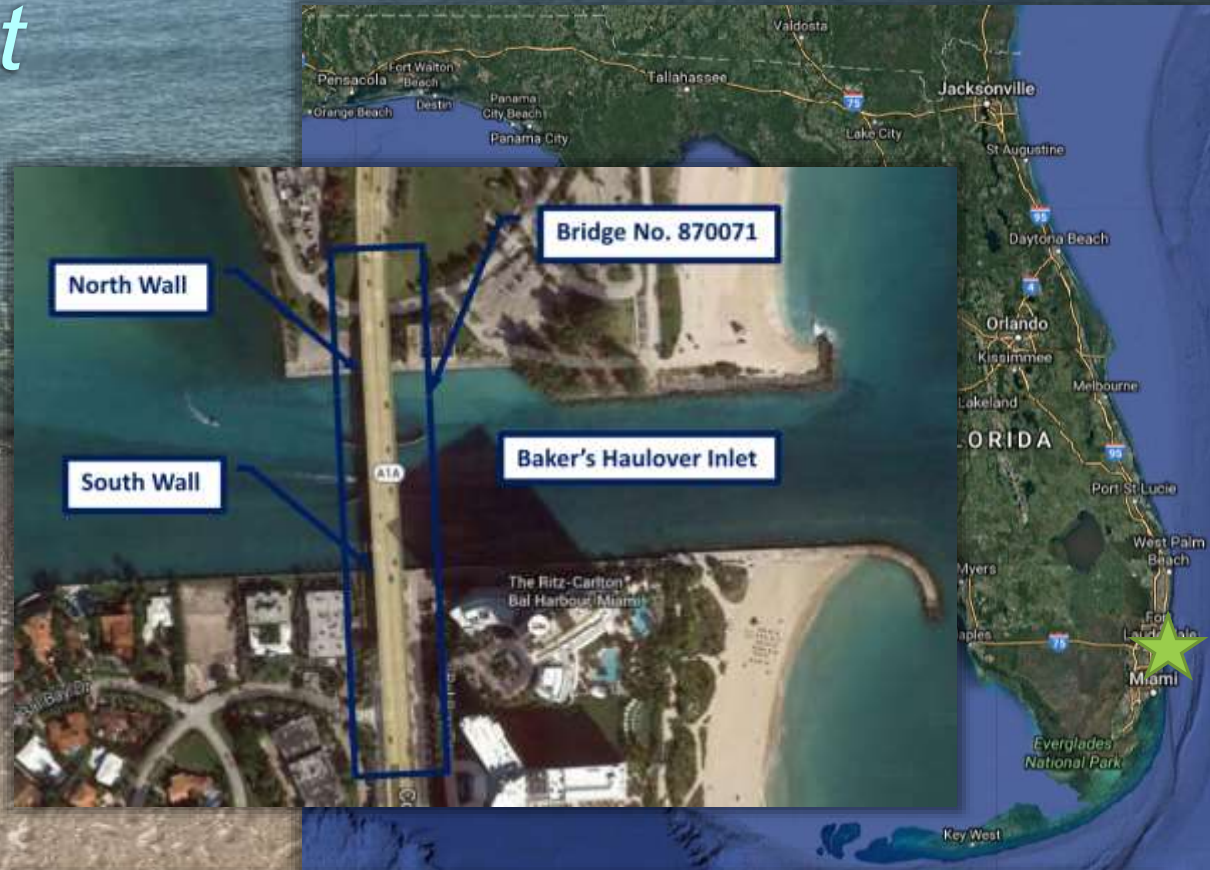
Project Example #3

Bakers Haulover Cut Bridge Bulkhead Replacement

914-415-104	FIBER REINFORCED POLYMER BAR #4	BULKHEAD CAP, PARAPET & FASCIA PANEL	LF	12,199.32
914-415-105	FIBER REINFORCED POLYMER BAR #5	BULKHEAD CAP, PARAPET & FASCIA PANEL	LF	7,071.14

- Replacement of bulkhead cap with GFRP reinforced concrete;
- CFRP/GFRP Prestressed Concrete Sheet Piles (extension);
- GFRP-RC Traffic Railing;
- No test blocks.

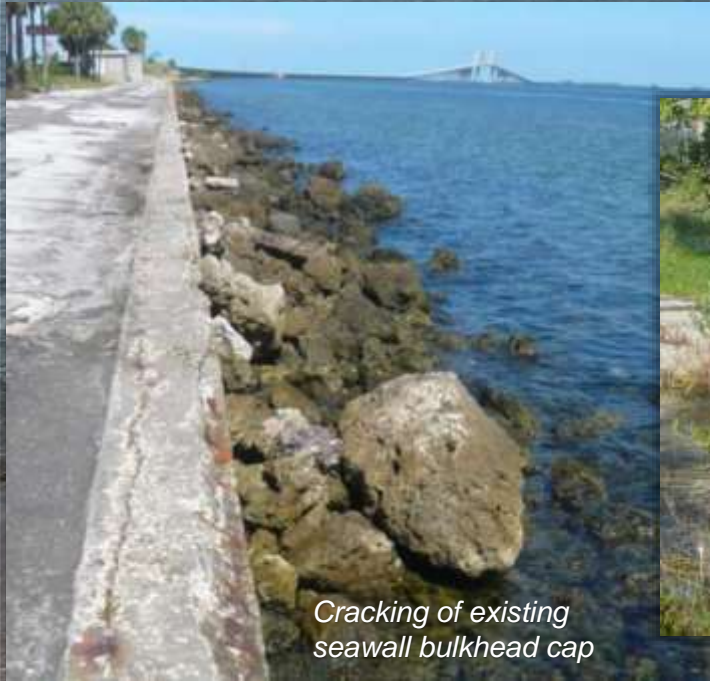
Cracking of existing seawall bulkhead cap

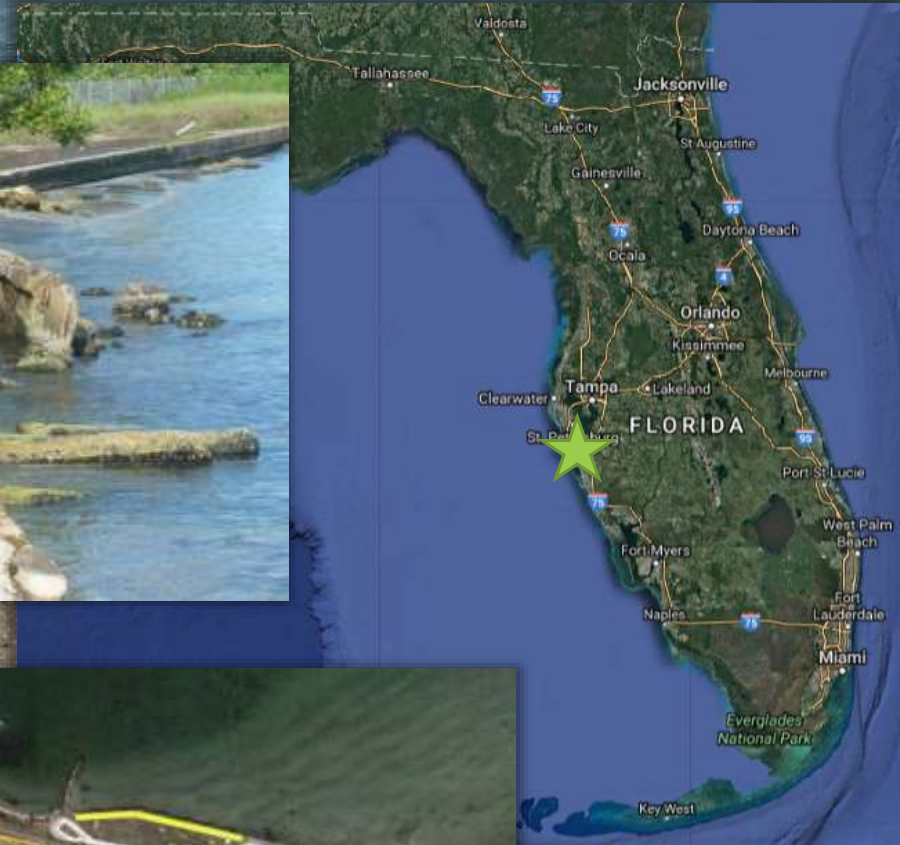
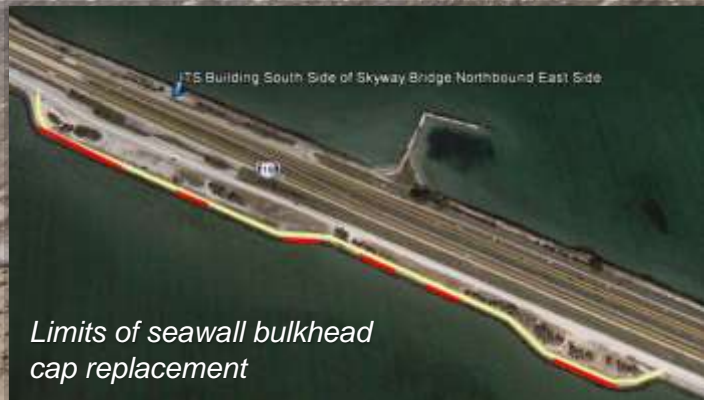
Limits of seawall bulkhead cap replacement
