ORDINANCE NO. 2021-006

AN ORDINANCE OF THE MAYOR AND COMMISSION OF NORTH BAY VILLAGE, FLORIDA, AMENDING THE VILLAGE UNIFIED LAND DEVELOPMENT CODE OF ORDINANCES BY CREATING SECTION 8.16, ENTITLED, “SEA WALL STANDARDS,” IN DIVISION 4, “SUPPLEMENTAL DEVELOPMENT STANDARDS,” CHAPTER 8, “ZONING”; ESTABLISHING SEA WALL DESIGN STANDARDS THROUGHOUT THE VILLAGE; PROVIDING FOR CONFLICTS; PROVIDING FOR SEVERABILITY; PROVIDING FOR INCORPORATION; PROVIDING FOR IMPLEMENTATION; AND PROVIDING FOR AN EFFECTIVE DATE

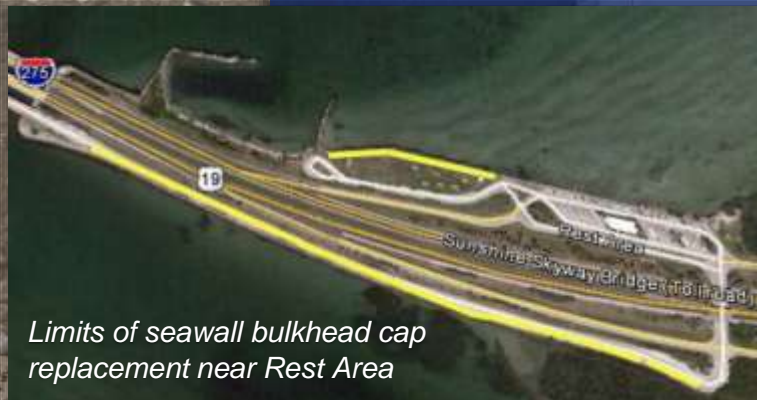
Limits of seawall bulkhead cap replacement near Rest Area
